## Detailed study of interphase degradation in SiC/BN/SiC ceramic matrix composites after elevated temperature tensile testing

<sup>c</sup> Rolls Royce plc., Derby DE24 8BJ, UK

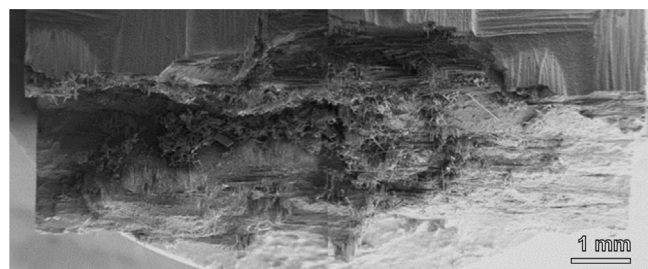
(a) CMC1000

Fig. 2. SEM images of the fracture surfaces from the tensile creep test. The top of the images show the edge of the fracture surface and a small section of the sample surface which was exposed during the test.

SEM imaging of the fracture surfaces reveals fractured fibres and fibre pull out, see Fig. 2. The amount of fibre pull-out varies between samples, with less fibre pull out in the samples tested at lower temperature and longer time until fracture. The sample tested at 1000 °C has very minimal fibre pull out along the edges, as can be seen by the fibres having fractured at a plane close to that of the matrix, and fibre pull out across the internal regions of the sample, see Fig. 2(a). This type of “picture frame” degradation has been seen before and is attributed to early degradation along the surface, leading to cracks propagating also through the fibres due to changed interface and interphase properties. The remaining fibres cannot withstand bearing the load and the sample fractures, but with fibre pull out in the centre where the interphase is still close to the as-manufactured state and deflects cracks as intended [32,42,44].

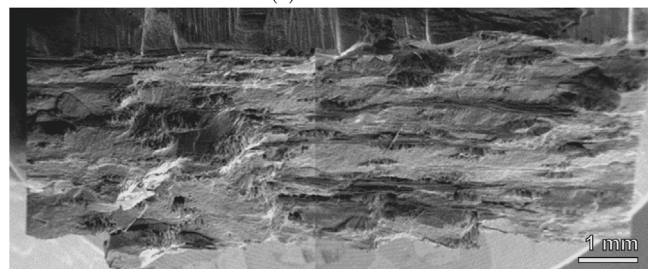
(b) CMC600

The sample tested at 600 °C has less fibre pull out of shorter fibres, again with fibres fractured close to the matrix plane dominating around the edges, see Fig. 2(b). Finally, the sample tested at 400 °C has almost exclusively fibre fracture close to the matrix fracture plane all across

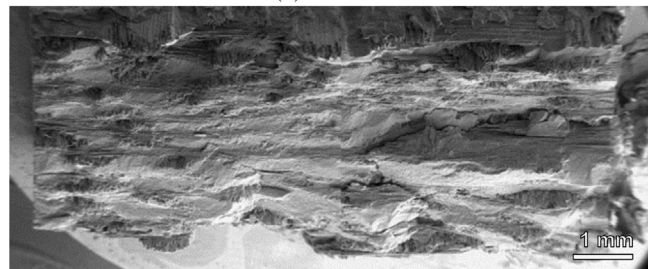
(c) CMC400

the fracture surface, and minimal fibre pull out, see Fig. 2(c). Thus, in the sample tested at 400 °C the early degradation along the surface did not lead to significant fibre fracture and transfer of load, instead the degradation was allowed to penetrate the entire sample before significant fibre fracture occurred, leading to more or less complete loss of the crack deflecting properties of the interphase.

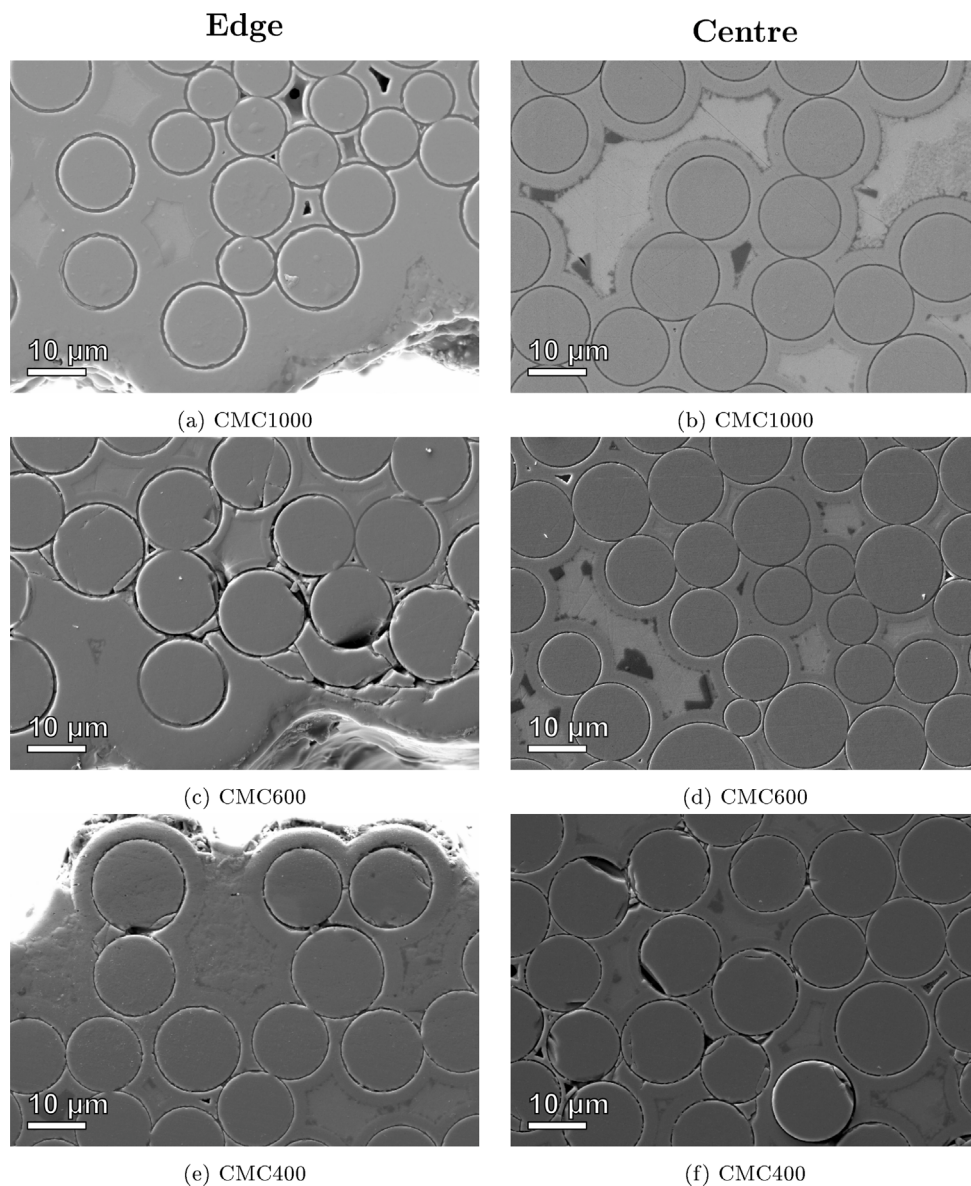
The polished cross sections show that in the centre, the microstructure of the CMC1000 sample looks very similar to a pristine one [26,33] with even contrast in the interphase, see Fig. 3(b), the CMC600 sample has some variations in contrast in the interphase, see Fig. 3(d), and finally the CMC400 sample has both uneven BN interphase and fractured fibres, see Fig. 3(f). In images acquired at the cross section edge, all samples show uneven boron nitride interphase as well as cracks and chipping in the SiC fibres, which both are indications of degradation of the interphase and fibres. The uneven contrast of the BN interphase and the chipping of fibres as seen in Fig. 3 can only be interpreted as an indication of degradation, rather than a confirmation. As such it tells the same story as the fracture surfaces, namely that at the higher temperatures failure happened before the degradation could reach the centre, while the samples tested at lower temperature had time for transport of oxidising agents also to the centre. The investigation of the TEM-lamella will provide details and confirm this.

Fig. 3. SEM images of the cross sections showing the edge of the sample (the original sample surface) (a, c and e) and parts of a fibre tow from the centre of the sample (b, d and f).

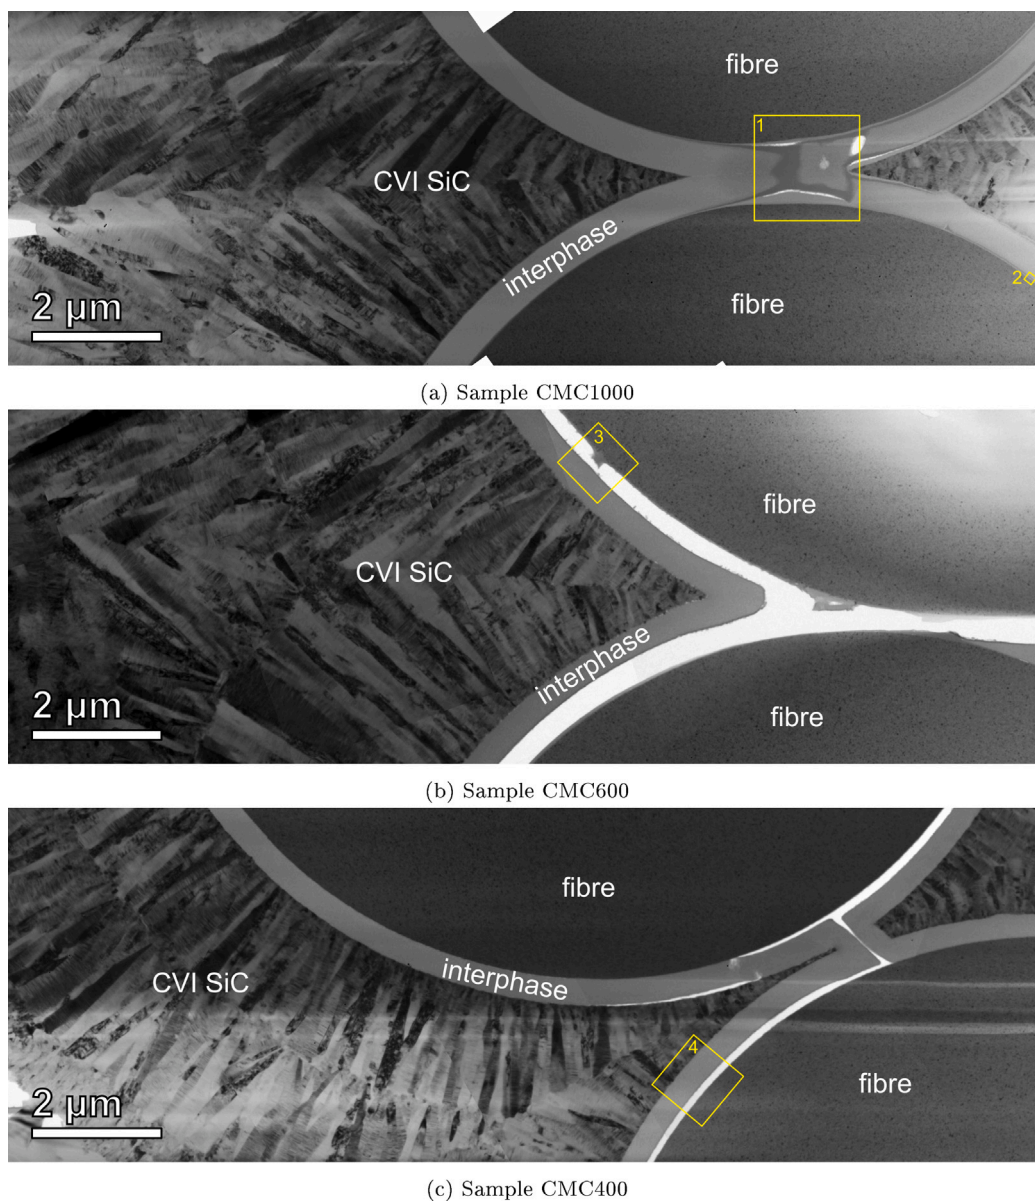
Overview images of the electron transparent region of all surface samples can be seen in Fig. 4. Samples CMC600 and CMC400 have cracks between fibre and interphase, indicative of inside debonding. They were present already during the early stages of sample preparation and not caused by the ion milling. The following will focus on the interphase as well as the interfaces between fibre and interphase and CVI SiC and interphase.

Fig. 4. Bright field TEM images of the surface samples. Yellow squares show where more detailed investigations were made.

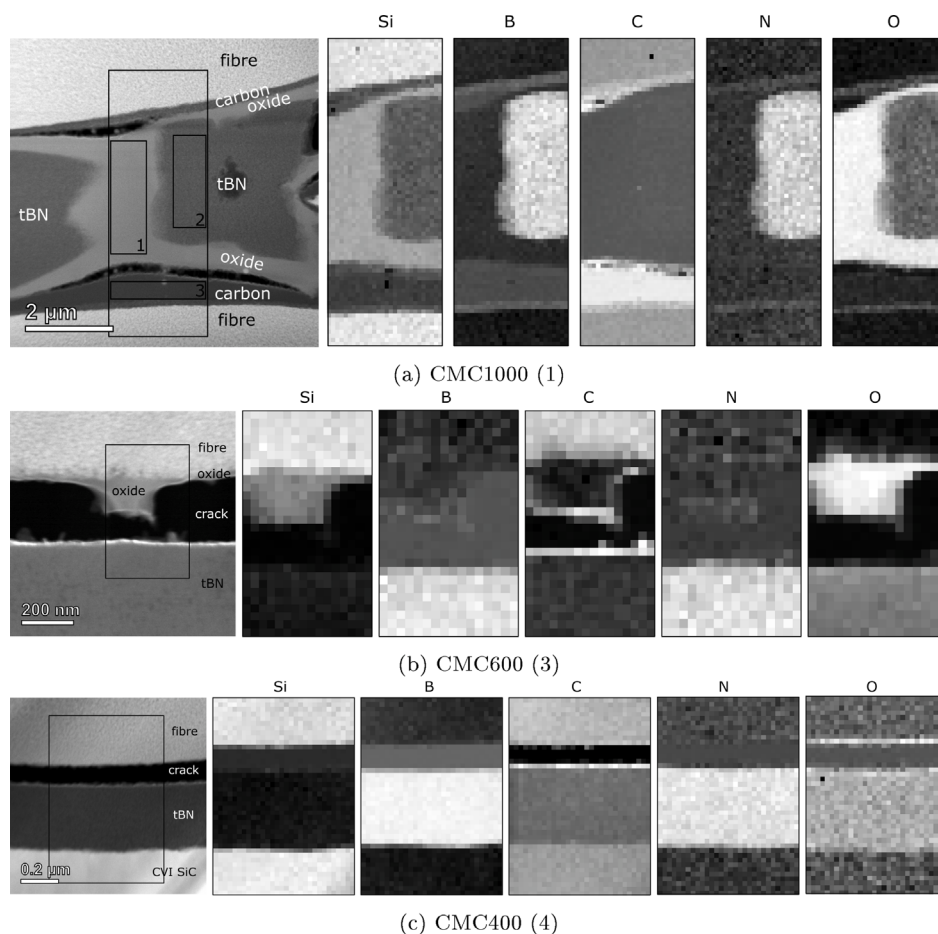
From the elemental maps produced by EELS analysis, see maps in Fig. 5, it is possible to see that all surface samples have oxide layers at the fibre/interphase interface, or in the case of a crack separating the fibre and interphase the oxide is at the fibre surface. The thickness of the oxide layer increase with temperature, approximately 20 nm for sample CMC400, 80 nm for sample CMC600 and 20 to 200 nm for sample CMC1000.

It is evident that the oxide layers differ between CMC1000 and the other two samples, where the former has oxide layers on both fibre and CVI interfaces, see oxygen maps in Fig. 5(a) and in Figure S8 in the Supplementary Information, and the latter have oxide layers on only the fibre, see Fig. 5(b) and Figures S9 and S10 in the Supplementary Information for CMC600 and 5(c) for CMC400. The oxidation seems to have been especially severe in the area where the two fibres are separated by only interphase in CMC1000, where the oxide layers following the fibre/interphase interface form a bridge that joins the

In some areas of sample CMC1000 there is an additional layer of carbon, see Fig. 5(a). This carbon also stretches into layers following parts of the interfaces between interphase and SiC. EELS fine structure analysis confirms that this is amorphous carbon, see Fig. 9. Similar amounts of carbon were not found in any of the other surface samples which indicate that it is not an artifact from sample preparation or surface treatment of the fibres during sample manufacturing. It is likely

Fig. 5. Elemental maps from all samples. Numbers in parentheses show where the maps were acquired, referring to the numbering of yellow squares in Fig. 4.

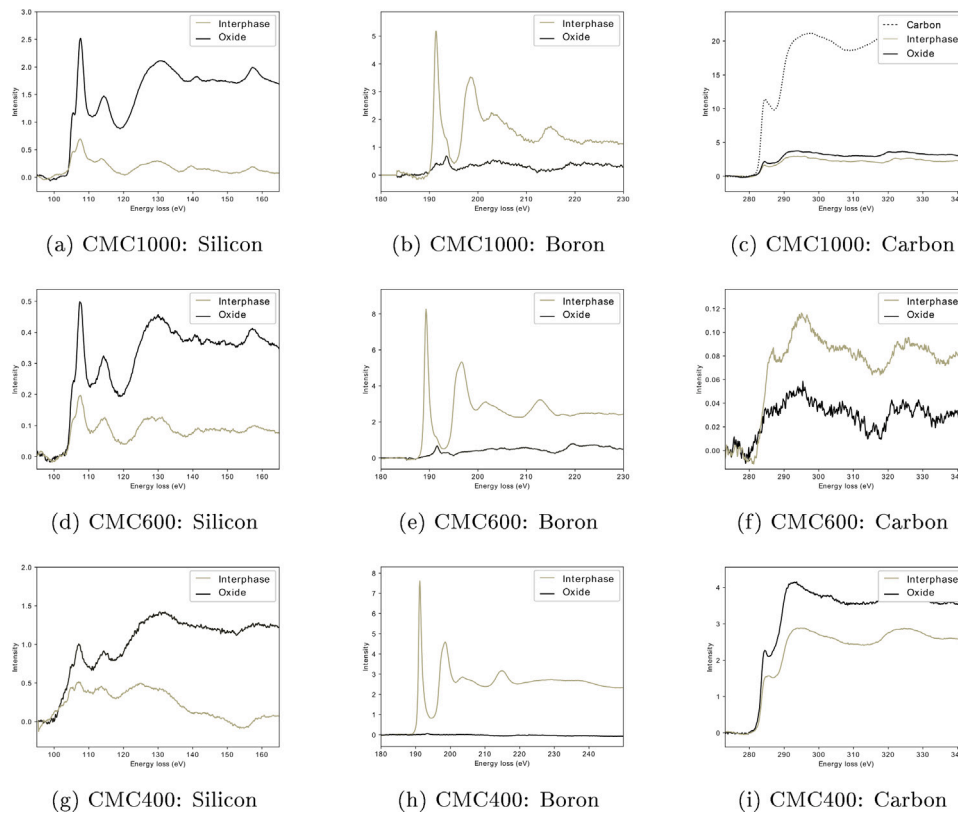
fibres together see Fig. 5(a). Selected area diffraction and the EELS silicon edge from the oxide bridge show that it is amorphous silica, see Fig. 6(a) and compare to Figure S7a in the Supplementary Information. It can also be seen from the boron spectra, see Fig. 6(b), that there are small amounts of boria in the same area, indicating a borosilicate with low boron content. In general, the oxide layers of CMC1000 had detectable amounts of both silica and boria, while those of CMC600 and CMC400 showed clear signal for silica, see Fig. 6, and may have a weak boria signal, but it is too weak to properly determine if it is present, see Figs. 6(e) and 6(h). Inspecting the oxide layer in CMC600 there are features such as the one in Fig. 5(b), that have a shape similar to what one would expect from necking in a viscous fluid. This would require boria in the oxide as 600 °C is below the glass transition temperature for pure silica. The feature in Fig. 5(b) has increased amounts of boron at the edge closest to the interphase, indicating that the oxide and interphase were connected before complete separation of the surfaces.

The boron signal from the tBN interphase of sample CMC1000, see Fig. 6(b), show that the signal is dominated by tBN, but the small shoulder at about 1.5 eV above the first peak indicate that there is also some boria in the interphase, along with silica as can be seen in the silicon spectra from the same region in Figs. 6(a) and 8(b). Both CMC600 and CMC400 also show signs of silica in the interphase, see Figs. 6(d) and 6(g), while boria could be identified in CMC600 but not clearly in CMC400, see Figs. 6(e) and 6(h). The silica in the interphase is again indicative of a diffusion of silicon containing species as a part of the oxidation process.

Fig. 6. Spectra from interphase and oxide layers of the surface samples of CMC1000, CMC600 and CMC400. CMC1000 spectra are from the regions marked 1 (oxide), 2 (interphase) and (3) carbon in Fig. 5(a). Spectra in (b), (e) and (g) were post-processed for background correction in Digital Micrograph.

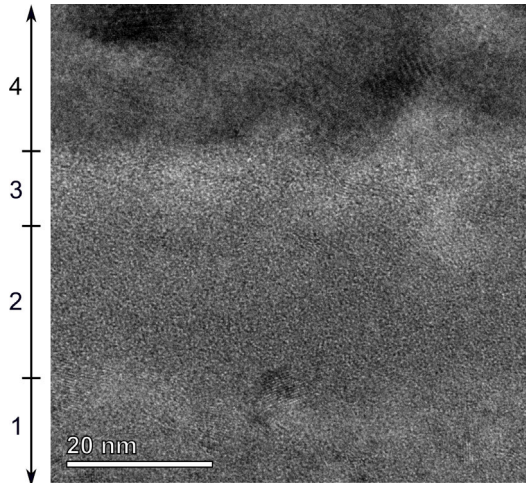
Fig. 7. HR-TEM image across the layered structure, showing fibre (4), an unknown layer (3), an amorphous oxide layer (2) and interphase (1). The image is taken from the region marked 2 in Fig. 4(a).

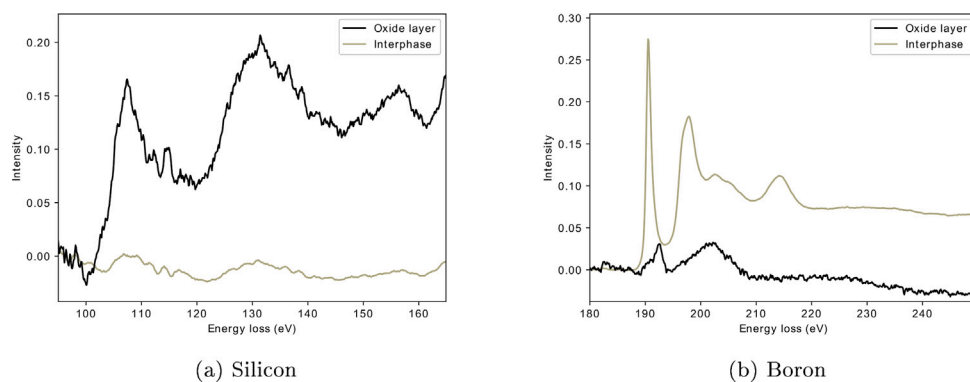
show that this region consist of silica, and this silica layer also contain boria, as seen in Fig. 12(b). A weak silica signal was also found on the other side of the crack at the edge of the interphase, and a weak silica signal can be found throughout the interphase, see Fig. 12(b). This indicates that the test conditions did enable boria formation and it is likely that boria was formed also on the surface but the proximity to the atmosphere allowed for sufficient exposure to water for volatilisation of boria according to reaction (5), which led to the lower signal in the surface samples.

Fig. 12. Spectra from the interphase and oxide layer of the centre sample of CMC400.
