Some observations on the breakage of ultrasonic files driven piezoelectrically

Ahmad M, Roy RA. Some observations on the breakage of ultrasonic files driven piezoelectrically. Endod Dent Traumatol 1994; 10: 71-76. © Munksgaard, 1994.

Majinah Ahmad, Ronald A. Roy

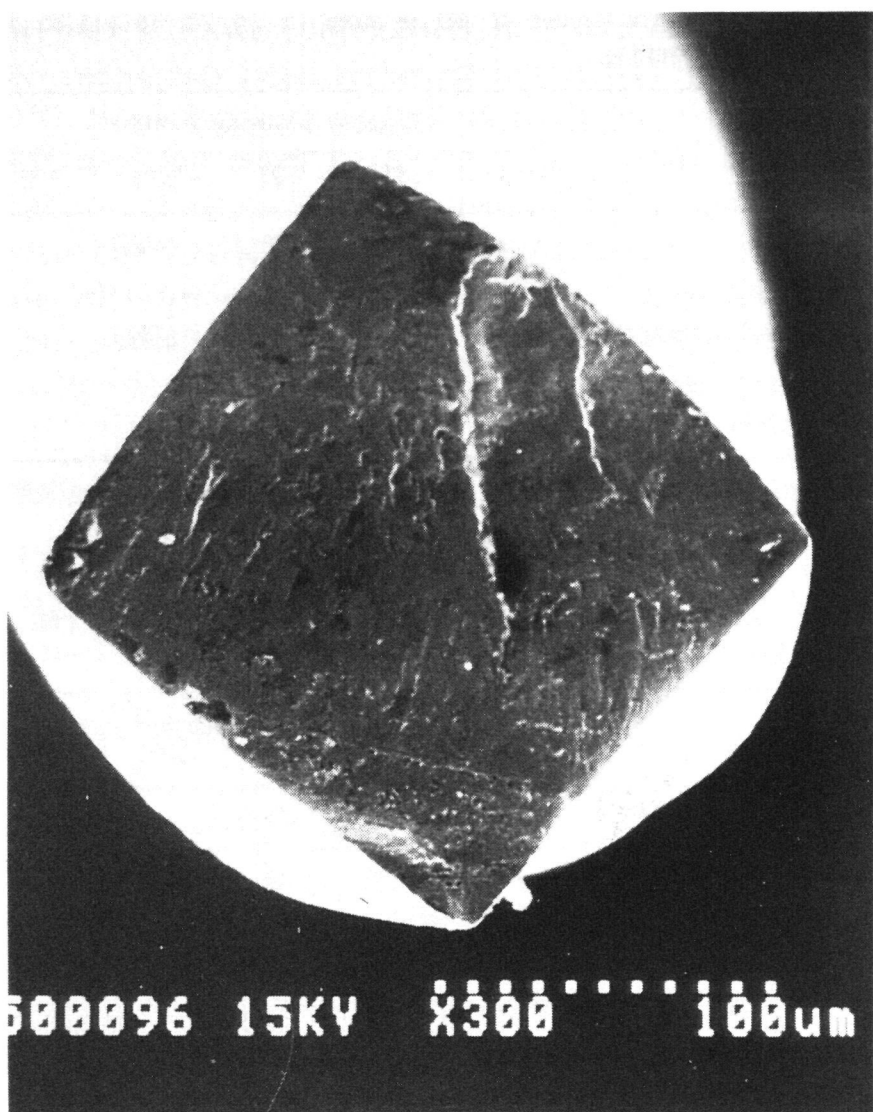
All fractured surfaces exhibited brittle failure. Each cross-section had four sides which were of unequal lengths (Fig. 2). In addition, the sides ap-

peared to be distorted. Fatigue cracks were observed at the corners of the cross-sections of some of the samples.

Fig. 2. A typical example of the cross-sectional surface of the file showing brittle failure.

Observations of the cross-sections of the fractured ends of the files, revealed that the sides of the file's cross-section were not equal in length, they appeared distorted. Such distortions could have been the result of the twisting process imparted during manufacture. The apices of the corners must have been severely deformed and acted as points for the initiation of fatigue cracks when the file vibrated.

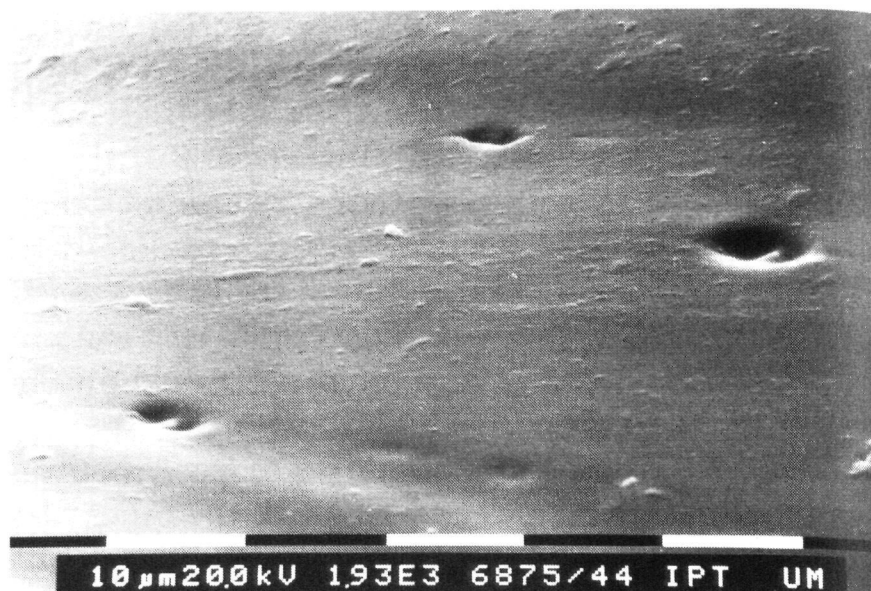
All the files examined for cavitation exhibited pitting on their surfaces (Figs. 3a, b). The pitting was present in both fractured and unfractured files (Table 4). Unused files which were not subjected to the cavitation test did not exhibit such pitting (Fig. 3c). Most of the pits appeared at the coronal one third of the file and they were irregularly distributed. The size and depth of the pits varied. The largest measured 10 µm in length, 5 µm in diameter and 5 µm in depth. The smallest pit was 5 µm in length, 3 µm in diameter and 3 µm in depth. The sides and base of each pit appeared smooth.

Fig. 3a. A typical example of pitting produced by cavitation implosion ($\times 190$).

The phenomenon of transient cavitation is characterized by the implosion of cavitation bubbles. It is well-known that when such implosion occurs near the vicinity of a hard surface, for example a metal, pitting of the latter can result. In the present study some of the files examined for cavitation exhibited pitting on their surfaces. The pitting was most likely the result of the cavitation bubble imploding on the surface of the file. The position of the pitting appeared to be related to the antinode position on the file which is the site to which cavitation bubbles would normally migrate.

It appeared unlikely that pitting from cavitation contributed to fracture. Fracture was observed to

have occurred at the nodal positions while the positions of most of the pitting appeared to be related to the antinodal points.

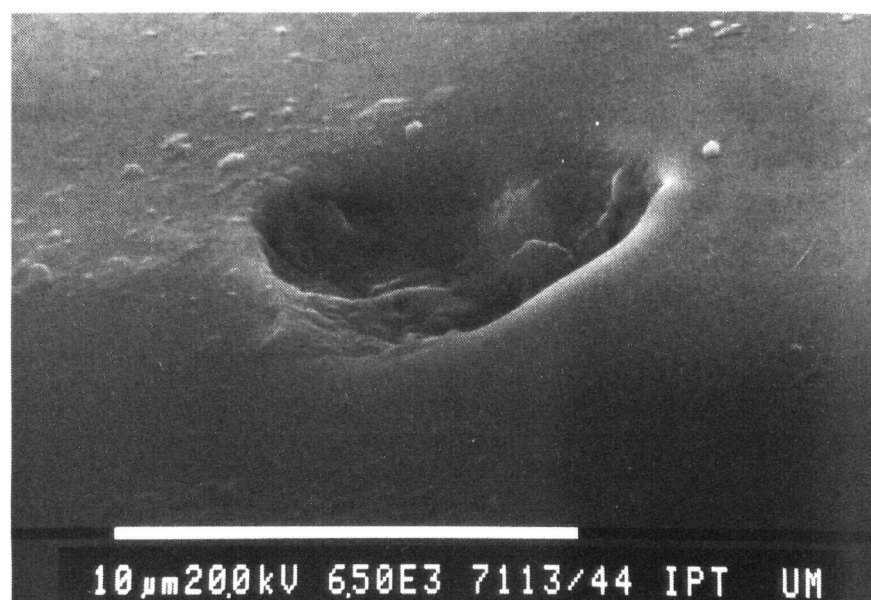
Fig. 3b. Close-up view of a cavitation pit ($\times 650$).
