## How Oxidised Grain Boundaries Fail

### **Abstract**

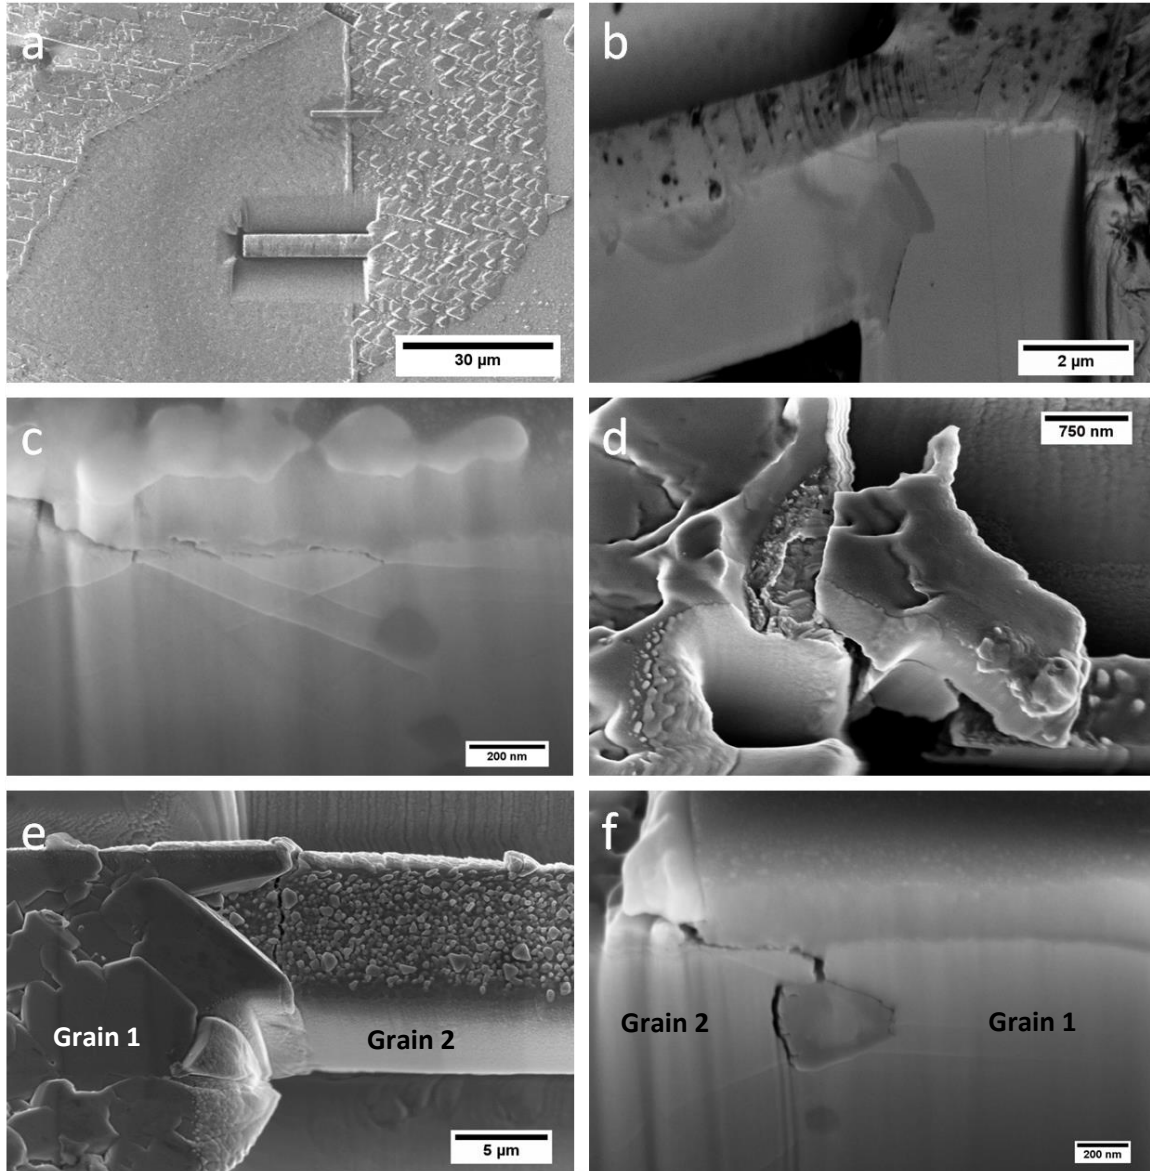
*(a) Plastic Deformation and no fracture:* Five of the cantilevers tested (~31%) did not fracture, but simply exhibited plastic yield on the load/displacement curves, as shown in Figure 2 (green plot, plastic deformation). Figures 2b and 2c show typical examples of such cantilevers after testing; both cantilevers are shown after longitudinal cross-sectional surfaces have been exposed by FIB milling after testing. Slip lines are visible on the top surface in Figure 2b and it is clear that the cantilever has

deformed plastically. In figure 2c, slip lines can be seen on the side of the cantilever close to the grain boundary, though no fracture has occurred. The grain boundaries shown in figures 2b and 2c are only incompletely oxidised, even immediately near the exposed surface; this might have prevented crack initiation.

*(b) Brittle Fracture:* The majority of the cantilevers underwent some sort of fracture. Two main types of fracture behaviour were observed. Three cantilevers (~19%) exhibited complete fracture, unstably propagating through their full depth. A typical example is shown in Figure 2d where the crack has propagated along the fully oxidised grain boundary. Eight cantilevers (~50%) did not show full fracture, though some crack growth was found on examination after testing. In four cases (~25%), crack growth was small. Figure 2e shows a typical example in which a small crack was found close to the fixed end of the cantilever, together with evidence of plastic deformation in the cross-sectional view; such cantilevers are also bent down towards the bottom of the trench. In these cases, the load/displacement curve, Figure 3 (blue, stable fracture), shows no obvious fracture event. In the other four cases, such as the example in Figure 2f, the cantilever did fracture substantially, but the crack propagated only part-way through the cantilever – in this case, encountering a grain boundary precipitate. In these cases, a recognizable fracture event was found in the load/displacement curve; Figure 3 (red, unstable fracture).

The mechanical behaviour of even a single oxidized grain boundary was found to be inhomogeneous. The cantilevers shown in Figures 2c and 2f were produced on the same grain boundary, separated from each other by 2 $\mu$ m; one has fractured and one has not. In order to better understand these results, a more detailed characterization linking local microstructure and composition and fracture behaviour was required. FIB 3D slicing [18] and high-resolution analytical TEM [21] were used to characterize the tested regions.

Figure 2: FIB SE images showing: (a) untested microcantilever and three observed deformation modes: (b) (c) plastic deformation without fracture, (d) intergranular brittle fracture and (e)-(f) intergranular crack growth without total fracture.

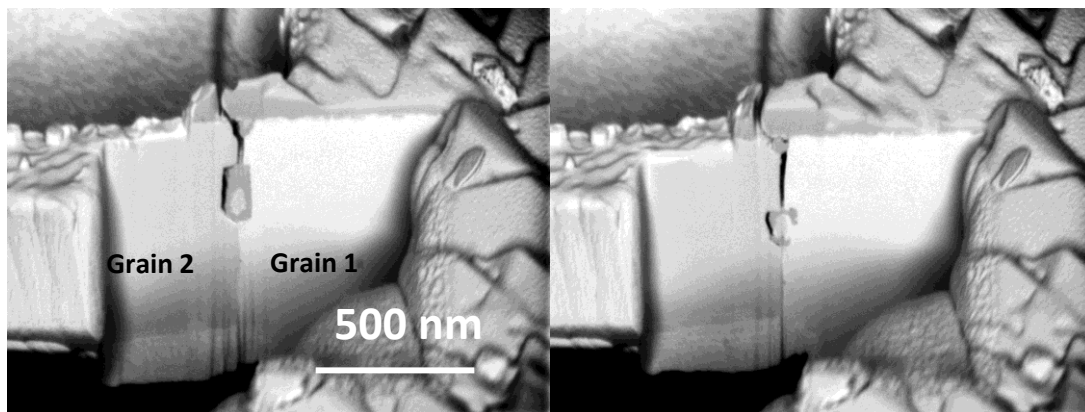
Regions containing oxidized grain boundaries in the cantilevers were cross-sectioned and imaged in the FIB-SEM with nanometre resolution (see Figure 4). This sequential milling + imaging approach

3. Crack paths could be modified significantly by the presence of grain boundary carbide particles (see Figure 2f). Grain boundary planes were found to have a ~50% carbide coverage. Intergranular carbides were elongated along the grain boundary plane (over 1µm in length), and were usually larger than the intragranular carbides (which were equiaxed with ~0.5µm diameter). These carbides, when in contact with the intergranular oxide, showed no signs of oxidation themselves but were surrounded by a Cr-depleted matrix that had preferentially oxidized (see Figure 4). This oxide surrounding the Cr-carbides was never observed to fracture during the tests.

Figure 4: FIB SE images showing a cross-sectional view of the base of cantilever after testing. Original surface oxide, crack path (black), internal oxides (dark grey) and an intergranular carbide (light grey) are clearly visible. Left and right images show the crack path at different sections during the FIB 3D slicing acquisition.

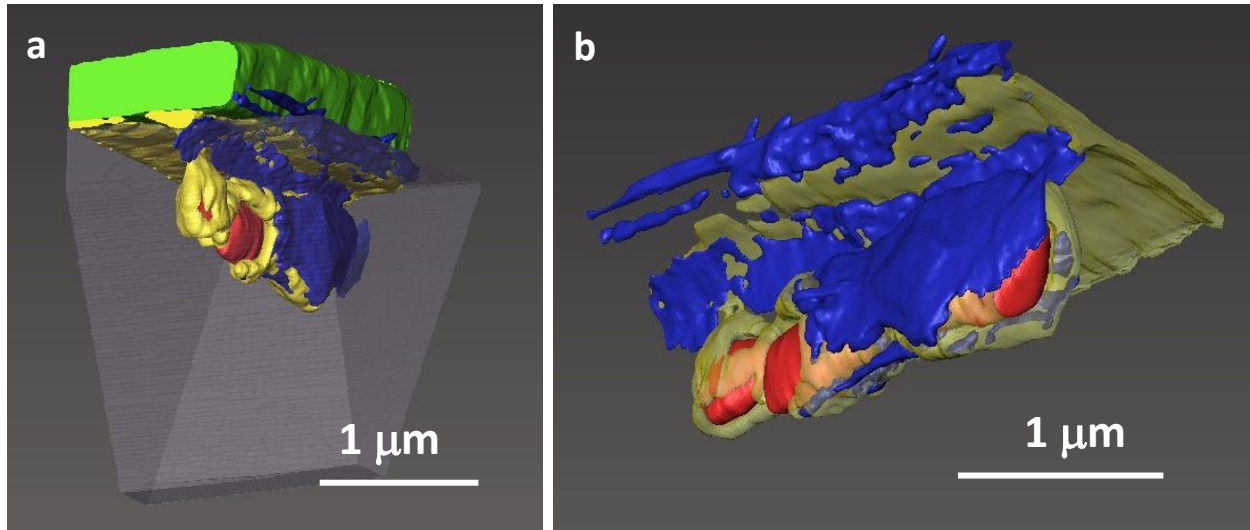
(FIB 3D slicing) allowed 3D reconstructions of the crack path and intergranular oxidation (see Figure 5) with high detail (voxel size 10x10x30nm). It was found that:

1. As the SIO model suggests, fracture of grain boundaries is directly correlated with the presence of a grain boundary oxide film. In the cantilevers that had not fractured completely, the intergranular oxidation did not reach the lower part of the grain boundary, and fracture stopped where the oxide terminated.

2. However, contrary to the assumptions of the SIO model, when grain boundary fracture occurred, it never propagated through the oxide itself, but always along the oxide-metal interface. The fracturing interface was the one adjacent to the grain that exhibited an interface more nearly perpendicular to the stress direction (along the cantilever axis).

Figure 5: 3D models generated from the FIB 3D sequential sectioning showing the various items reconstructed: carbides (red), Fe-rich external oxide (green), Cr-rich internal oxide (yellow) and open crack (dark blue). (a) shows all the features together with a portion of the cantilever (semi-transparent). (b) shows the crack path in detail and how it follows the oxide-metal interface, although the crack depth is not homogeneous along the boundary.

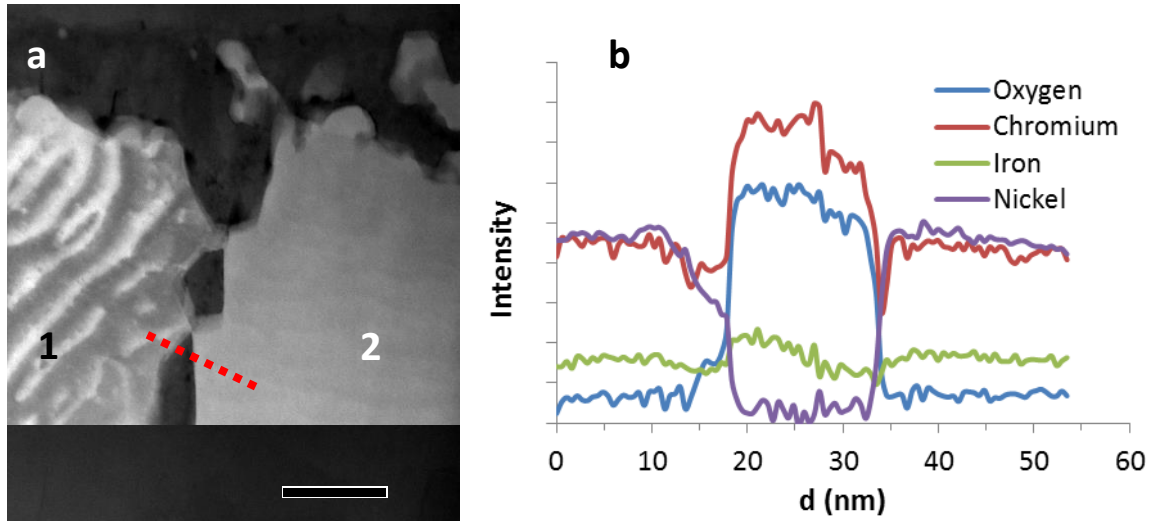
In-situ lift out samples [22] containing the same oxidized grain boundary as that tested by micromechanics were prepared for TEM characterization. This allowed a comprehensive nano-scale analytical mapping including Energy Filtered TEM (EFTEM), Energy Dispersive X-ray (EDX) and EELS, as well as indexation of all the relevant crystallographic directions through electron diffraction and atomic resolution TEM. The surface oxide was found to have the structure previously found by Robertson et al. [23] consisting of an external Fe-rich spinel  $(\text{Fe, Ni})_3\text{O}_4$  and an internal Cr-rich oxide

Figures 6: (a) STEM ADF image showing a cross-sectional view of the oxidized grain boundary next to exposed surface. Grains are labelled as 1 and 2. (b) EELS line-scan across the oxidized boundary. Spectra acquired in steps of 0.5nm. Every mark in the y-axis is equal to 20000 electrons. A Cr-depleted (and therefore Fe-rich) oxide can be observed at each of the oxide-metal interfaces. A 5% relative error is assumed for the plots in (b).

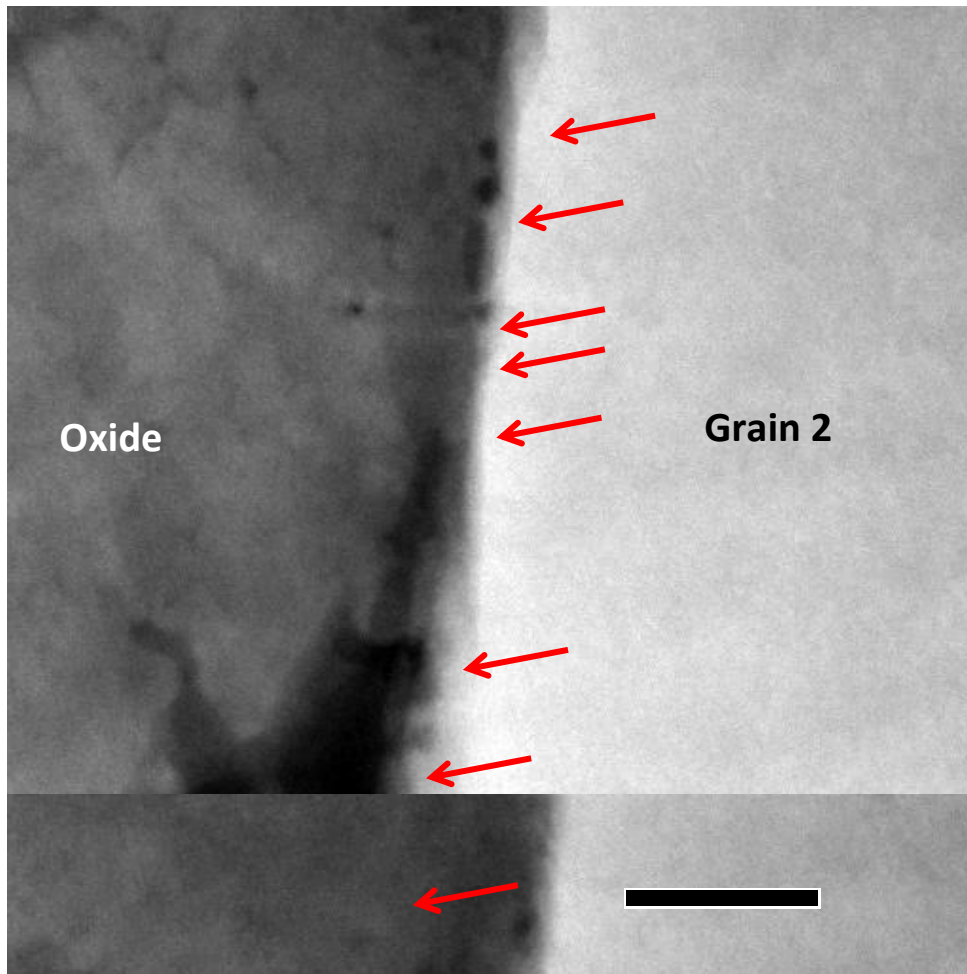
(Cr, Fe)<sub>3</sub>O<sub>4</sub> (~30nm thick). In the oxidized grain boundaries, the position of these layers was reversed. The Cr-rich spinel had formed first, remaining at the centre of the oxidized portion. Then, when the locally-available Cr became depleted, Fe-rich spinel formed next to the oxide-metal interface (Figure 6). High-angle annular dark field (HAADF) imaging showed that the inner Fe-rich oxide (next to the metal) is often less dense than the outer Cr-rich oxide (see Figure 7). FIB 3D slicing revealed that fracture follows the interface between the oxide and the metal, which is exactly the area where this low-density Fe-rich oxide is observed (as arrowed in Figure 7).

Figure 7: HAADF image showing the oxide-metal in grain 2. The darker regions (arrowed) at the oxide near the interface can be interpreted as having a lower density than the oxide further away.

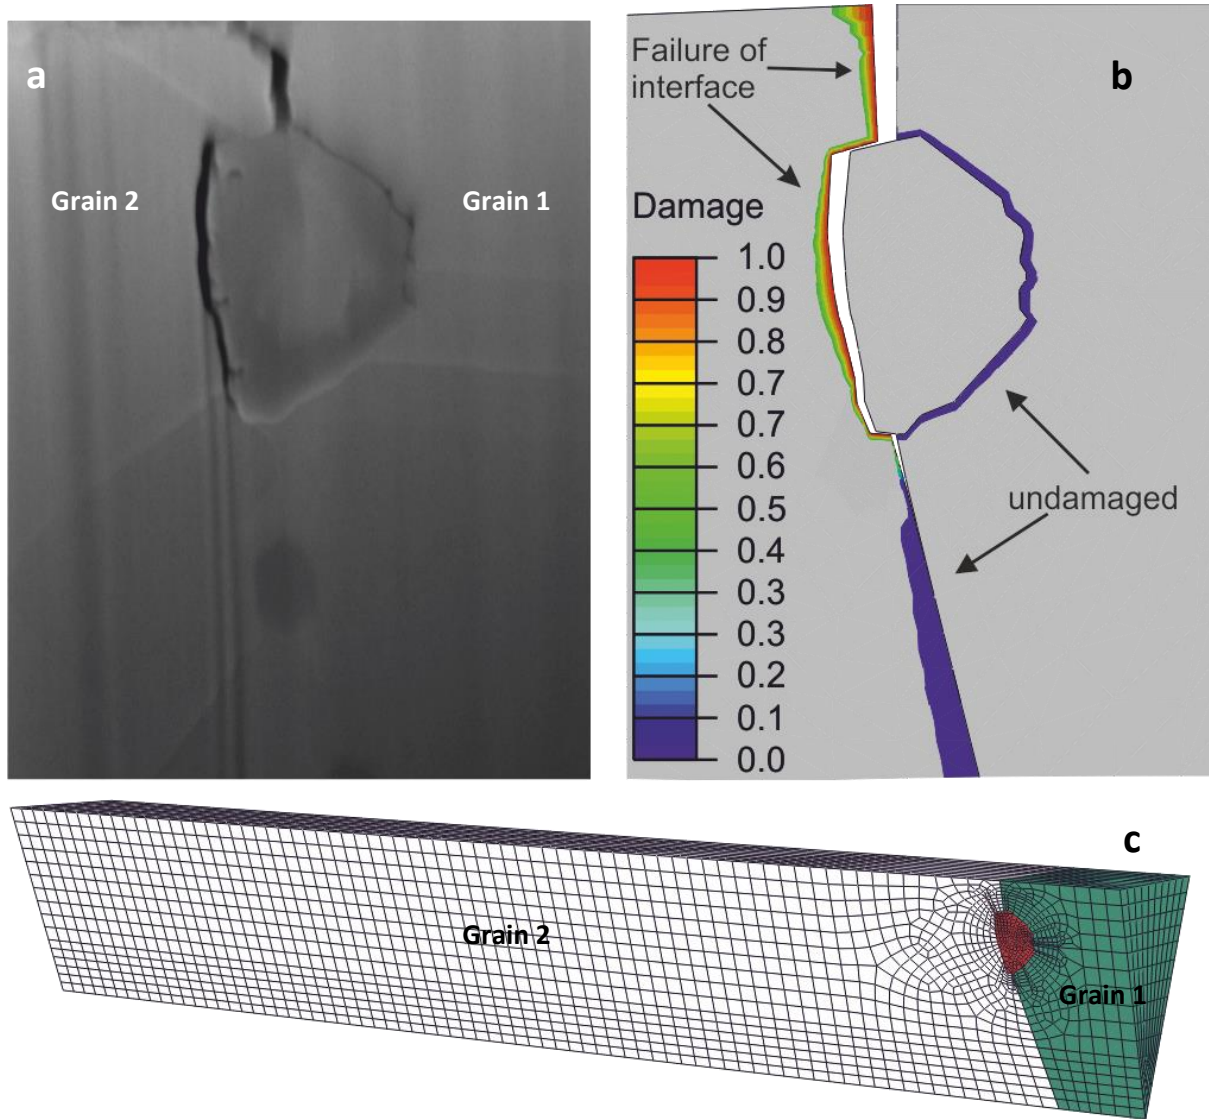
The finite element modelling was able to accurately reproduce the “real” fracture events. Figure 8 shows that the observed fracture behaviour (Figure 8a) is comparable to that one predicted by the model (Figure 8b). The crack initiates where the oxidized grain boundary meets the free surface at the top of the beam and then propagates downwards, branching left around the oxide that surrounds the Cr carbide before arresting where the oxidized region finishes (Figure 2g). This creates a high stress region at the crack-tip which might cause the crack to continue to propagate along the un-oxidised grain boundary below the carbide. This did not occur in the experiment, indicating that the un-oxidised grain boundaries must be significantly stronger than oxidised boundaries. In order to reproduce this arrest behaviour in the model, the un-oxidised grain boundary interface required a minimum fracture energy of  $G = 25 \text{ J/m}^2$ .

After calculating the mechanical properties of oxidized grain boundaries and observing that the cracks tend to follow the oxide-metal interface, fracture along oxidized grain boundaries free of carbides was also simulated by finite element modelling. The overall stress to failure was found to be  $\approx 5\%$  higher in the boundaries with a carbide present (although the exact value depends strongly on the exact position and morphology of carbides). This suggests that grain boundary carbides can have a minor strengthening effect. The beneficial role of intergranular carbides in SCC of Alloy 600 under primary PWR conditions has been reported in the literature [25,26]. Various explanations have been given, including the formation of a denser and more protective Cr-rich oxide around the carbides [27] or their role as obstacles preventing grain boundary sliding [28]. This work suggests that a plausible explanation could be their role in deviating the crack from a straight path (grain boundary) into a more complex one following the oxide-metal interface around the carbide.

Figure 8: SEM SE cross-sectional view of cantilever after testing, where it can be seen that the crack has propagated along the oxidized grain boundary and then along the oxide-metal interface around the oxide surrounding the carbide (a) and the predicted damage obtained from the finite element model (b). The mesh (extracted from FIB 3D slicing reconstruction) is shown before testing (c).
