Adhesion of Lacquers to Tinplate

Thesis submitted for the degree of  
Doctor of Philosophy in the University  
of Oxford

Hilary Term 1985

David G. Dixon  
Linacre College

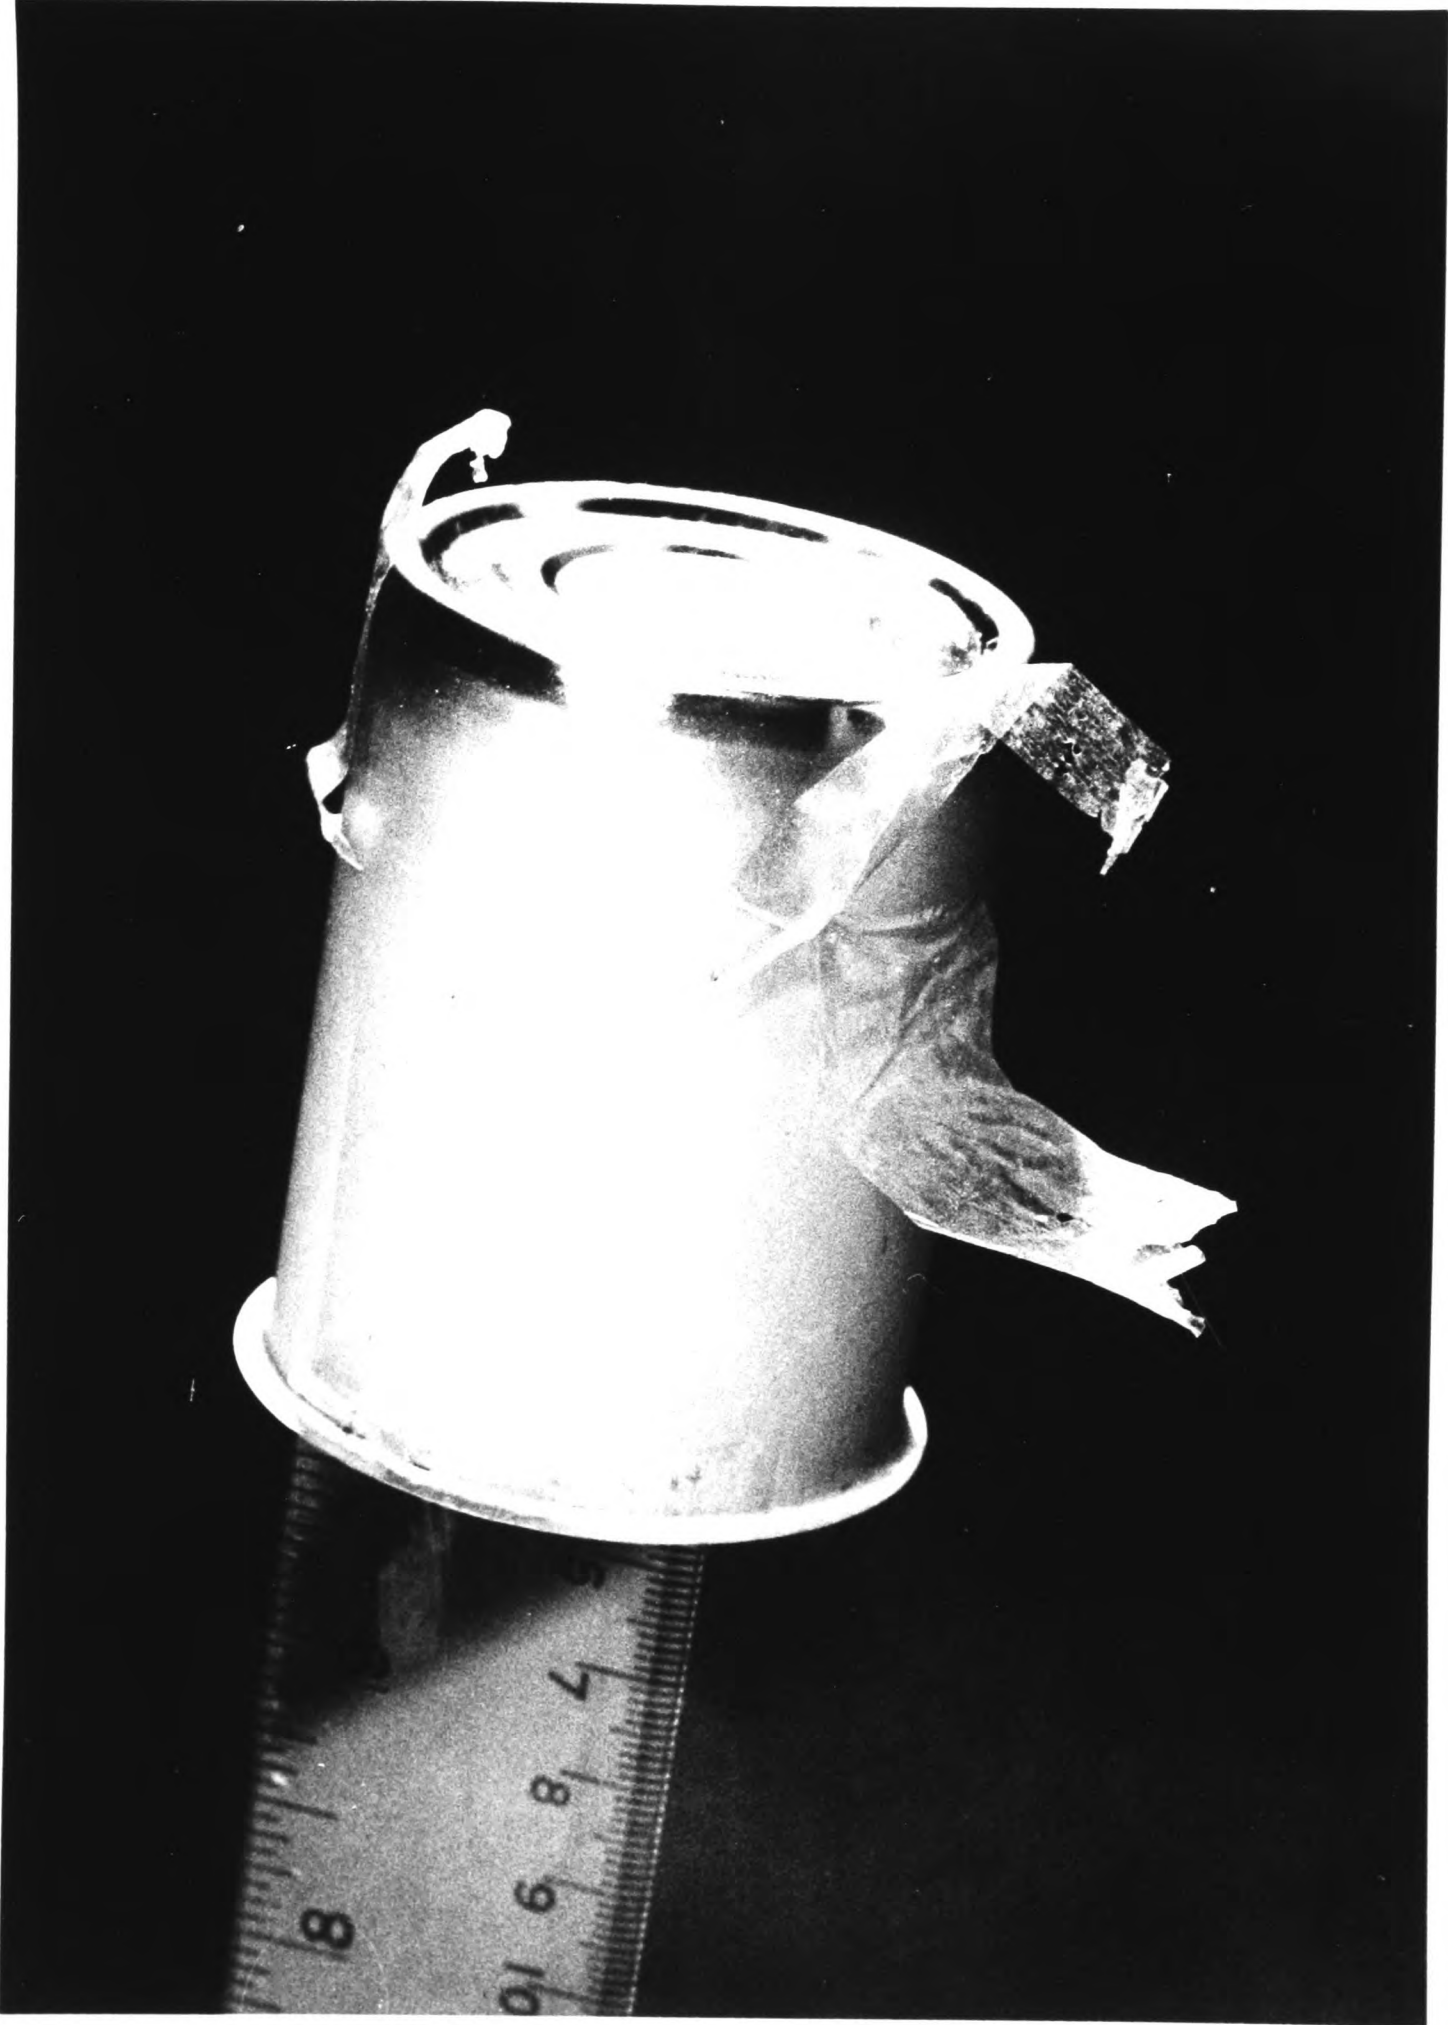
Figure 1. Lacquer debonding on a deep-drawn can  
(externally lacquered)
