Article

In Situ, Non-Destructive Testing for Evaluating the Role of Pointing Mortar in Preventive Conservation Strategies. A Case-Study on Reigate Stone at the Wardrobe Tower, Tower of London

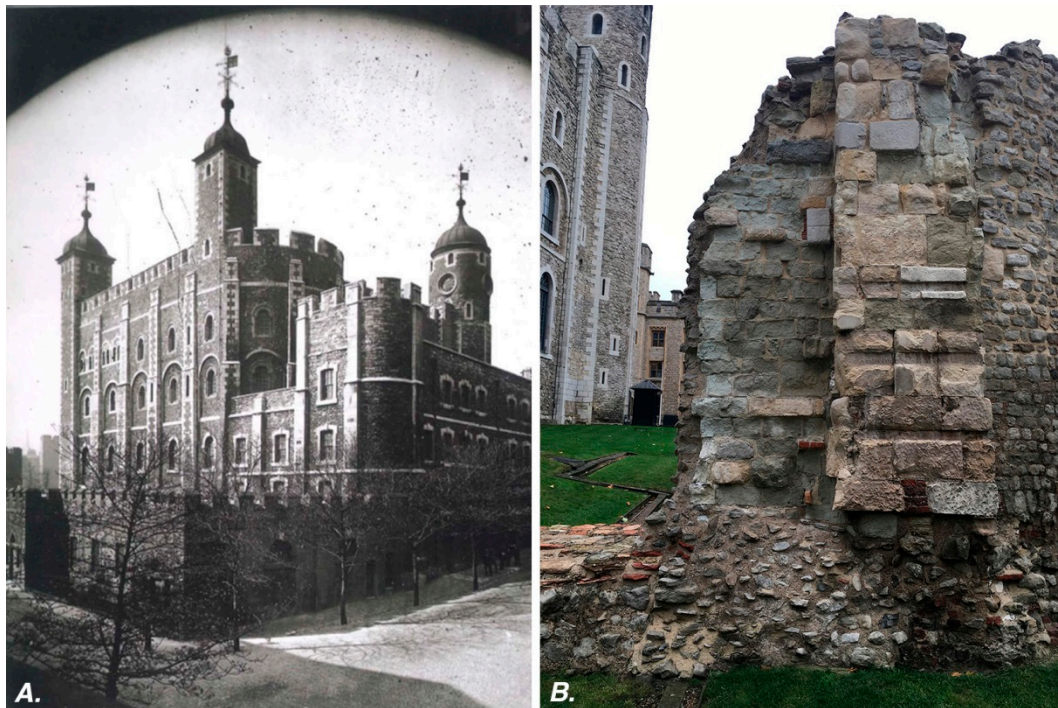
Figure 1. (A) Extent of late- and post-medieval auxiliary construction surrounding White Tower (main building) and Wardrobe Tower (foreground). Photo from south-east c.1870 (HRP archives). (B) Present-day condition of Wardrobe Tower, following 2017 conservation work, viewed from south. Photo November 2017 (Authors own).

There is evidence of historic repair and conservation work in the material fabric and documentary history of the Wardrobe Tower (Figure 1B). Several stones exhibit decay features which clearly predate their current location, indicating recycling of material during the original construction or early repair of the tower. Historic records show work was carried out to the Wardrobe Tower in 1532 and 1673–4 [48]. Repairs in 18th century red brick are also evident. Since its partial demolition in the 1880s, remnants of a coarse render and a patchwork of pointing mortars suggest conservation work was carried out on several occasions. Records indicate 'lime-method' repairs were carried out in 1995 by St Cuthbert Conservation, London. In total at least four different historic pointing mortars are evident.

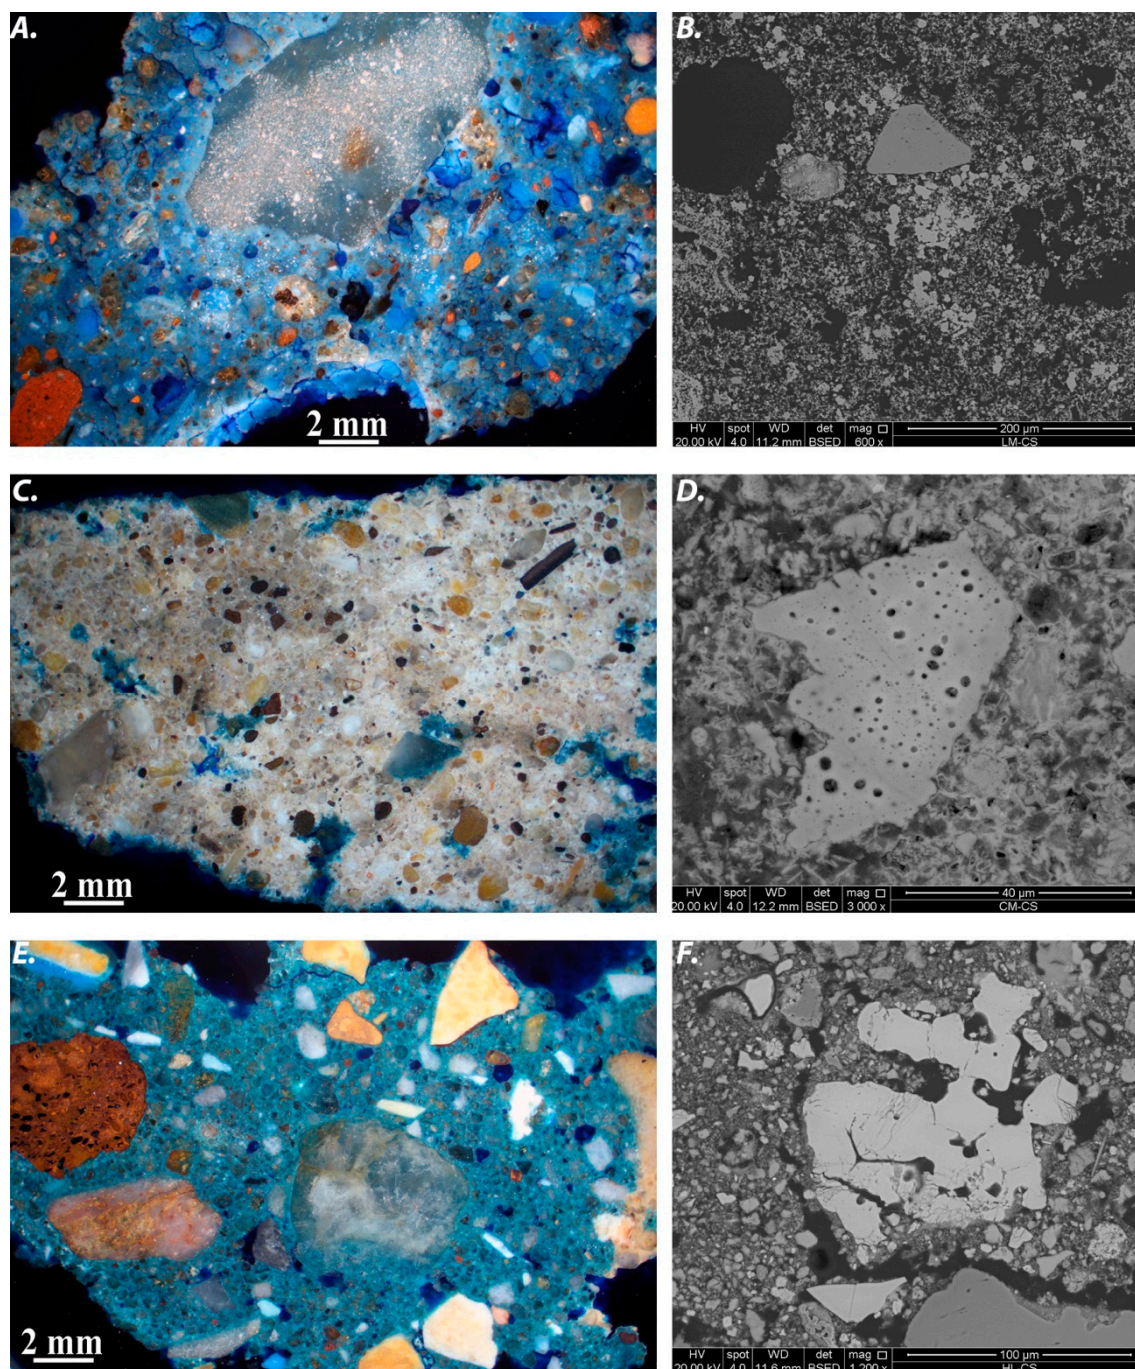
Figure 3. Optical (left) and scanning electron microscopy (SEM, right) micrographs of mortars collected from Wardrobe Tower during 2017 conservation work. (A) Original bedding mortar (BM), showing (B) porous lime binder with partly recrystallized calcite. (C) Probable early 19th-century pointing mortar (HM3), with (D) residual calcite indicating low temperature of calcination. (E) Probable late 20th-century pointing mortar, with (F) large crystal of rankinite. Note differing scale bars for SEM images.

The original bedding mortar (Figure 3A) is a highly porous lime mortar with aggregate from quartz, small fragments of hardened lime mortar, and occasional brick. The binder is pure air lime, calcined from a foraminifera limestone. Short-time or low-temperatures of calcination caused large lumps of raw feed stone which has in part kept the original texture. The high lime content, visible as a microcrystalline mass that makes up the bulk of the material (Figure 3B), provides a high, interconnected microporosity. The shrinkage cracks may reflect that the mortar was still moist when samples were extracted. The first historic pointing mortar (Figure 3C) is a compact mortar with aggregate of rounded quartz, iron-oxide siltstone grains, and minor amounts of alkali feldspar and occasional slate. Typical grain size of aggregate is 0.4 to 1 mm, maximum 3 mm. It is relatively lean, but the fabric is binder-supported (no contact between aggregates). The binder is cementitious, though Ca-silicate clinker remnants are rare and no alite can be found. The temperature of calcination of the binder was generally below, or in the lower stages, of sintering (Figure 3D). It appears highly carbonated, with secondary calcium carbonate dispersed in a silica-rich matrix. Capillary porosity is low, a consequence of the intense carbonation. Occasional air voids are in the range of max. 1 mm in size. It could be a natural cement, or an early, artificial ('Proto-Portland') cement dating to the early 19th century. The other historic pointing mortar (Figure 3E) is a porous mortar with gravel and sand aggregate of quartz and occasional iron-oxide grains. Typical grain size of aggregate 0.4 to 0.5 mm, maximum 6 mm. It is relatively lean, but the fabric is binder-supported (no contact between aggregates). Compared to the first, the binder is relatively porous; capillary porosity seems to be high with almost no air voids. The binder is cementitious, Ca-silicate clinker remnants are abundant (Figure 3F), but due to their composition (mostly

in the range of rankinite, a non-reactive low-temperature precursor of belite) the binder was not able to hydrate sufficiently for the development of a dense and strong fabric. Free lime is missing, as are typical features of a natural NHL raw feed, suggesting it could be a 'hybrid' mixture of the type used in the 1908s and 90s [17].

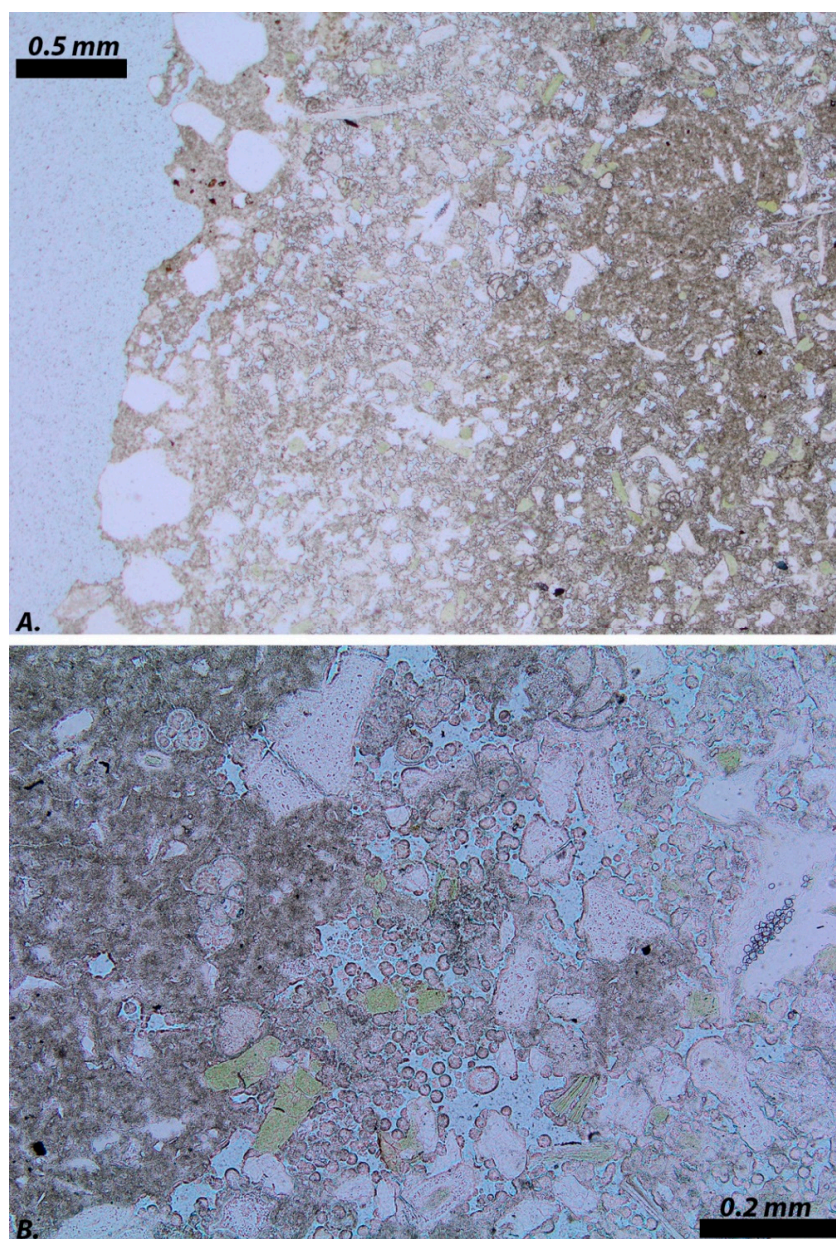
Figure 4. Optical micrographs of material collected from Wardrobe Tower during 2017 conservation work showing interface of Reigate Stone (right) and a hard mortar (left). (A) A porous band of Reigate Stone sits between mortar and denser, underlying stone fabric. (B) The bond is poor, and the stone fabric displays a high level of dissolution.

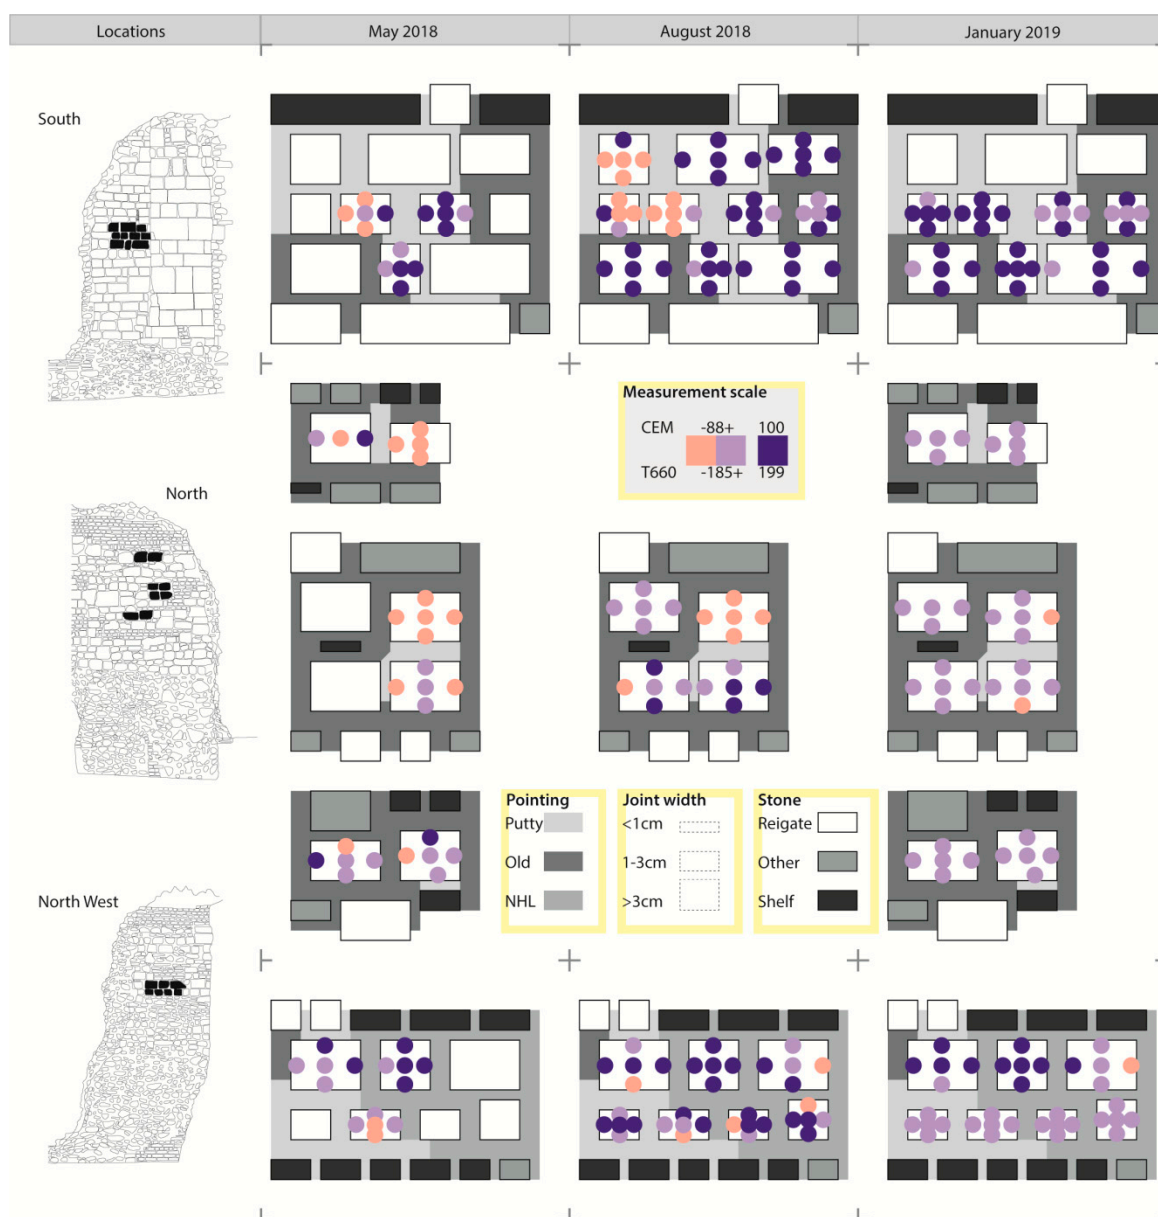
Figure 5. Distribution of CEM (displays readings at 1–100) or T660 (displays at 1–200) moisture meter readings at individual stone scale across three separate surveys, showing low, high and maximum readings for individual Reigate block edges and centres (three measurements per zone). The measurements can provide some indication of differential drying following the recent wetting of the masonry prior to each survey. There is some indication that block edges adjacent to putty mortar are drying more rapidly, but no clear pattern according to mortar type or mortar width. Ambient climate and exposure (both aspect and micro-contextual shelter) provide better indicators.

Figure 5 maps the distribution of moisture meter readings across different survey dates and areas, along with type and size of mortar joint and adjacent masonry. Three readings at each centre and edge of individual Reigate blocks are averaged and resulting values are sorted into groups. The May 2018, August 2018 and January 2019 surveys were selected as being reflective of three different wetting and drying scenarios. Edge readings are interpreted as being more likely to be affected by adjacent pointing mortar, due to differences in localised moisture ingress or subsequent poulticing effects. This produces few patterns which directly relate moisture distribution or drying rates across Reigate Stone surfaces to pointing mortar type. However, the overall effect of the different wetting

The good drying conditions in May 2018 and August 2018 are reflected in relatively drier points across several stones in all areas. During the May 2018 survey, some south and north-west facing points appear saturated by the recent wind-driven rain spell; north facing stones, which were sheltered from wind, appear relatively drier. The heavy wind-driven rain spells prior to the August 2018 survey appear to have fully saturated much of the masonry; run-off or deep penetration may be responsible for the wetting of areas not directly exposed to the wind. There is some apparent effect of pointing mortar on drying

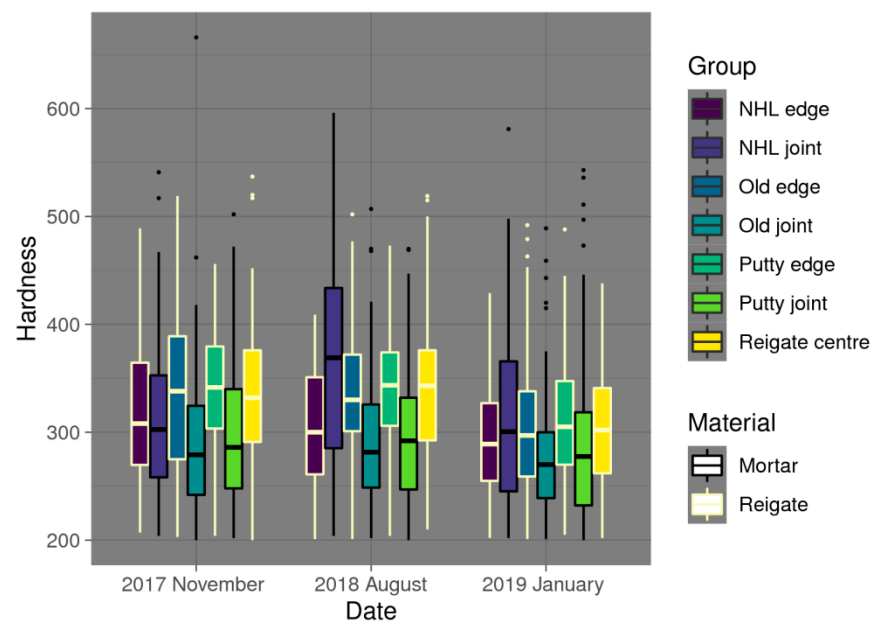
Figure 7. Boxplot of surface hardness measurements across three separate surveys, organised by mortar type and adjacent Reigate block edge (or centre). Central line represents mean value, upper and lower extents of box represent interquartile range (IQR: all measurements within 25th and 75th percentile). Whiskers represent maximum range of measurements less than $1.5 \times \text{IQR}$, outliers are single measurements more than $1.5 \times \text{IQR}$. Only includes data used in ANOVA tests (i.e., measurements taken from same locations across all three surveys). Whilst Reigate centres and edges adjacent to putty and old mortar joints respond similarly to seasonal variation, and corresponding mortar joints follow general pattern, edges adjacent to NHL mortar joints and NHL mortar joints themselves respond differently.

the variation between NHL edges and other Reigate material groups. In Figure 7, the distribution of individual SH measurements made on different material groups (block centres and edges, and different mortar joints) is plotted across separate surveys. The high SH of NHL mortar is notable, and clearly indicates the hydraulic set. In putty and old mortar joints, the November 2017 and August 2018 surveys return a similar distribution of values, whilst values are lower in January 2019. This pattern is reflected along putty and old mortar block edges, and at the centre of Reigate blocks. These results imply block centres and block edges adjacent to putty or old mortar joints are responding similarly to parameters affecting SH, and a similar response is taking place within the mortar joints themselves. Along NHL mortar joints, SH is higher in August 2018 than in November 2017 or January 2019; along corresponding block edges mean SH decreases across all three surveys. The response pattern of this mortar type is different to that of its adjacent block edges. Caution is necessary in interpreting these results. In mortars in particular, they can be skewed by point measurements taken on harder aggregate. This is a probable reason for the high number of outliers in mortar groups (Figure 7). However, if the changes in SH can be partially attributed to moisture, this could imply that putty and historic mortar joints are performing a suitable role in moisture regulation, by maintaining the block edges in a comparable state to the block centre. The general distribution of SH values at Reigate centres, putty edges and old edges, and their adjacent mortar joints reflects ambient conditions, with lower values recorded during the wetter, winter survey. The increase in NHL SH from November 2017 to August 2018 could reflect ongoing setting of the hydraulic binder [2]. The corresponding lower SH along NHL block edges may indicate a higher MC, resulting from the denser NHL performing a less effective poulticing.

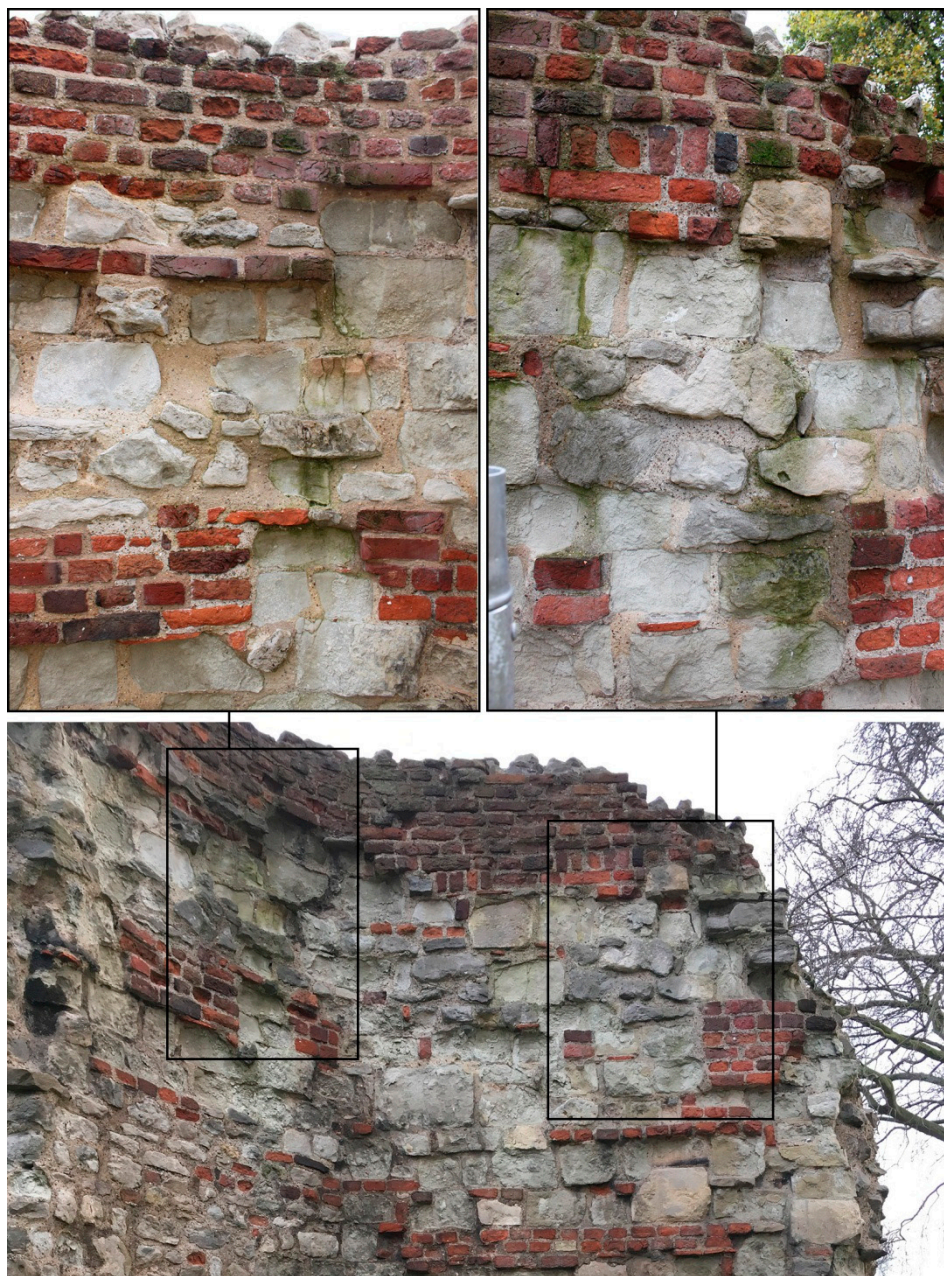
Figure 9. Parts of north facing masonry included in Wardrobe Tower photographed shortly before 2017 conservation (below) and in October 2019 (above). Water run-off channels have reformed, their location corresponds to past decay features.

The effect of over 2 years of rainfall and water run-off is clearly visible when comparing photos of the upper masonry taken after the Spring 2017 conservation with those taken in October 2019 (Figure 9). Water run-off channels are visible as areas of algal growth, often following recessed masonry and wide mortar joints. In some cases, these channels also define areas of more advanced decay, which affect stones that lie several meters below the masonry cap. Comparing these with photos taken before 2017 conservation work suggests that the channels have re-formed and continue to concentrate water run-off along the same routes as previously.

Topographical features can also be seen to limit the effect of good pointing and augment the effects of inadequate pointing. The wide joint to the left of WRD3 defines a gully which functions as a bottleneck for one of the main run-off channels along the north-west facing masonry (Figures 9 and 10). It is likely to be saturated following any heavy rainfall and unable to effectively poultice moisture from the adjacent stone, resulting in increased decay along this edge. WRD14 lies on one of the main run-off channels along north-facing masonry. There is evidence of ongoing decay across the entire surface; however, the poorly bonded old mortar joints along the top and left edges have not functioned as a poultice, resulting in a build-up of moisture and algal growth. The joints at the right and bottom edge, whilst in the same cementitious mortar, have remained in bond and appear to perform a more effective poultice. WRD40 also sits along a run-off channel. Besides algal growth on the centre of the stone surface, there appears to have been greater ongoing decay at the intersection between the upper edge and the more permanently saturated portion of the joint, which may not have been able to regulate

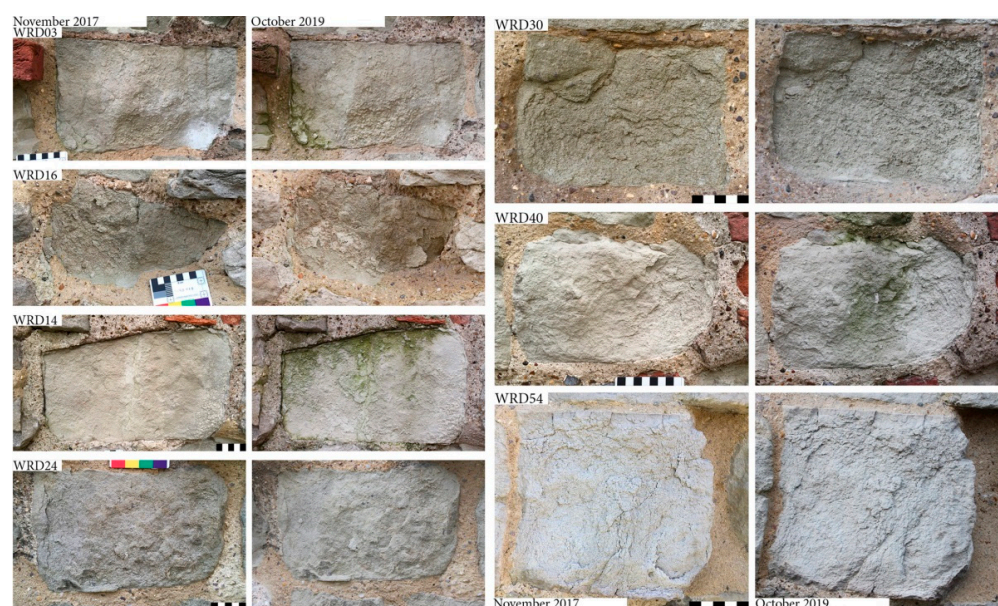
Figure 10. Selection of individual Reigate Stone blocks photographed in November 2017 and October 2019. Some signs of ongoing decay can be associated with inadequate pointing (e.g., WRD16 and WRD14), some can be associated with exposure and macro-context (e.g., WRD03, WRD40, WRD54). There are few examples of ongoing decay which can be more closely associated with type of pointing mortar (WRD24, WRD30).

There are few visual indications conclusively linking pointing mortar with ongoing decay. Generally, these can be attributed more to contextual or morphological features than mortar type. WRD16 for example, which was in a highly decayed condition in November 2017, has continued to decay rapidly despite repointing with lime putty (Figure 10). This is likely to be due to the wide joint below the stone forming a shelf, which may result in moisture pooling and inhibit the poulticing function of the mortar. Decay to the exposed right edge of WRD54 could be explained by the lack of adjacent mortar and poulticing effect, with moisture fluctuations and salt crystallisation taking place at the surface of the arris. In cases where decay appears to progress more rapidly along NHL or old, cementitious joints, such as WRD24 (left edge) and WRD30 (top left), pre-existing decay features appear

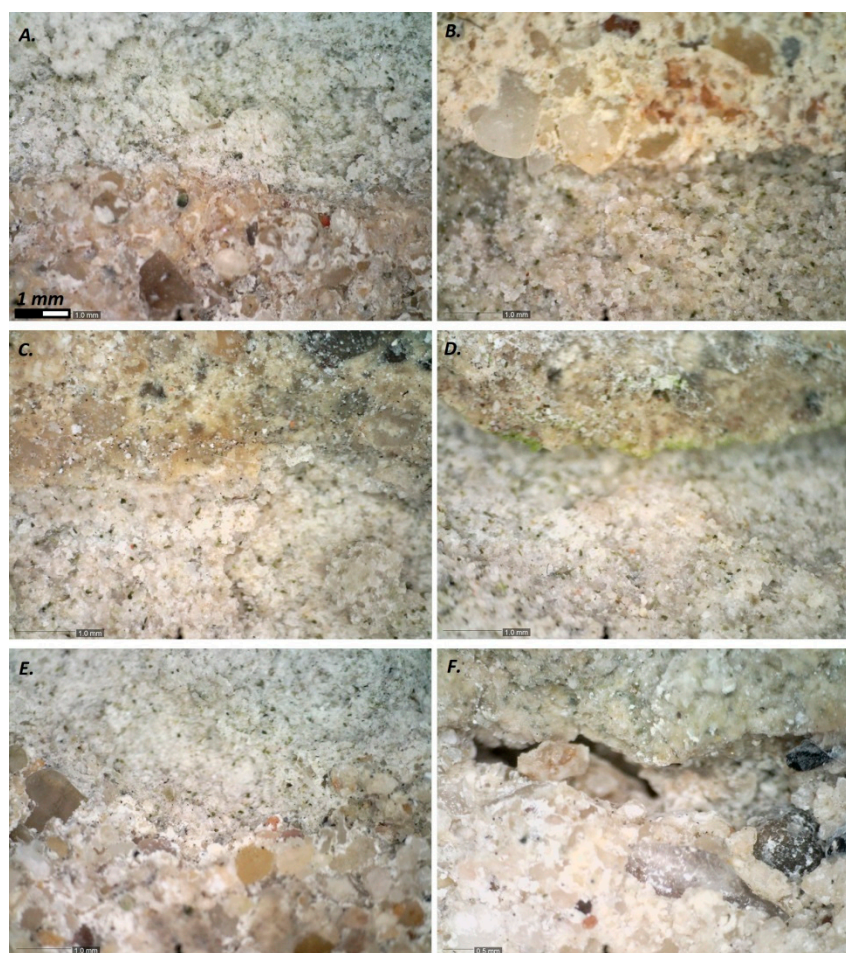
Figure 11. USB micrographs showing: (A) well bonded putty mortar (WRD12); (B) poorly bonded putty mortar (WRD27); (C) well bonded NHL mortar (WRD29); (D) poorly bonded NHL mortar with algal growth (WRD30); (E) well bonded old mortar (WRD53); (F) and poorly bonded old mortar (WRD39). (scale bar 1mm).

to have played a role. USB microscopy identified emergent biological growth on several poorly bonded, new NHL joints (Figure 11). However, there were both well and poorly bonded joints along putty, NHL and historic pointing, indicating that soft or hard mortar types are not a guarantee for good or poor long-term bonds respectively. The timescale of the project and lack of uniformity between initial conditions along block edges makes it hard to assess the impact of pointing mortar on specific stones.
