# Environmental drivers of earthen heritage deterioration in dryland regions

Thesis submitted for the degree of  
Doctor of Philosophy in  
Science and Engineering in Arts Heritage and Archaeology

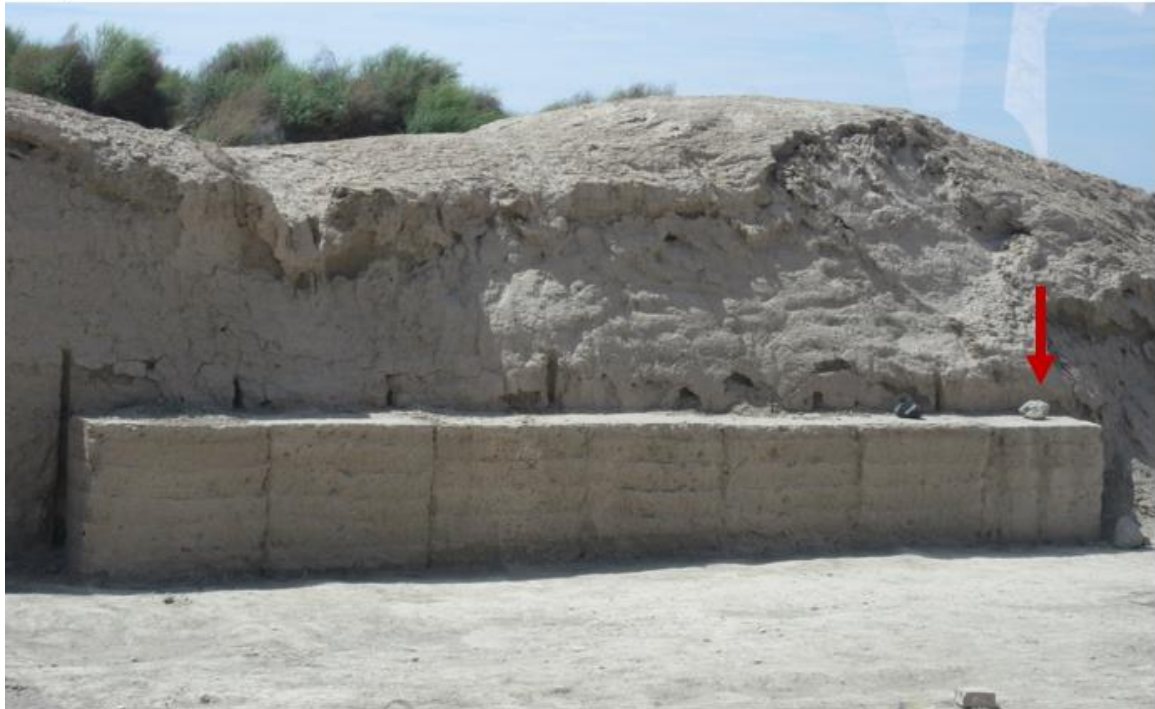
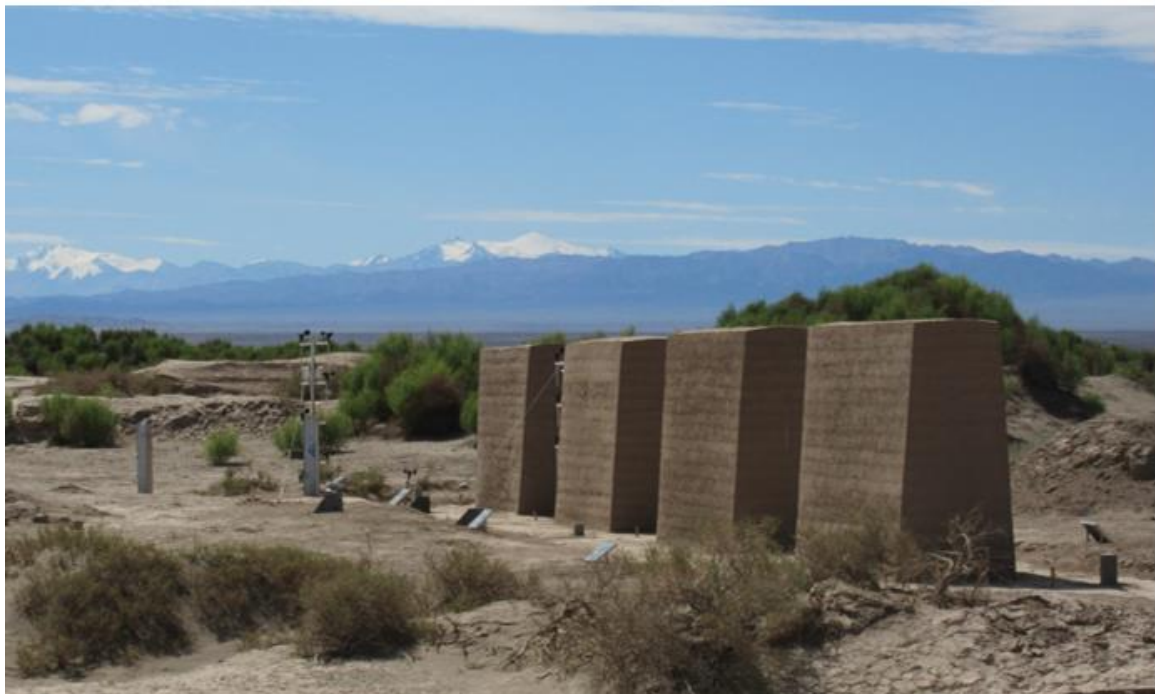
**Figure 3.7: The tests walls located at Suoyang in the experimental area. a) The small test wall with the section of the test wall used in this research indicated with a red arrow and b) the large test walls.**
