Royston R, B. Sheil B and W. Byrne B (2022)
Monitoring the construction of a large-diameter caisson in sand.
Proceedings of the Institution of Civil Engineers – Geotechnical Engineering **175**(3): 323–339,
<https://doi.org/10.1680/jgeen.19.00266>

Paper 1900266

Monitoring the construction of a large-diameter caisson in sand

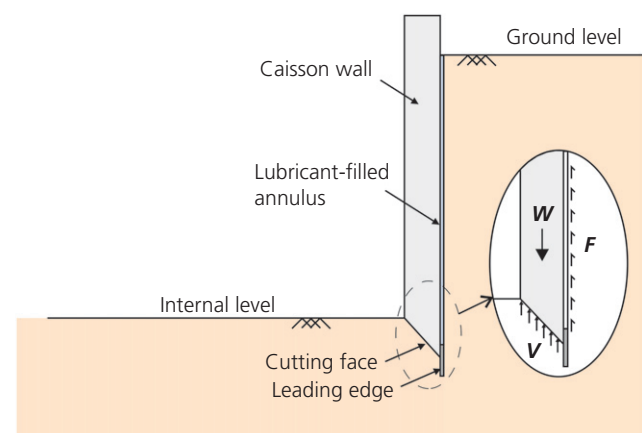
Figure 1. Schematic of cross-section through caisson wall showing typical features and definition of forces

Figure 1 illustrates a typical section through a caisson wall. An angled ‘cutting face’ at the base of the caisson aids the sinking

process and ensures soil failure is mobilised towards the inside of the caisson for excavation. An annulus that encircles the caisson is constructed using a leading steel ‘cutting edge’ located at the base of the wall (Newman and Wong, 2011). This annulus is typically pumped with lubricant to minimise the development of soil–structure frictional stresses. Current practice involves the use of excessively thick caisson wall sections to provide sufficient self-weight (W) to overcome the soil bearing resistance (V) beneath the walls as well as the soil frictional resistance (F) acting on the exterior face of the caisson (see Figure 1). A rudimentary sinking coefficient (S) can be defined as the ratio of the total downward force to the total upward soil resistance (Yao *et al.*, 2014)

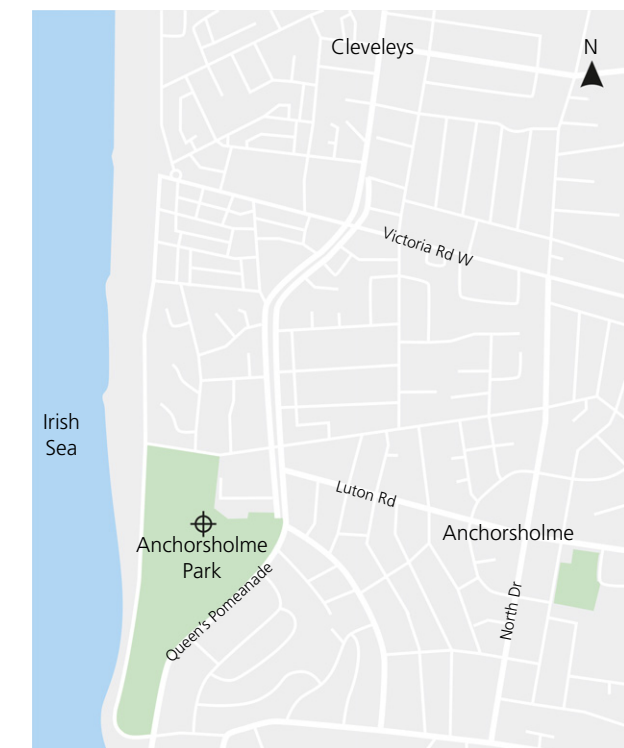
(a)

The site investigation for the project included four boreholes and ten cone penetrations tests (CPTs) undertaken around the

towards the north-east of the caisson. Particle size distribution tests carried out at multiple levels revealed a uniform sand layer. Due to the close proximity of the site to the Irish Sea, piezometer measurements were observed to vary between 0 m AOD and 5 m AOD. Each CPT was penetrated to a depth of –14 m AOD, slightly below the expected caisson depth, using a 36 mm dia. piezocone with a cone angle of 60°. Figure 4 shows the results of the CPTs (cone tip resistance q_t , cone sleeve friction q_s , friction ratio R_f and pore pressure u) and the inferred soil parameters (friction angle ϕ' , undrained shear strength s_u and relative density I_D). Individual tests are indicated by the grey curves and the means of all ten tests are shown by the black curves. The angle of friction was back-calculated from the cone resistance following the work of Kulhawy and Mayne (1990)

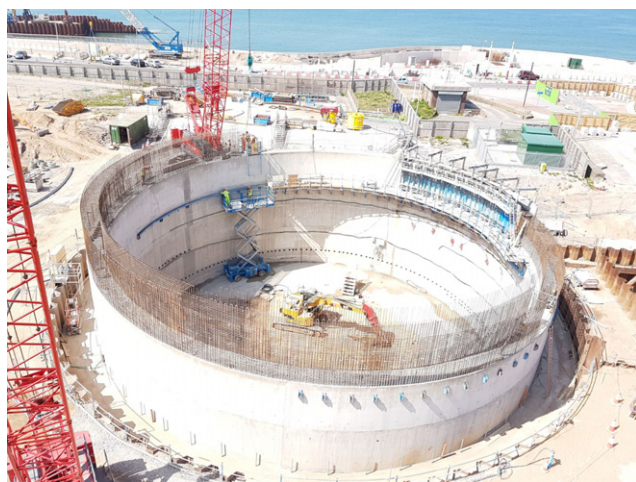
Figure 2. (a) Project location at Anchorsholme Park, Blackpool, UK; (b) caisson under construction

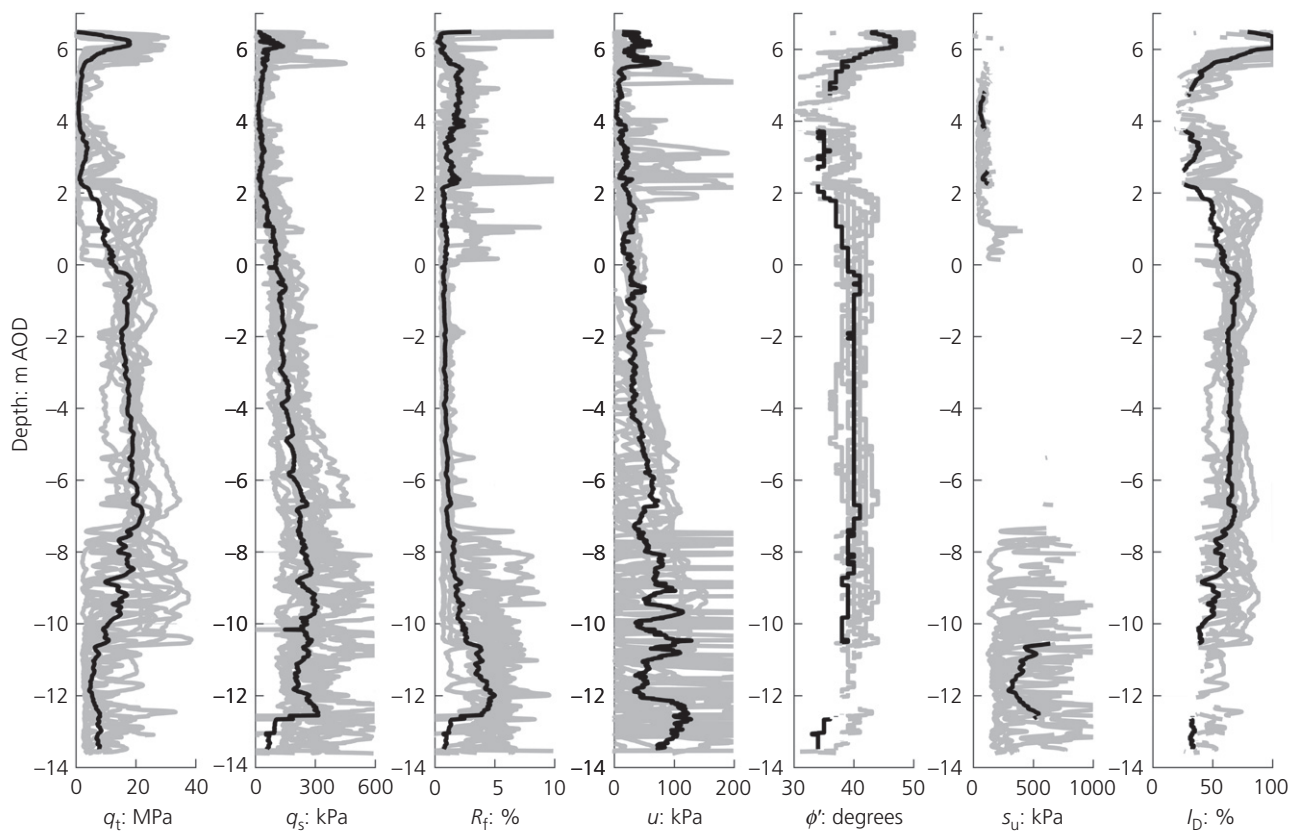
Figure 4. Results of CPTs undertaken around caisson at Anchorsholme Park (see locations in Figure 3(a)). The grey curves indicate individual CPTs and the black curves denote the mean of all ten CPTs

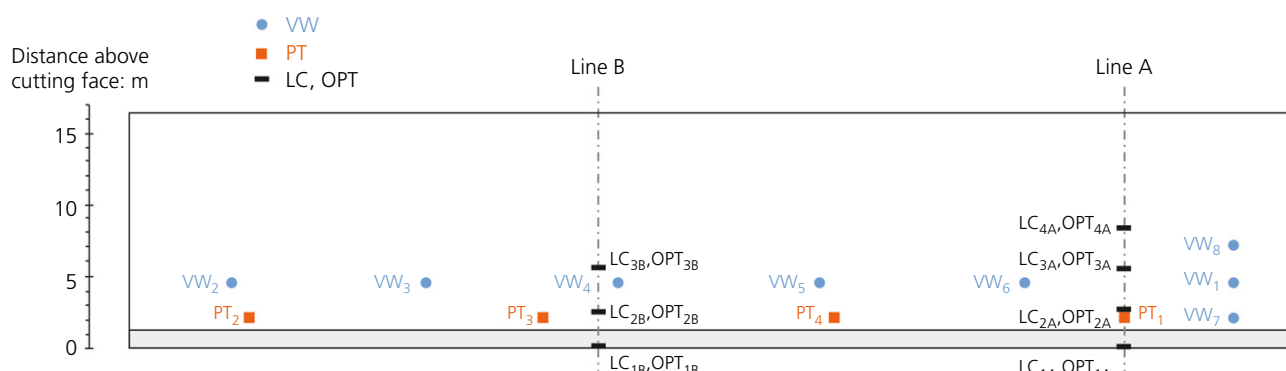
Figure 5. Rolled-out elevation of Anchorsholme Park shaft showing sensor locations. Note the concentration of sensors along two main lines at opposite sides of the shaft denoted line A and line B

Two main ‘lines’ of instrumentation, line A and line B, were installed and aligned vertically on the caisson wall, as shown in Figure 5. There were four monitoring points on line A and three on line B. The lower LCs on each line (LC_{1A} and LC_{1B}) were located in the leading cutting edge to measure contact stress in the virgin ground. The upper LCs (LC_{2A}–LC_{4A}, LC_{2B} and LC_{3B}) were cast flush with the caisson wall to monitor conditions in the annulus; a PT was placed beside each of these LCs to monitor the lubricant pressure in the annulus (OPT_{2A}–OPT_{4A}, OPT_{2B} and OPT_{3B}).

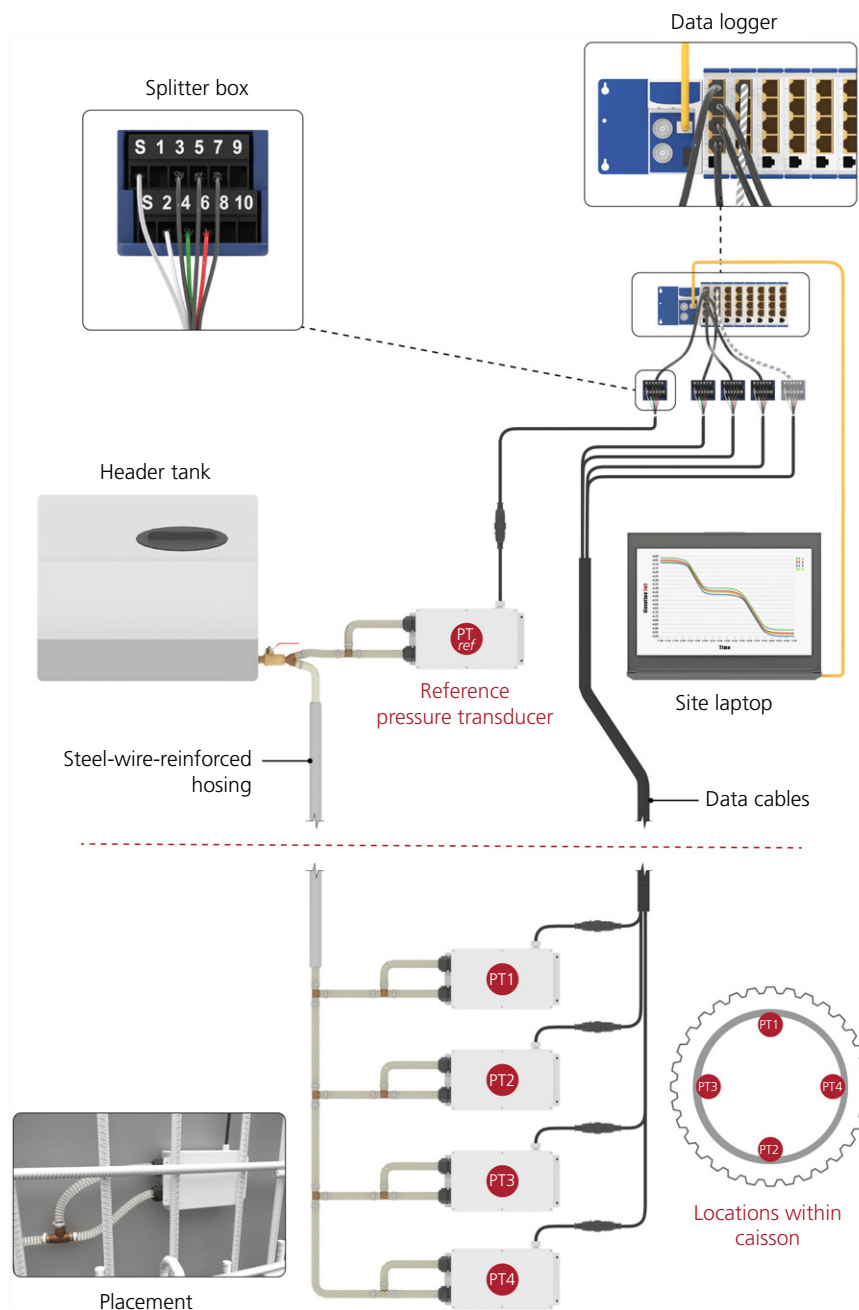
Figure 6. Schematic diagram of the layout of the level detection system comprising the header tank connected to PT_{ref} (fixed at ground level) and PT_1 – PT_4 (fixed to caisson wall) by way of reinforced hose

A bespoke liquid-level detection system was deployed on the caisson to monitor the elevation and tilt of the caisson during sinking (see Figure 6). The system comprised four pressure transducers (PTs) cast into the quarter points of the caisson wall. All four PTs (denoted PT_1 – PT_4) were hydraulically linked by $0.5''$ (1.27 cm) wire reinforced hosing to a header tank filled with de-aired water, as shown in Figure 7. The difference in pressure between the PTs and a reference PT (PT_{ref}) fixed at ground level enabled the level of the caisson at each location (relative to PT_{ref}) to be deduced. The PTs were fitted within IP68 containers with a bleed valve to allow the

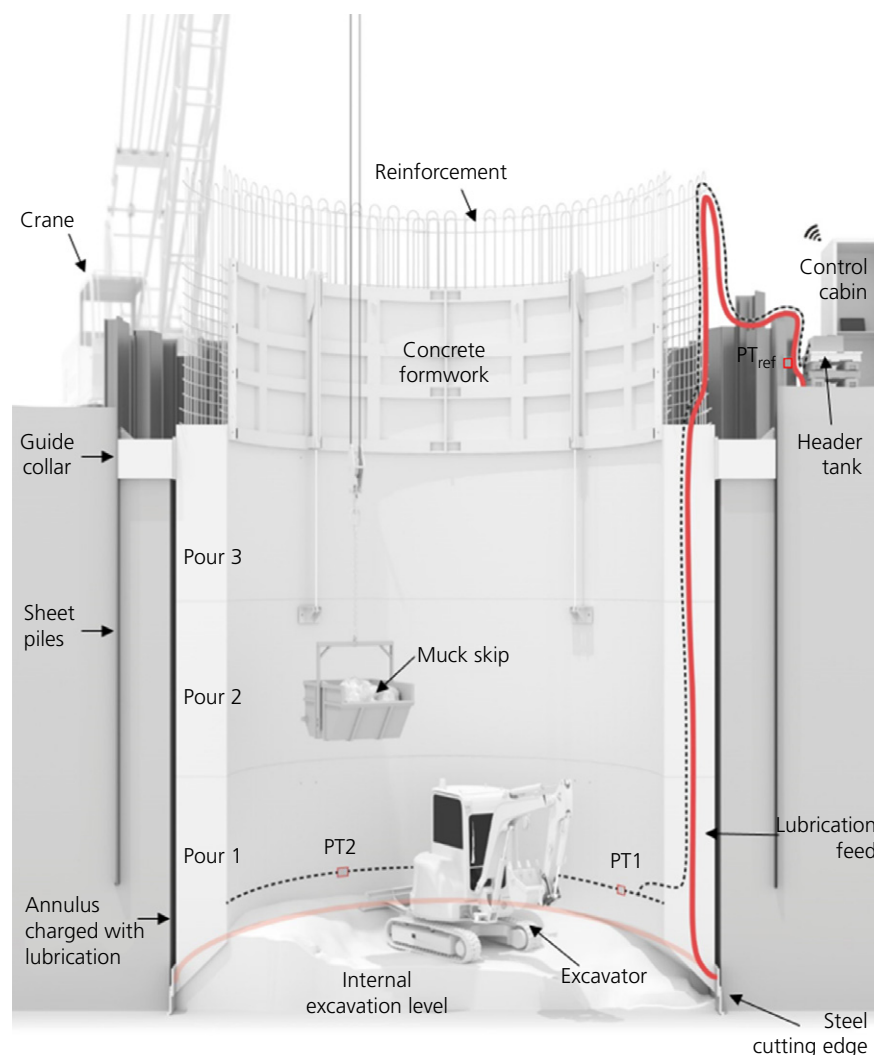
Figure 7. Schematic diagram showing typical layout of the bespoke liquid-level detection system developed for this project

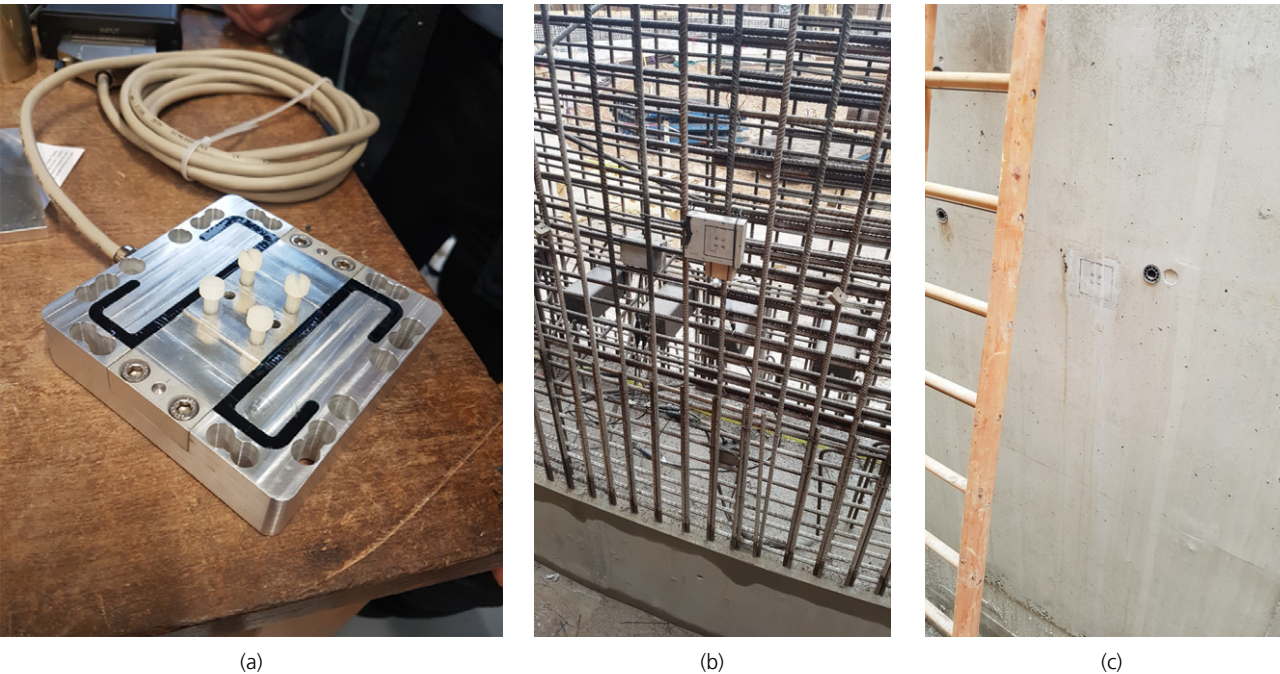
Figure 8. Three-axis LCs used for monitoring soil–structure normal and shear contact stresses: (a) sensor as procured; (b) sensor fitted within bespoke waterproofed aluminium housing and fixed to steel rebar prior to casting of the concrete walls; (c) sensor post-casting showing exposed 100 mm square ‘sensing face’

Seven commercial three-axis load cells (LCs) supplied by Interface Force Measurements Ltd were used to monitor the normal force and shear force applied by the soil to a $100 \times 100 \text{ mm}$ bearing plate on the exterior surface of the caisson (see Figure 8). The LCs were aligned to measure shear stresses acting vertically and circumferentially on the caisson wall, although the circumferential shear forces were not logged for

this project. A series of bending beam elements inside the cells allowed measurement of up to 5 kN in each direction. The LCs were located flush with the exterior face of the caisson using individual waterproof aluminium housings that could be cast directly into the wall. Each cell lid was isolated from the housing by a 1 mm gap filled with soft silicone rubber.

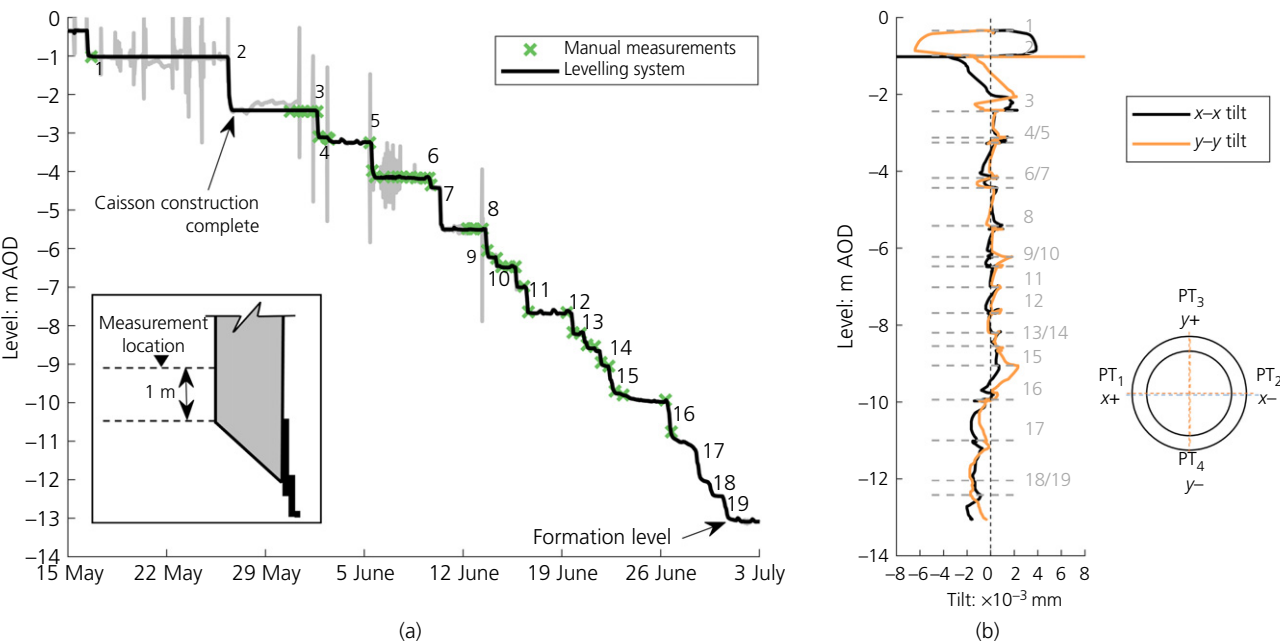
Figure 9. Caisson movements determined using the liquid-level detection system: (a) average elevation; (b) tilt. Labels 1–19 on the plot indicate movement numbers

were also taken periodically on site using a total station to verify the accuracy of the liquid level detection system. As shown in Figure 9(a), the caisson elevation determined using the level detection system was in excellent agreement with the manual measurement. The data indicate that caisson sinking is a ‘stop–start’ process with, for this project, a total of 19 distinct movements identified (numbered on Figure 9(a)). The first sinking movement occurred as a result of breaking out the concrete footing beneath the caisson wall. As wall construction was complete on 27 May 2017, the total wall weight W was constant from movement 2 onwards. Subsequent movements were therefore attributable to internal excavation activities only. Measurements of the caisson tilt during sinking are presented in Figure 9(b) for two mutually orthogonal axes, x – x and y – y . The movement numbers are again superimposed on the plot. Large tilting of the caisson was observed during the initial stages of sinking whereas only slight variations were recorded as the caisson became more embedded in the soil. This highlights the importance of establishing verticality early in the sinking process.

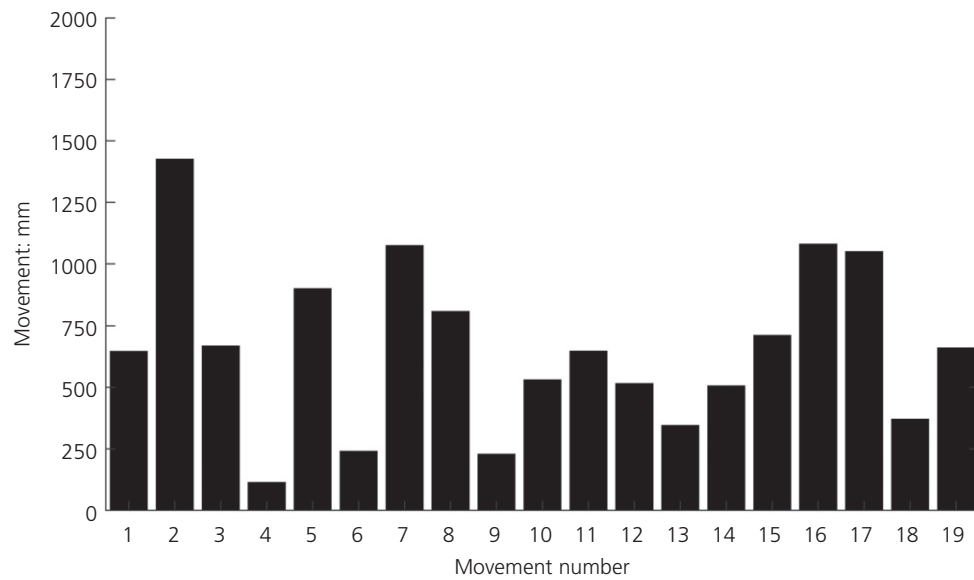
Figure 10. Summary of the magnitudes of all 19 caisson movements

A summary of all 19 caisson movements is presented in Figure 10. The largest sinking movement was 1425 mm (movement number 2), possibly because at this point the 45° cutting

face was not yet fully embedded in the soil. The average of all 19 movements was ≈ 750 mm or $0.6t_w$ (t_w being the caisson wall thickness). Minimal differences were observed in the rate or magnitude of the caisson movements whether the cutting face was embedded in the dense sand or stiff clay. This is likely because sinking behaviour is largely determined by the soil excavation technique adopted by the (same) operatives on site.

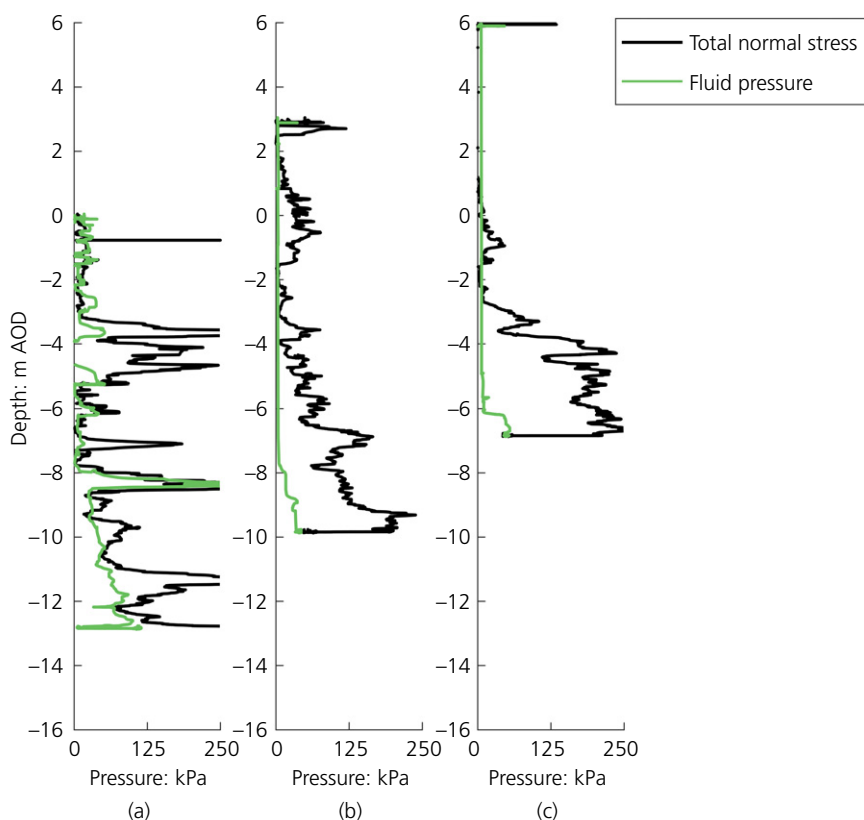
Figure 12. Comparison of total normal stress and fluid pressure measurements on the exterior face of the caisson wall along line A: (a) LC_{2A} and OPT_{2A}; (b) LC_{3A} and OPT_{3A}; (c) LC_{4A} and OPT_{4A}

Figure 12 shows the variation of total normal stress with depth measured by all LCs on line A. Fluid pressure measurements determined using the adjacent PTs are also plotted for comparison. Clearly the difference between these two sets of measurements corresponds to effective normal stress arising from soil contact. Figure 12(a) indicates that the annulus was stable (temporarily) during the initial stages of sinking, with good agreement found between the two sets of measurements. Below –3 m AOD, significant effective normal soil stresses developed on the caisson wall in the sand layer. Comparison of Figures 12(a)–12(c) shows a progressive increase in the effective stresses determined using sensors located higher on the caisson wall. This highlights the risks associated with sinking deep caissons in cohesionless soils. In contrast, there was improved agreement between the total normal stress and support fluid pressures in the clay layer, indicating a stable annulus (see Figure 12(a)).

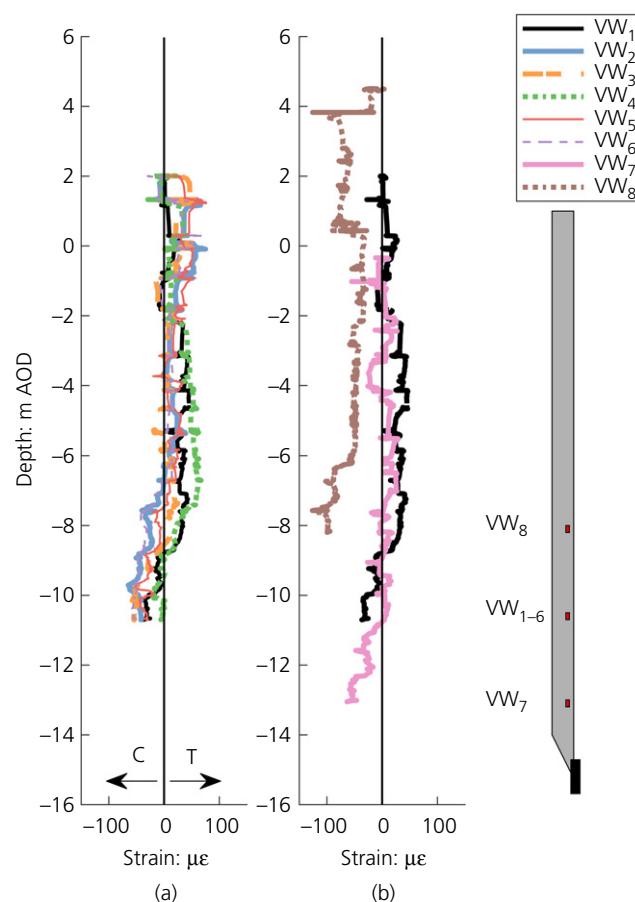
Figure 14. Variation of wall hoop strains with depth determined from VW strain gauges distributed (a) circumferentially (constant elevation) and (b) vertically (constant circumferential location) on the caisson

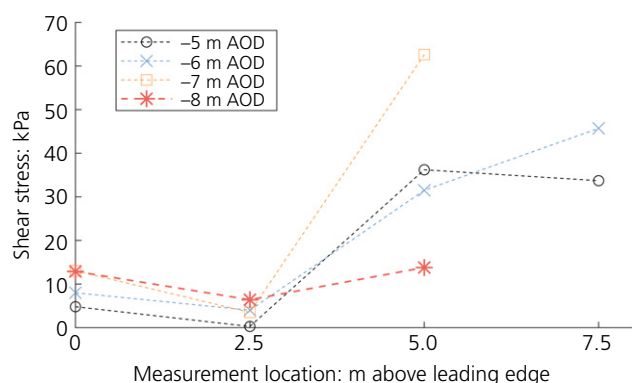
Figure 19. Comparison of monitored data and simplified predictions of the variation of the coefficient of lateral earth pressure with measurement location on the caisson wall

The data presented in Figure 18 are replotted in Figure 19 except now considered as a function of measurement location

on the shaft wall. In light of the monitored data, it appears that while no systematic variation occurs in the interface friction angle (see Figure 17), variations in the coefficient of lateral earth pressure during sinking should be considered in design.
