Seismic collapse of vaulted structures:
Unreinforced quasi-brittle materials and the case study
of the Basilica of Maxentius in Rome

Alejandra Albuerne

University of Oxford

Doctor of Philosophy

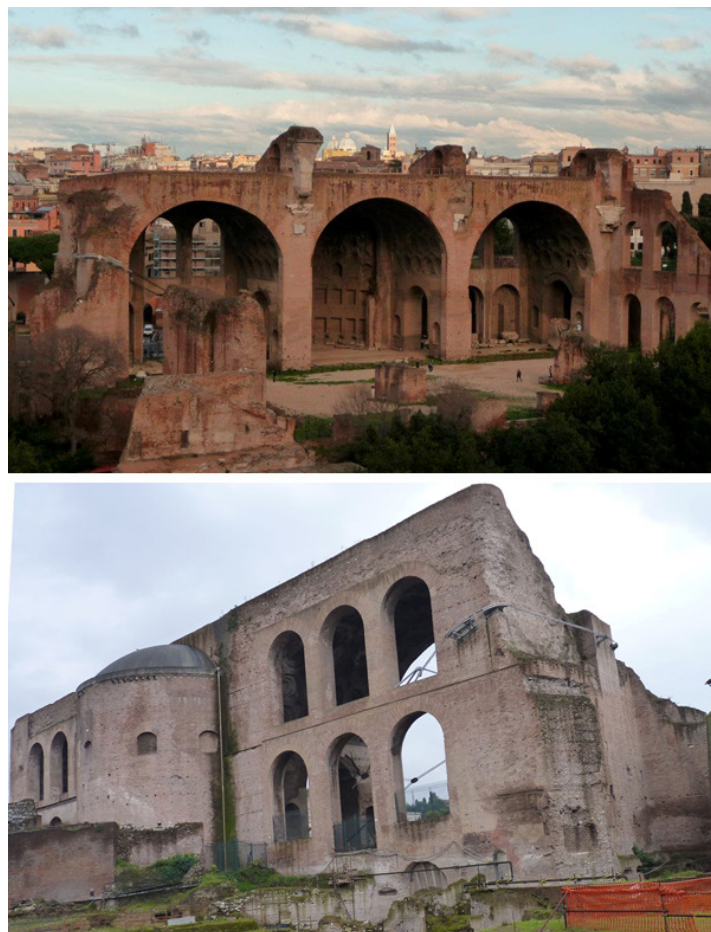
Fig. 1.1. Remains of the Basilica of Maxentius in the Roman Forum. Above: Interior, view from the south (by Macaro, 2012); below: exterior, view from the north (by Albuerno, 2011).

The three barrel vaults of the north nave of the Basilica of Maxentius, still standing today, are enough to reflect the feel of a grand space whose scale barely relates to traditional human scales. The Roman concrete structure featured three large naves. The central nave, higher and wider, was covered with three cross vaults, while the two side naves –naves north, still standing, and south- were roofed with three barrel vaults each. The west and north sides featured apses, while entrance porticoes could be found on the other two sides, east and south (Fig. 1.1). A detailed description of the geometry of the building is given in Chapter 2.

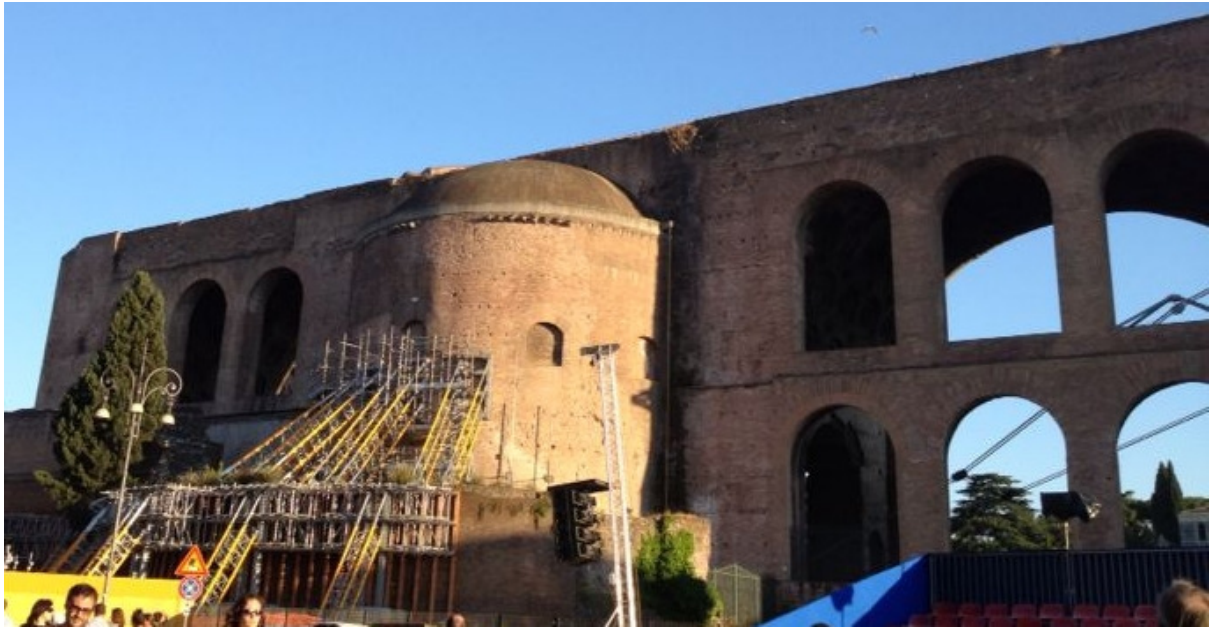
Fig. 1.6. Temporary propping of the north apse of the Basilica of Maxentius during the construction of a metro station and line a short distance from the monument (photo: Macaro, May 2014).

It is worth mentioning that, besides the excavations around the north-west corner of the building, which are aimed at the Temple of Peace, the Basilica is subject to a further structural man-generated threat: a new underground line is being built under the Via dei Fori Imperiali, just a few metres away. Furthermore, the new underground station for the Forum and Colosseum is being constructed directly across the road from the Basilica, less than 40 m away. These alterations to the sub-soil could result in ground settlements that could change the equilibrium conditions of the Basilica. As a result, the Basilica is being closely monitored for movements and the north façade, in particular the apse, is currently propped as seen in Fig. 1.6, taken in May 2014.

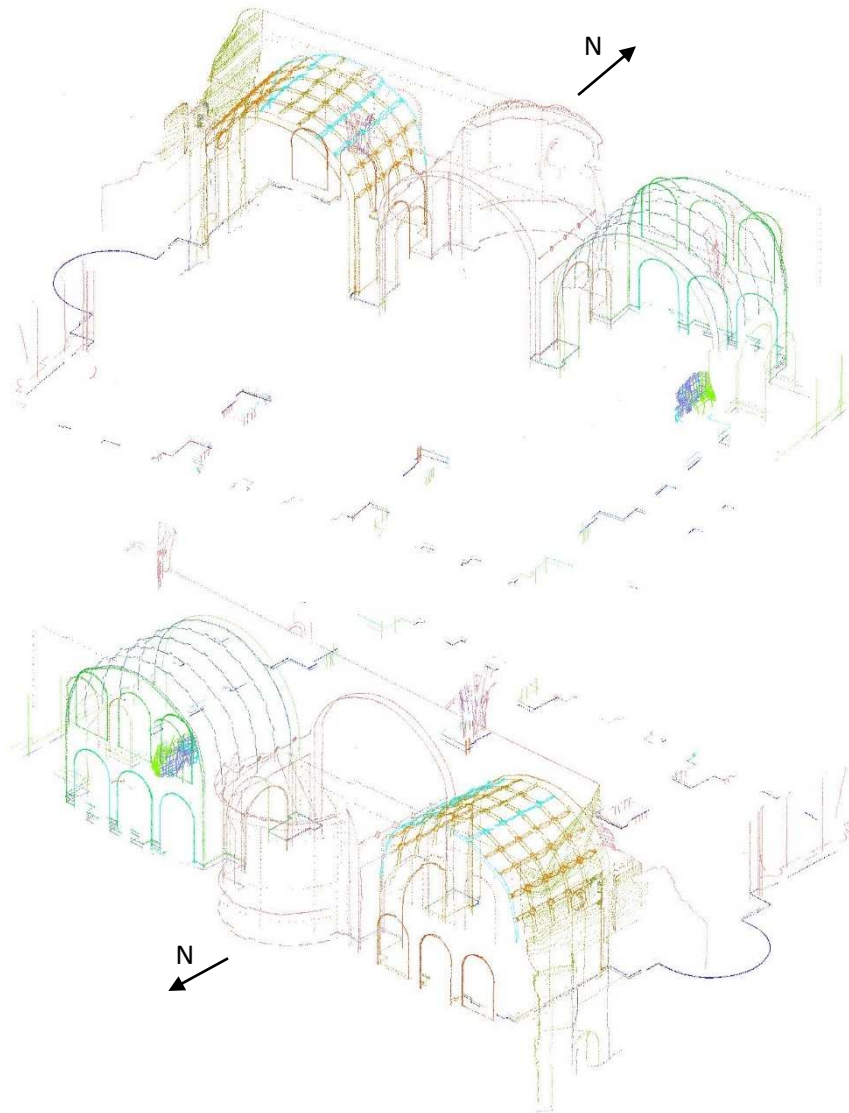
Fig. 2.1. Data points obtained through total station survey of the remains of the Basilica of Maxentius. The different colours signify the different setting out positions of the total station.

The survey was carried out using a Leica Flexline TS06 5" Power Total Station. Over 43 000 data points were recorded in 16 days of surveying work (see Fig.2.1), 10 days in January 2011 and 6 further days in July 2012.

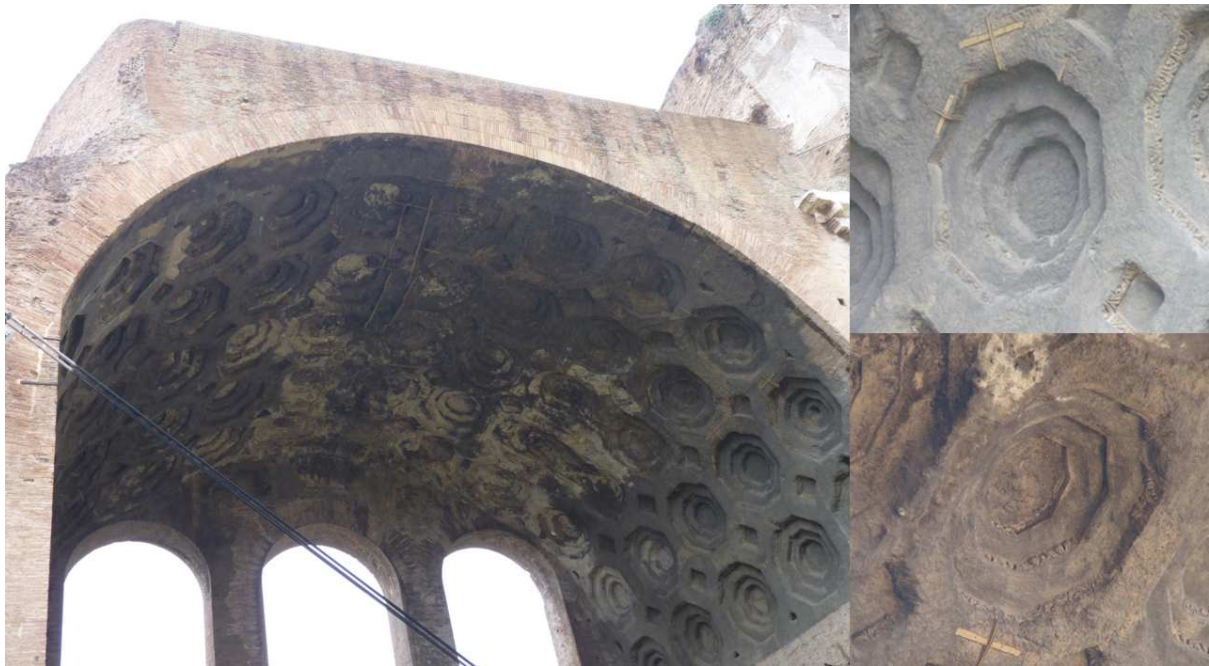
Fig. 2.4. Coffering decoration on the intrados of the barrel vaults of the Basilica of Maxentius. Left: west vault; right, up: detail of repaired coffering; right, down: detail of wear in ribs around coffering.

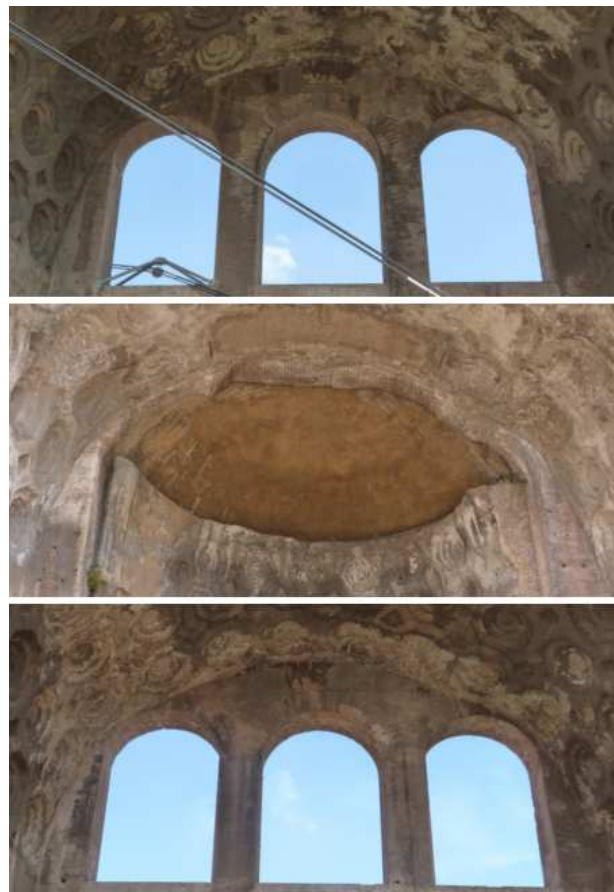
Fig. 2.5. Deformed profile of barrel vaults next to north façade. Left: west vault; right: east vault.

The three standing barrel vaults present similar deformations next to the north façade (see Fig. 2.5). The origin of these deformations must be explained in order to determine whether or not they featured in the as-built structure. Lancaster (2005, 34-36) explains them as the result of deformations of the centering during the construction process in response to the self-weight of the ascending layers of Roman concrete. However, the analysis of the surveyed data has shown that this geometry does not correspond to the shape of a deformed segmental centering.

Looking at the data it is possible to differentiate three parts, considering symmetry (see Fig. 2.5). From the springings of the vault, the lower 30° angles (approx.) seem to be constructed with a small curvature, the radius being larger than that of the ideal semicircular profile. Moving up, the next part has a substantially larger curvature and spans a smaller angle (roughly 25°). In the central angle of approx. 75° the curvature is close to the ideal curvature, with an approximate radius of 11.9m vs. the estimated ideal of 11.84m.

partly hidden on the inside by the vaults (Albrecht 2009). An error must have been made in the construction process: the windows in the top row were positioned either too high or too far apart from each other and do not fit with the semicircular profile of the vault where intended. The geometry of the vault had to be altered, deviating from the ideal semicircle, in order not to obstruct the windows. This can be clearly seen in Fig. 2.6 B, where the profile of the vault has been projected onto the north wall and the idealised semicircular profile is seen to cut through the top corners of the windows. This is true for the west vault too.

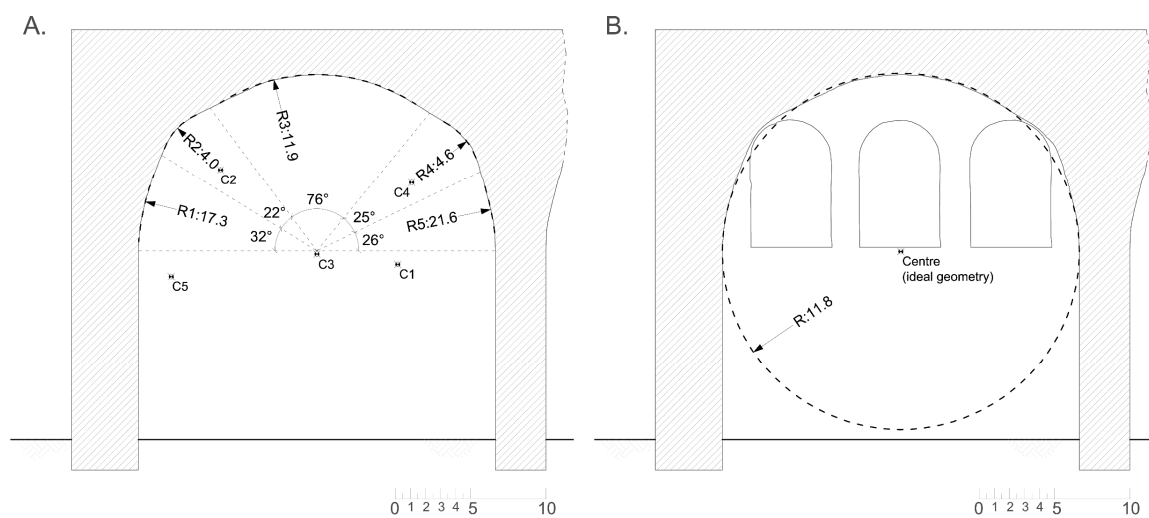
Fig. 2.6. Analysis of deformations generated as a result of the construction process. A. detailed analysis of the geometry; B. superposition of ideal geometry.

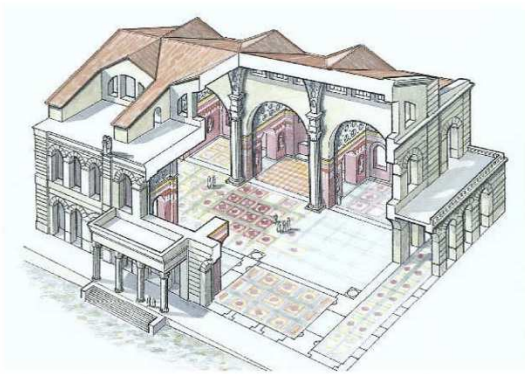
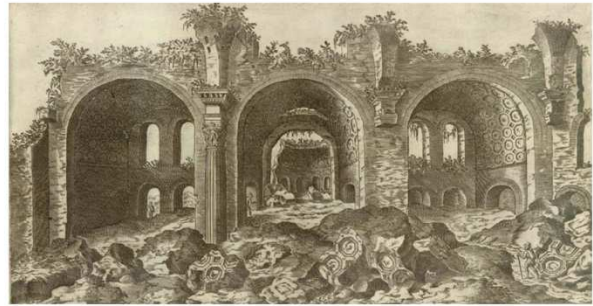
Fig. 2.10. As-built original and as-collapsed states of the Basilica of Maxentius. Study of the geometry and stability of the structure.

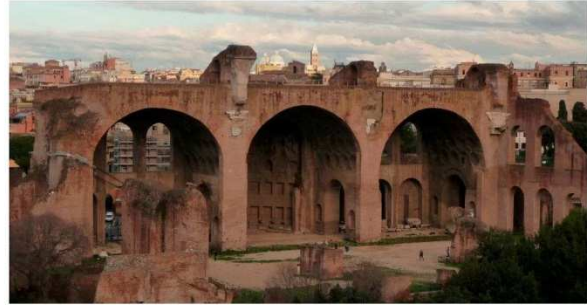
Fig. 2.11. State of the Basilica of Maxentius after the first and second excavations around the west and north of the Basilica.

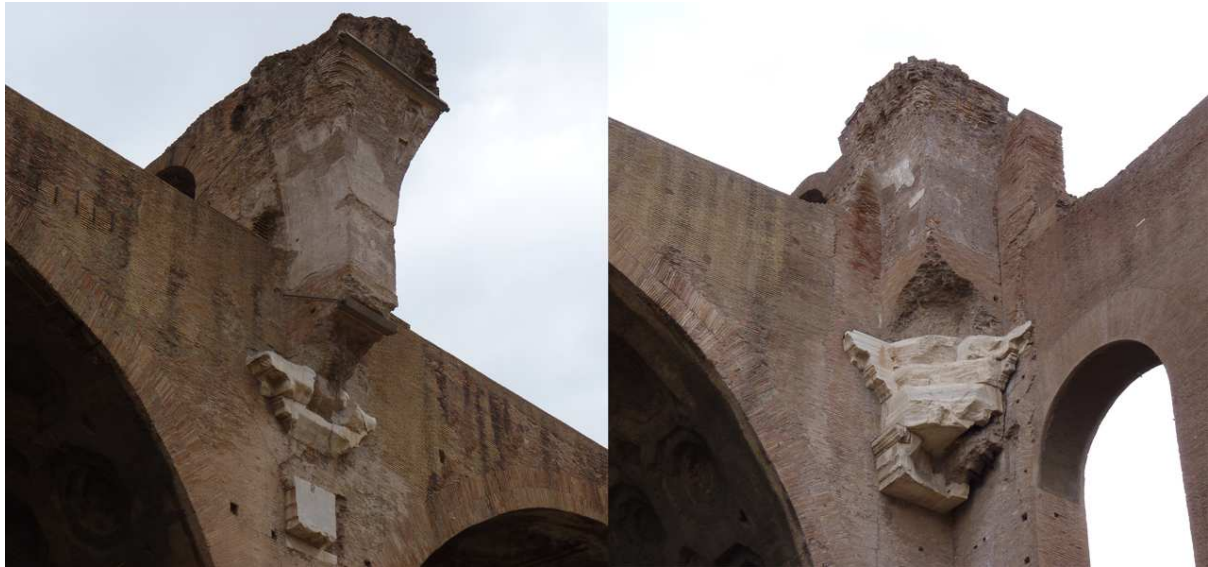
Fig. 2.13. Remains of the north side springings of the lost cross vaults over the central space of the Basilica of Maxentius: axis B (left) and axis D (right).

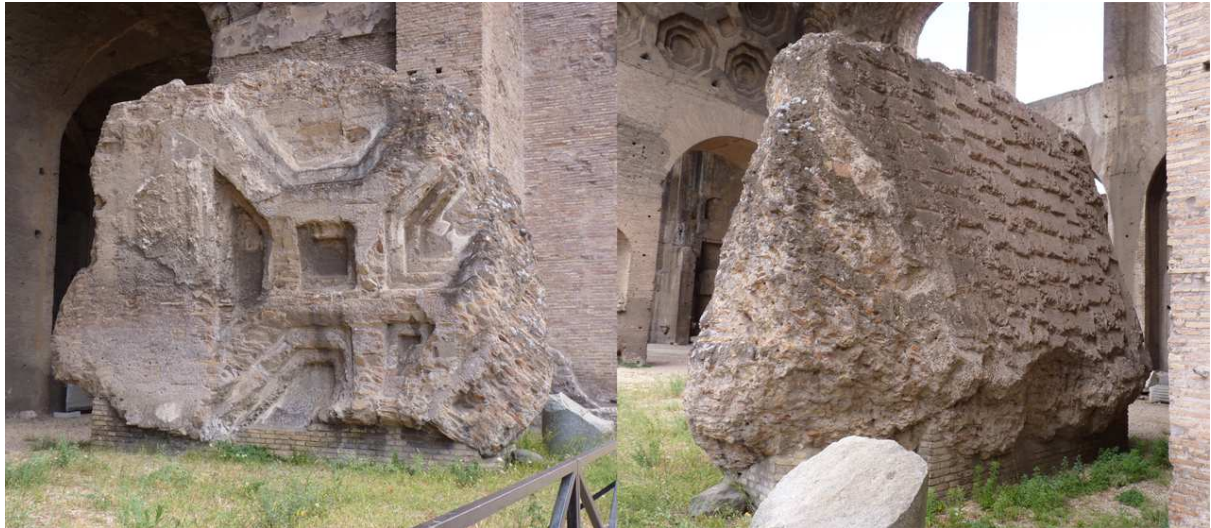
Fig. 2.14. Fragment A from the missing cross vaults of the Basilica of Maxentius: intrados (left) showing the coffering; and extrados (right) showing the traces of a tiled finish.

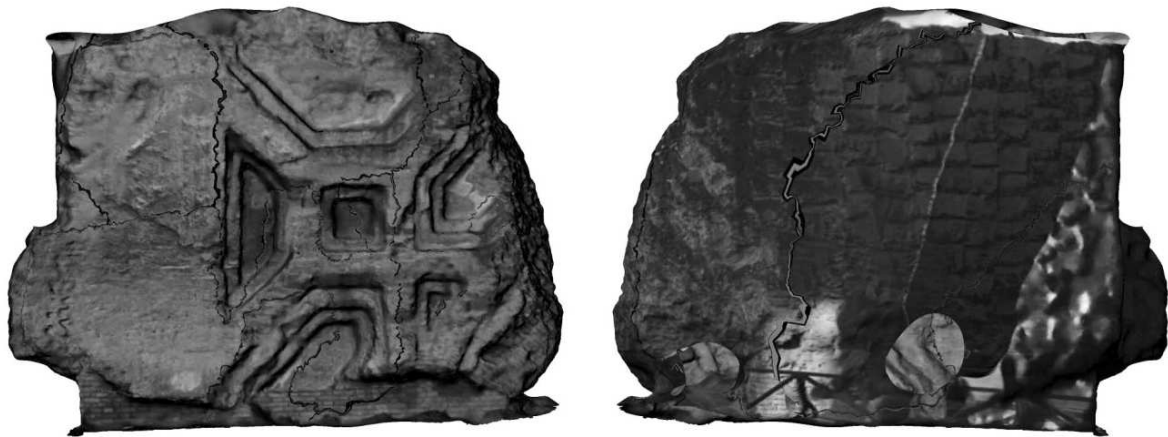
Fig. 2.15. 3D computer model of fragment A generated with photogrammetry software 123D Catch, by Autodesk: view of the intrados (left); view of the extrados (right).

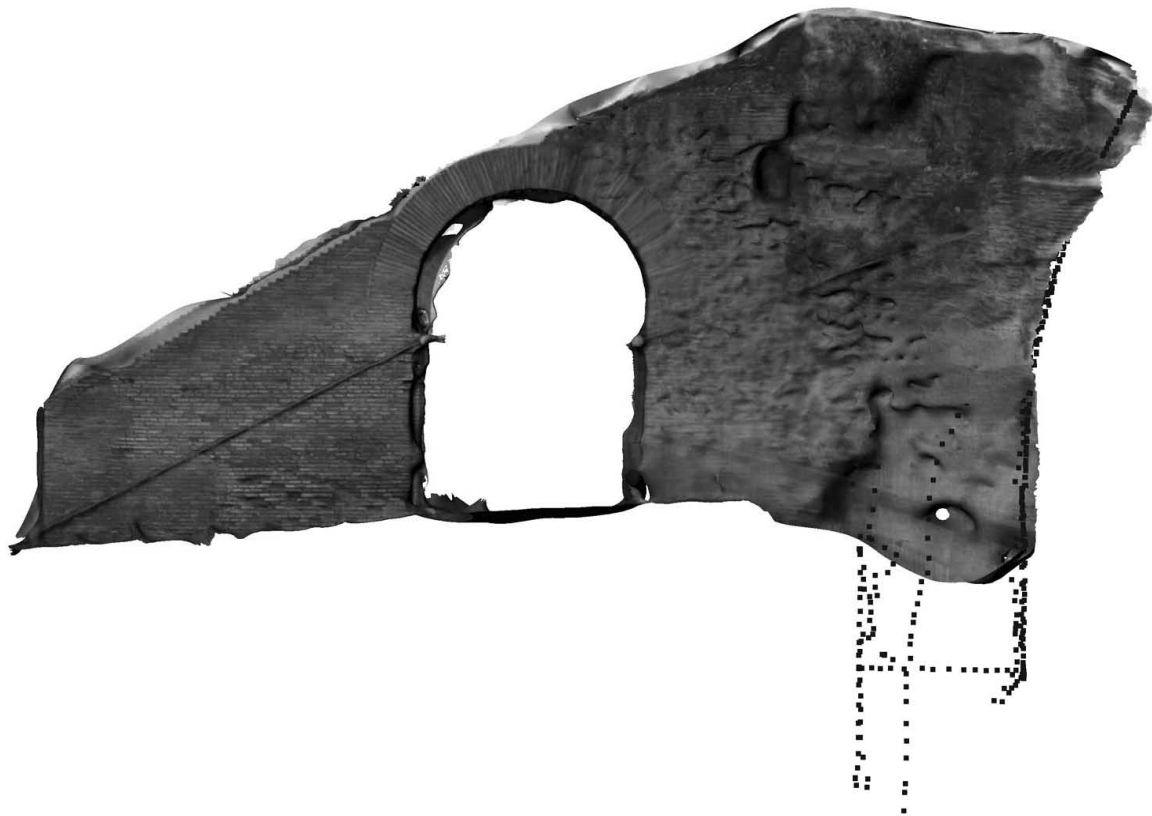
Fig. 2.16. 3D computer model of the roof buttress on axis B, generated with photogrammetry software 123D Catch, by Autodesk: Elevation showing the total-station survey data points used in combination with the 3D model to estimate the level of the lowest point of the roof.

The buttresses preserved on the roof of the north nave can also provide some information about the geometry of the roof of the cross vaults. These elements have been surveyed by a combination of total station measurements and photogrammetry (see Fig. 2.16 below).

A further check was carried out using the survey of the roof buttresses over the north nave. The one on axis B (Fig. 2.12) was used for corresponding to the largest springing remains. The profile of the top of the buttress follows a straight line (see Fig. 2.16), interpreted as being parallel to the original upper side. The original upper limit has been inferred and extended to reach the roof, verifying that the reconstructed height of the roof lies approximately at this height, and never lower, as expected.

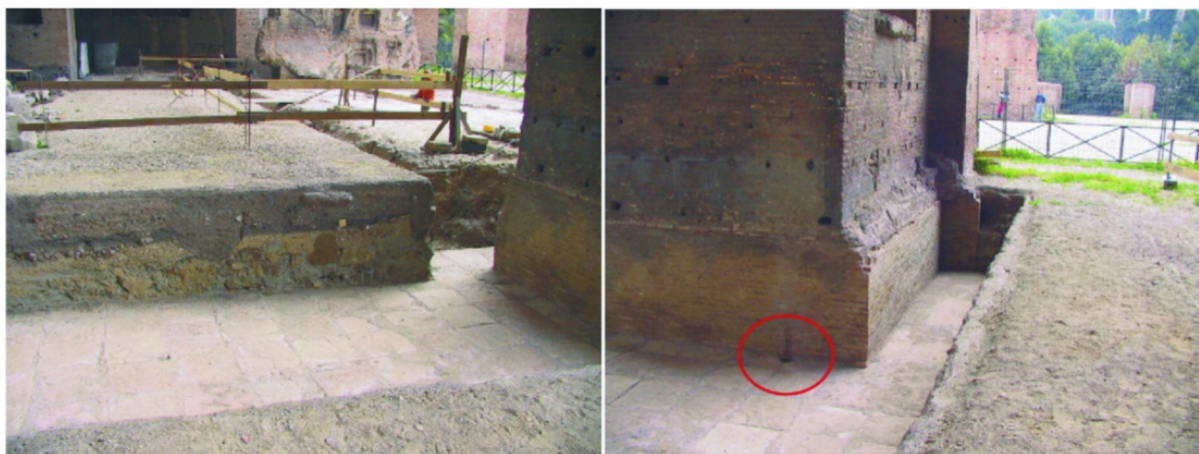
Fig. 3.1. Photographs of excavations of the foundations of the piers on the north nave of the Basilica of Maxentius in the late 1990's. Top layer of foundation structure exposed: levelled horizontal plane with bipedale finishing (photos: Cardarelli 2009).

The more recent investigations on the occasion of the 2000 Jubilee aimed, among other things, at establishing the structural safety of the remains of the Basilica. For such purpose, the top of the foundations of the north nave piers was excavated (see Fig. 3.1) and a geotechnical study of the area was carried out (Calabresi 2005), paying particular attention to the western façade, as it constituted the weakest point of the building (see chapter 9 for further discussion on this topic).

Only part of the foundation under the pier is visible -the north end-, while the end that joins the south façade falls outside the accessible basement, is still unexcavated. It appears to be a strip foundation running uninterrupted under the entire pier, a hypothesis that is validated by the excavation around the mirror pier in the north nave (Fig. 3.1). Furthermore, only the

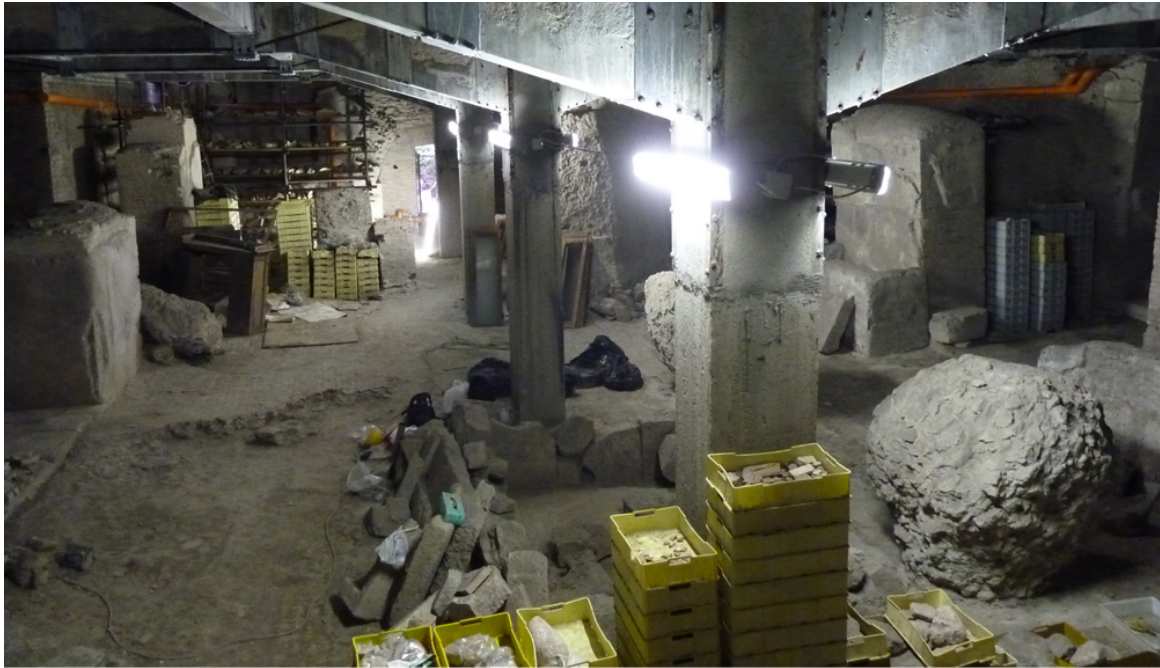
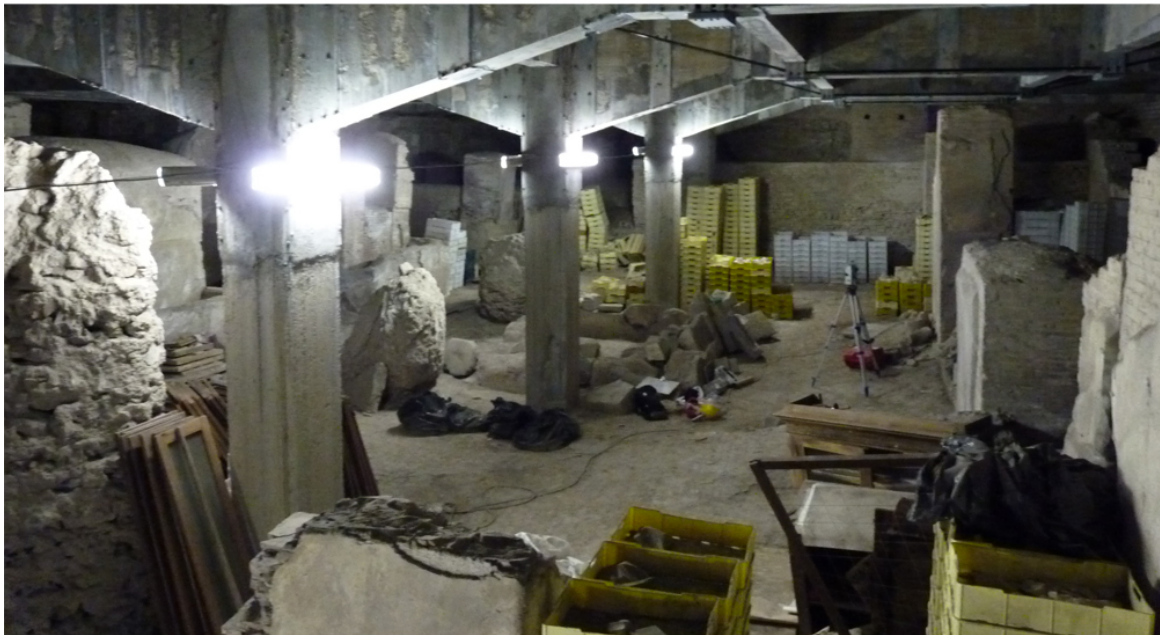
Fig. 3.5. Excavated basement space under the south nave of the Basilica of Maxentius, looking west (above) and looking east (below) (photo: Albuerne 2012).

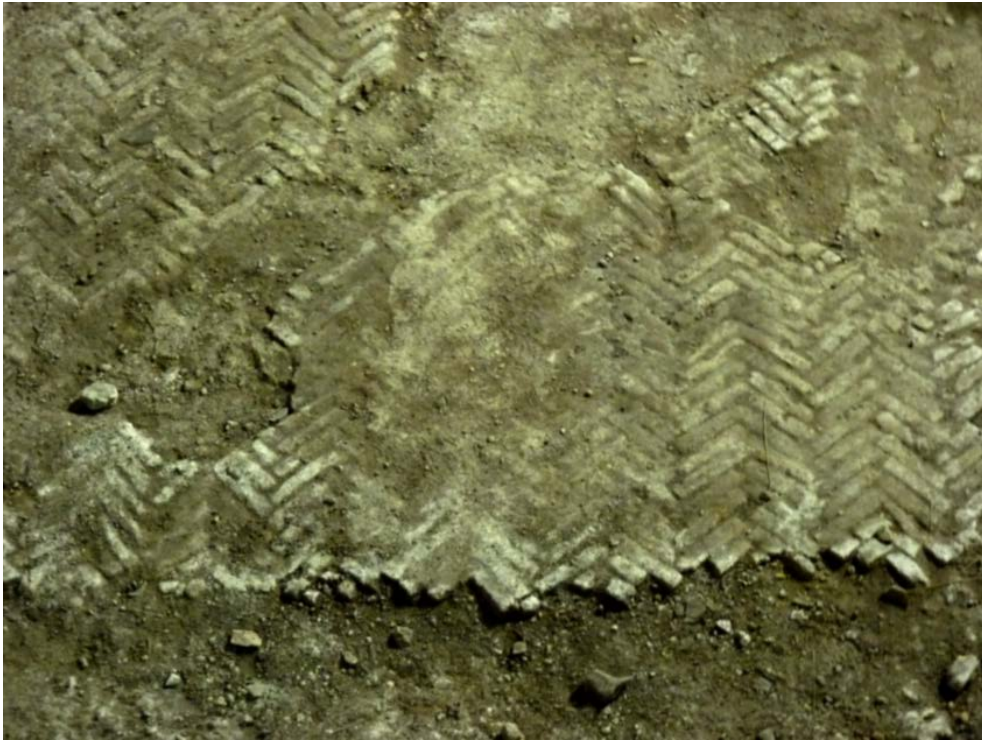
Fig. 3.6. *Opus spicatum* on the floor of Horrea Pipperataria (photo: Albuerne 2012).

The area that today remains accessible as a basement under a reinforced concrete slab built in the 1930's is shown in Fig. 3.4 In this area the grid of the warehouses is modified so that between 9 and 12 spaces, potentially shops, are arranged around an open courtyard around an *impluvium*, with a stone basin in the middle. The original floor around the area appears to have been comprised of brick *opus spicatum* (see Fig. 3.6).

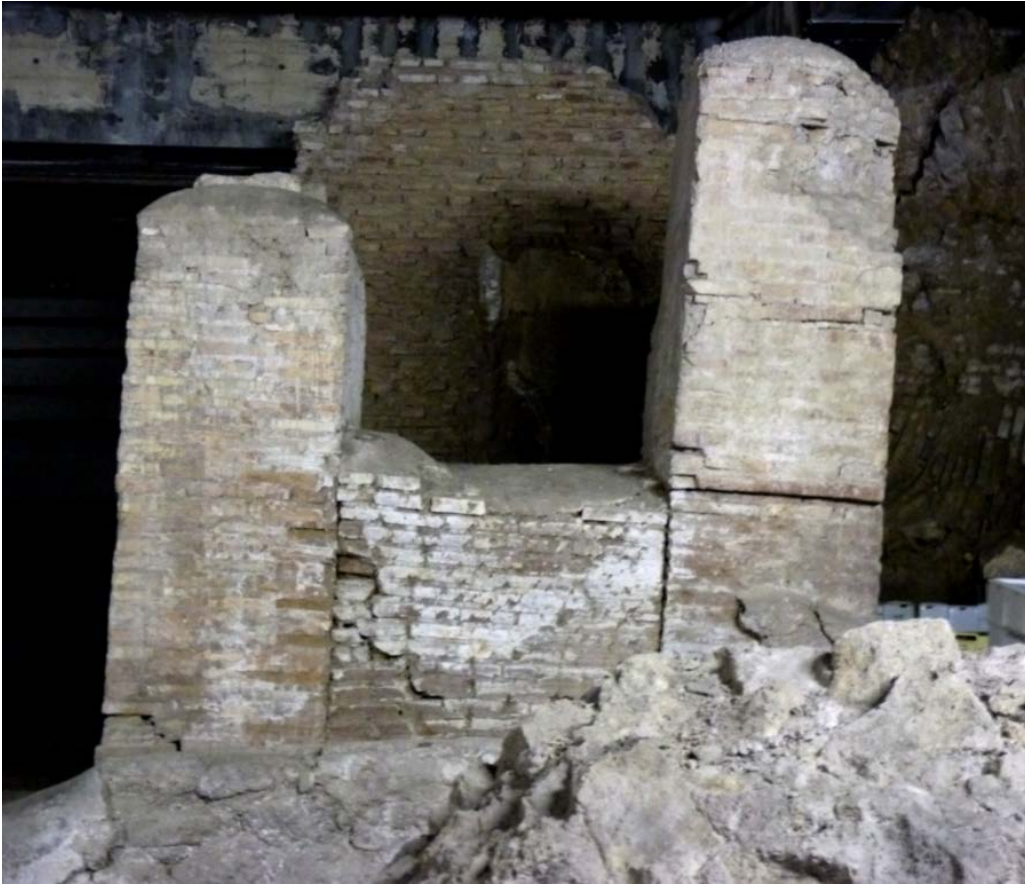
Fig. 3.7. Remains of Horrea Pipperataria, the building that occupied the site before the construction of the Basilica. These show signs of lateral load damage. Notice un-bonded behaviour at *bipedales* layers.

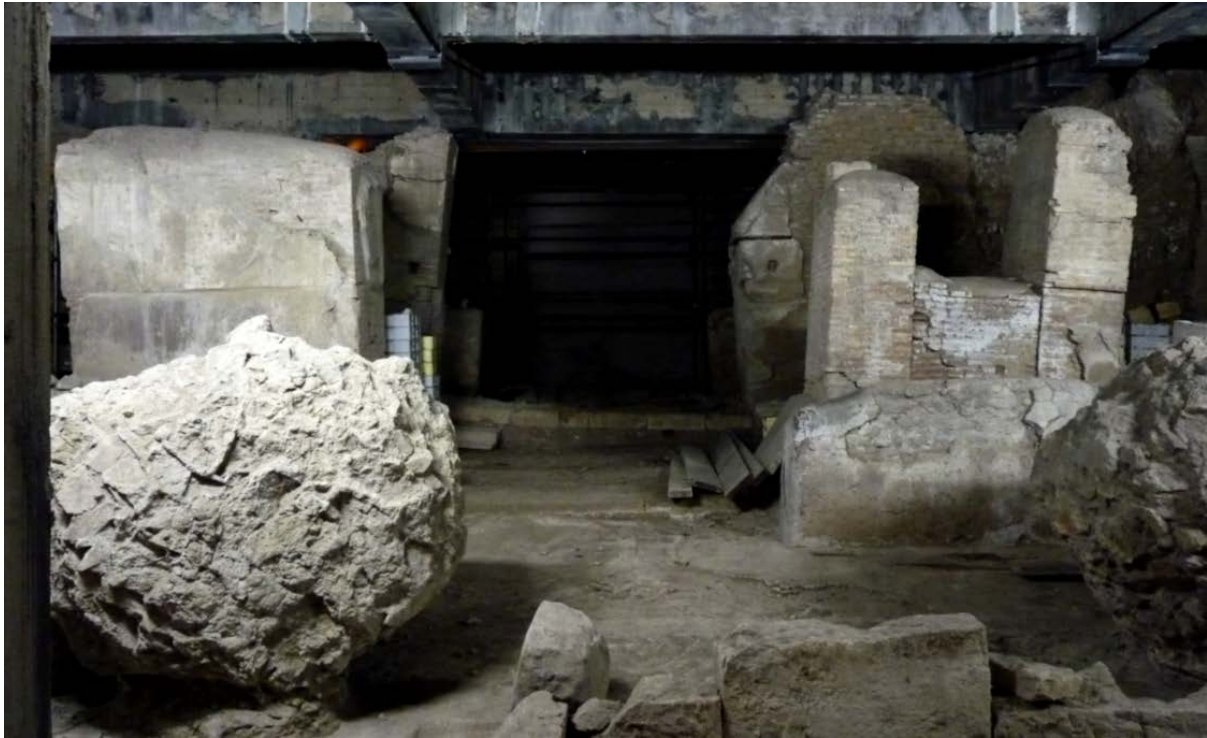
Fig. 3.8. Remains of four piers of the Horrea Pipperataria inclined in opposite directions. A sign that they have been exposed to lateral loading, probably oscillating seismic loading (photo: Albuerne 2012).

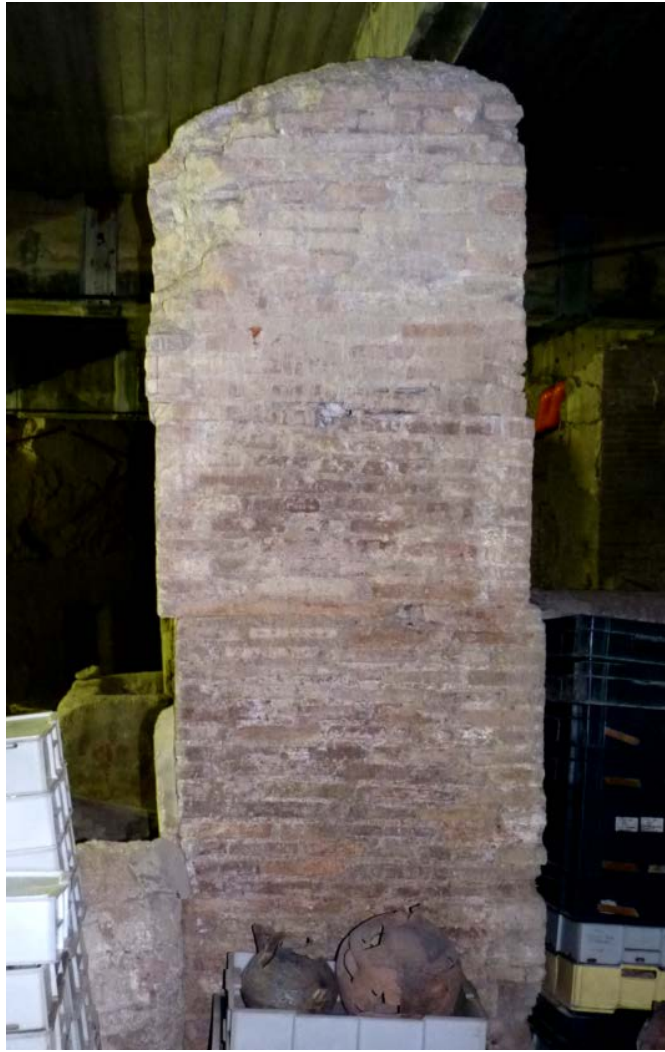
Fig. 3.9. Surviving wall of the Horrea Pipperataria showing slip at un-bonded bipedale layers, sign of horizontal loading (photo: Albuerne 2012). This type of damage is often observed in monumental ashlar columns, today free-standing, that have suffered damage in an earthquake.

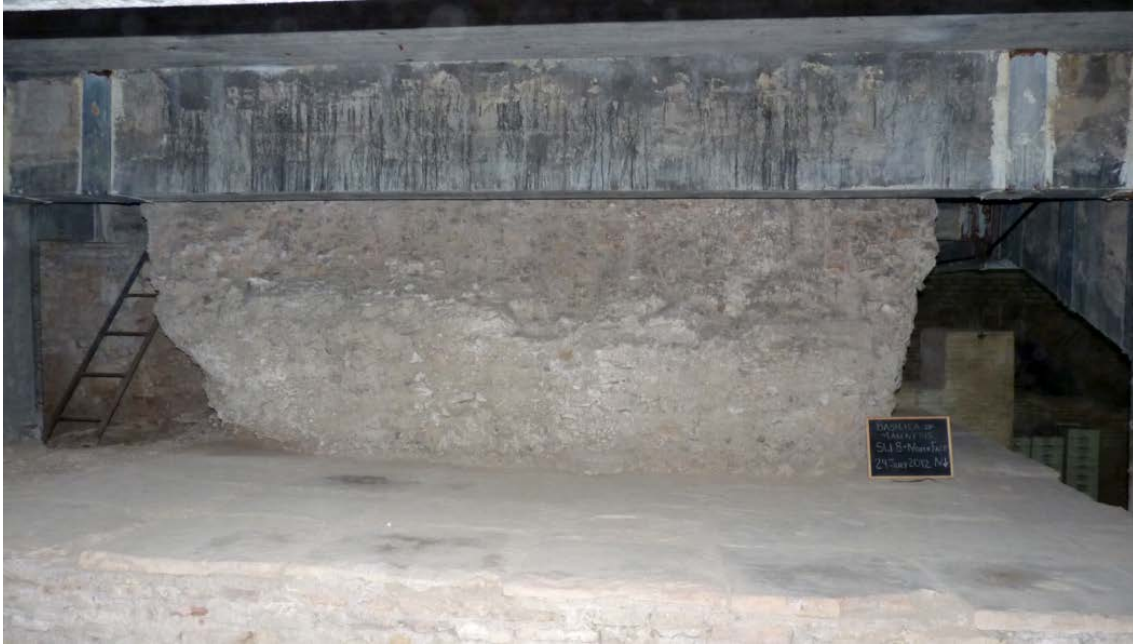
Fig. 3.11. Photograph of the Roman concrete foundation for the decorative column in front of the pier.

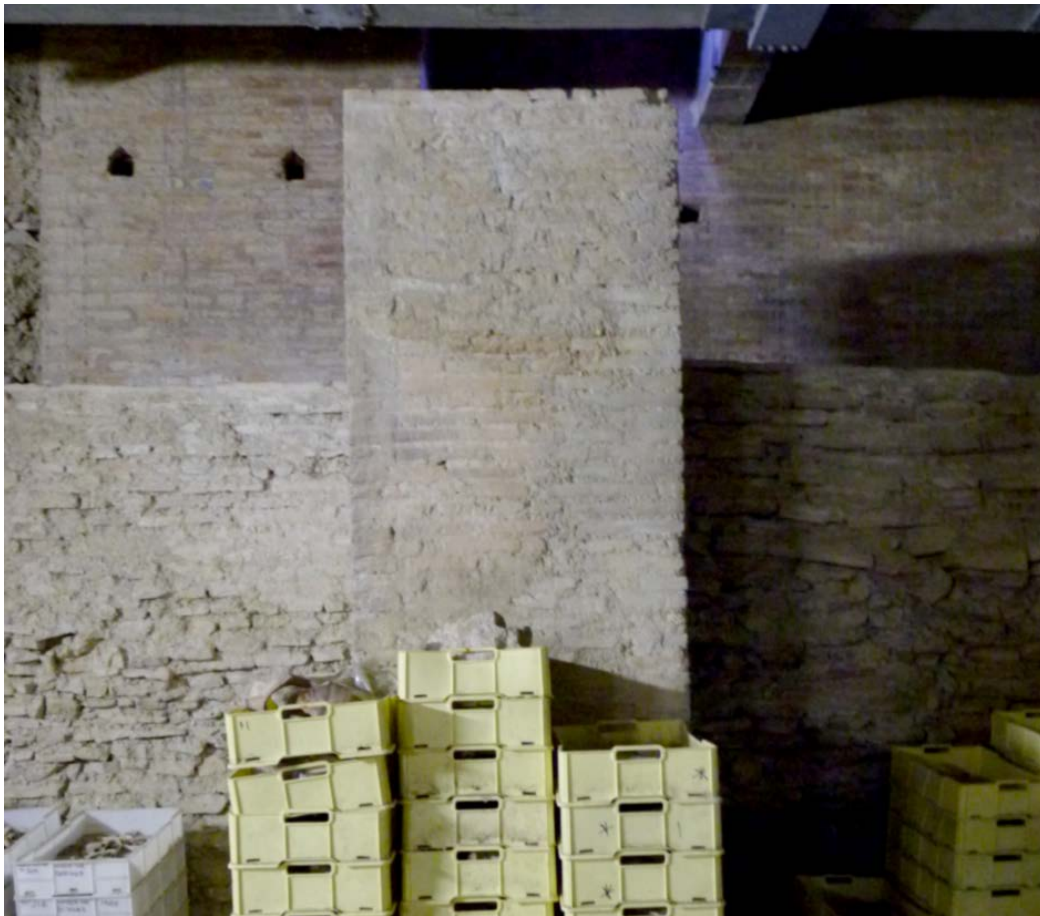
Fig. 3.12. West face of surveyed pier, showing the poor quality of the earlier structures incorporated into it (photo: Albuerne 2012).

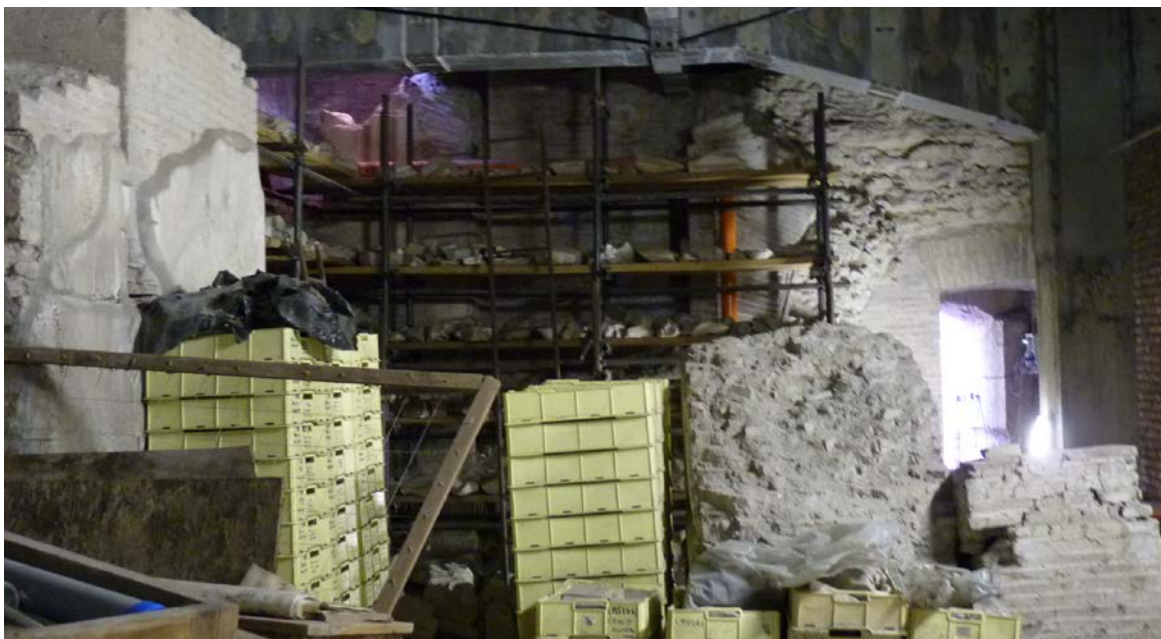
Fig. 3.14. Internal face of west façade, south nave, seen from inside the excavated basement (photo: Albuerne 2012) . A heavy duty shelf obstructs the view and access for a better survey.

The south section of the west façade is an even more intricate example of the incorporation of the pre-existing walls of the Neronian *porticus* and Flavian *horrea piperataria* into the substructure of the Basilica of Maxentius. Barosso's plan view of the area (Figs. 3.1 & 3.4) shows the façade wall enclosed in between two walls of the pre-existing buildings. The elevation of the inside view of this wall generated during the survey of July 2012 is shown in Fig. 3.14, where it is possible to see the complexity of the construction. In essence, the elevation comprises a wall of the earlier buildings featuring semi-circular ribs made of *bipedales*, openings, infills and other alterations. The wall has been cut through to build the wider section of the pier of the Basilica next to the central nave. In this stretch it is possible to see the appearance of the same type of foundation as seen in the internal pier (see §3.2.2): there is a lower section of rubble concrete, capped with a layer of *bipedales* on which the masonry in *opus testaceum* sits (see numbers 8 and 9 in Fig. 3.15).

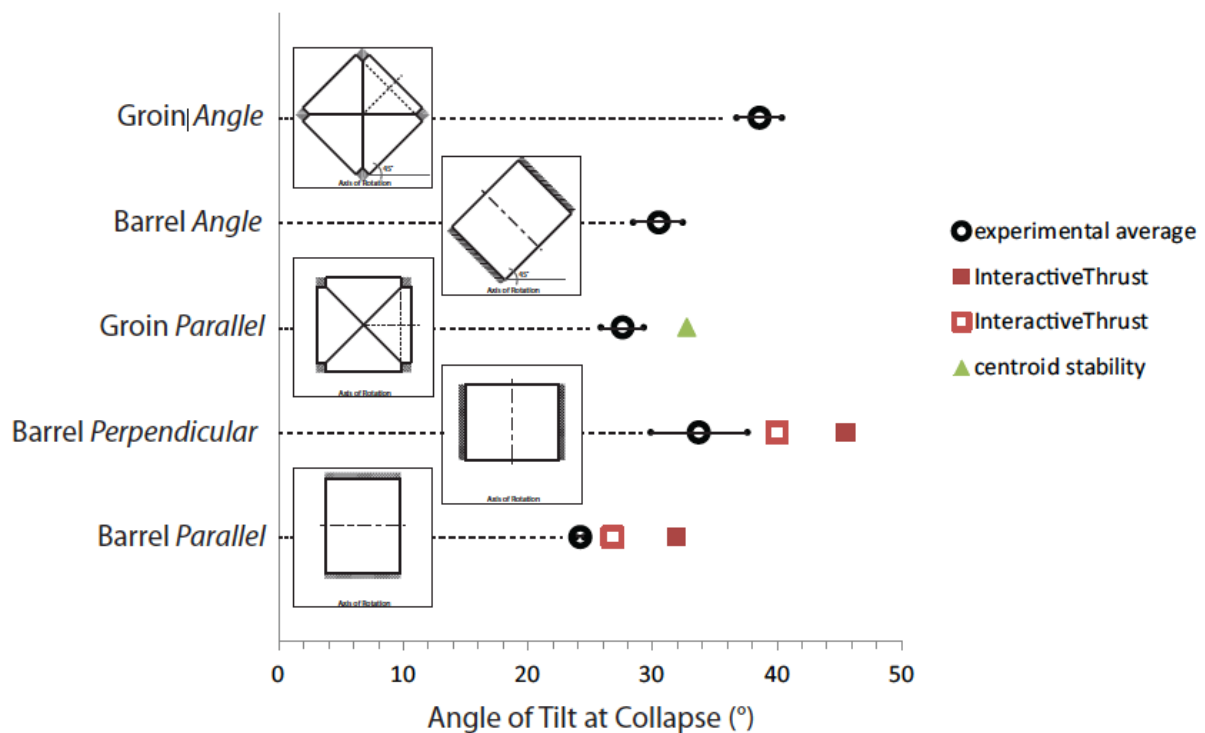
Fig. 4.8. Tilt collapse tests and analysis of barrel and groin vaults (Shapiro 2012).

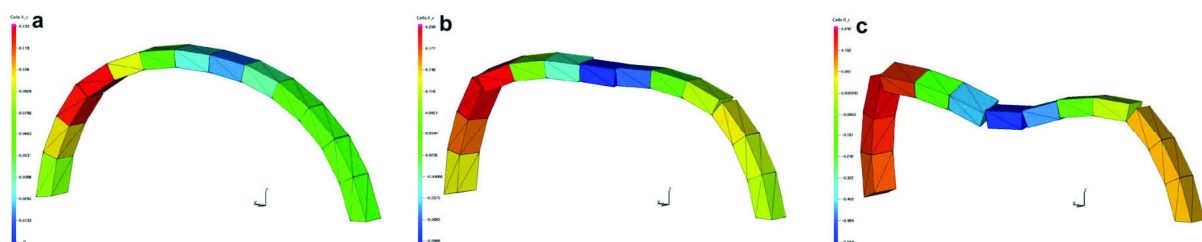
Fig. 4.15. Voussoir arch with dry friction contact subject to seismic loading modelled using LMGC90. Collapse mechanism showing vertical displacements (in m), at times (a) 2.5 s, (b) 2.8 s, and (c) 3 s of the analysis (Rafiee et al. 2008 (a)).

Alternative non-compliant codes exist that do not allow interpenetrability of the elements at contact surfaces. One such code is LMGC90, developed at the University of Montpellier (Dubois et al. 2007). This code has been used in the past for modelling the dynamic behaviour of masonry (Rafiee et al. 2008 (a) and (b)), but lacked validation against experimental tests. The code is discussed further in Chapter 8 and a comparison of modelling and experimental results for a voussoir arch under base motion are also presented.

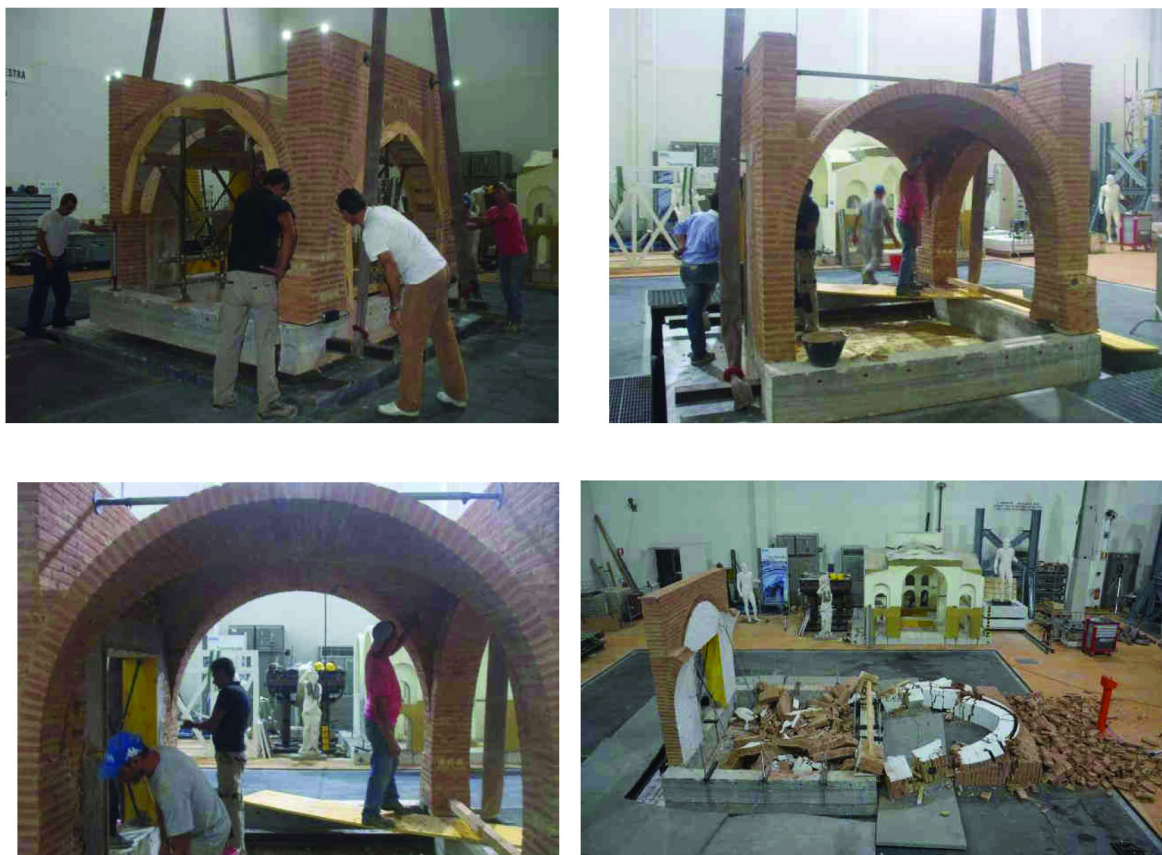
Fig. 4.17. Vault model of the Mosque of Dey (Algiers) constructed in brick masonry: positioning on shaking table and final collapse after testing (PERPETUATE 2012, 81-82).

Experimental tests on cross vaults or other type of vaults resting on their corners, rather than along a linear support the way barrel vaults are, are very rare. Only one shaking table test of an isolated vault is known to the author. As part of the PERPETUATE project, a 1:1 scale cross vault made of brick was subject to shaking table tests. The vault was modelled on the vaults of the Mosque of Dey (Algiers), it had a square plan and asymmetric boundaries. It was tested in a shaking table subject to increasing intensity earthquakes, the final shaking causing collapse (PERPETUATE 2012).

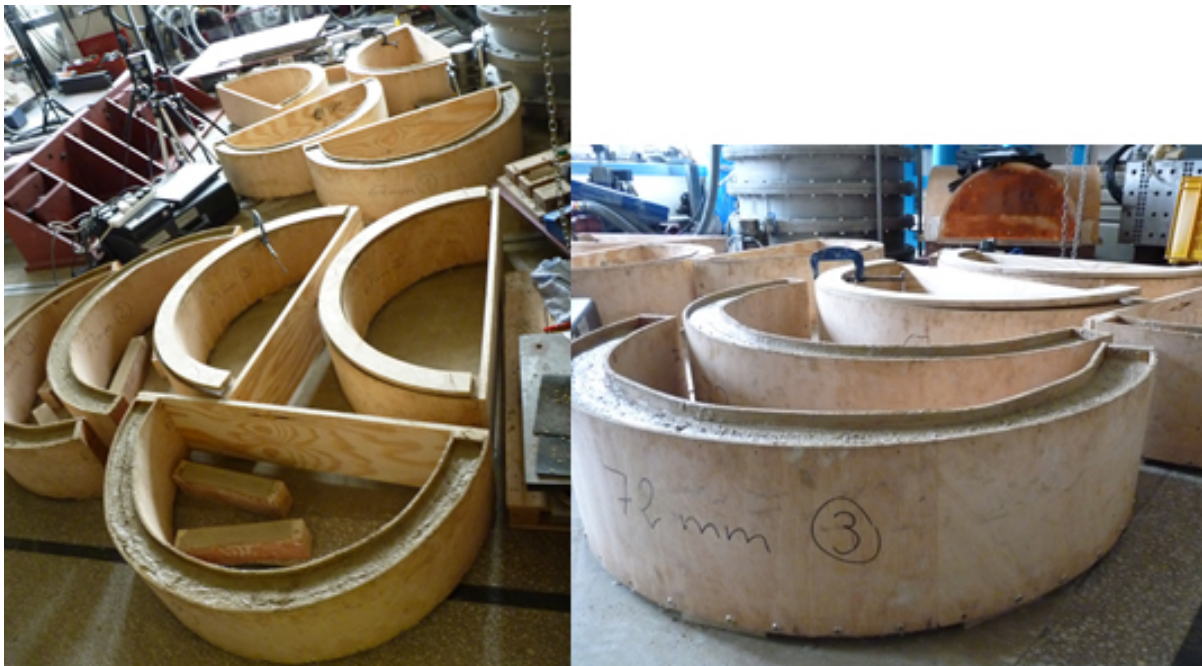
Fig. 5.2. Sample arches cast in timber moulds.

The intrados geometry of the arches corresponds roughly to a 1:25 scale of the barrel vaults of the Basilica of Maxentius, which have a clear span of just under 25m. The arches were continuous, cast in timber moulds, as shown in Fig.5.2.

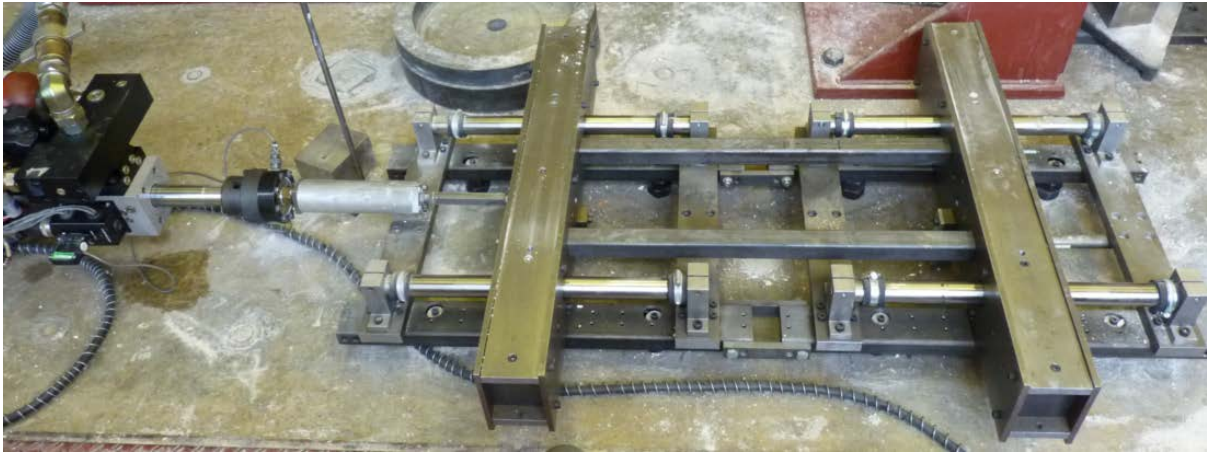
Fig. 5.13. Structure of shaking table: transverse box-section carriages running on linear bearings over cylindrical shafts.

The shaking table is a single degree of freedom system that comprises a platform, 1 m square approx., running horizontally on linear bearings. The platform is a solid mild steel plate #15mm and overall dimensions 1140 x 920mm, bolted on two horizontal carriages placed perpendicular to the direction of the motion. Each carriage runs on linear bearings over two cylindrical shafts, of length 600 mm and clamped at each end (see fig. 5.11).
