Seismic collapse of vaulted structures:
Unreinforced quasi-brittle materials and the case study
of the Basilica of Maxentius in Rome

Alejandra Albuerne

University of Oxford

Doctor of Philosophy

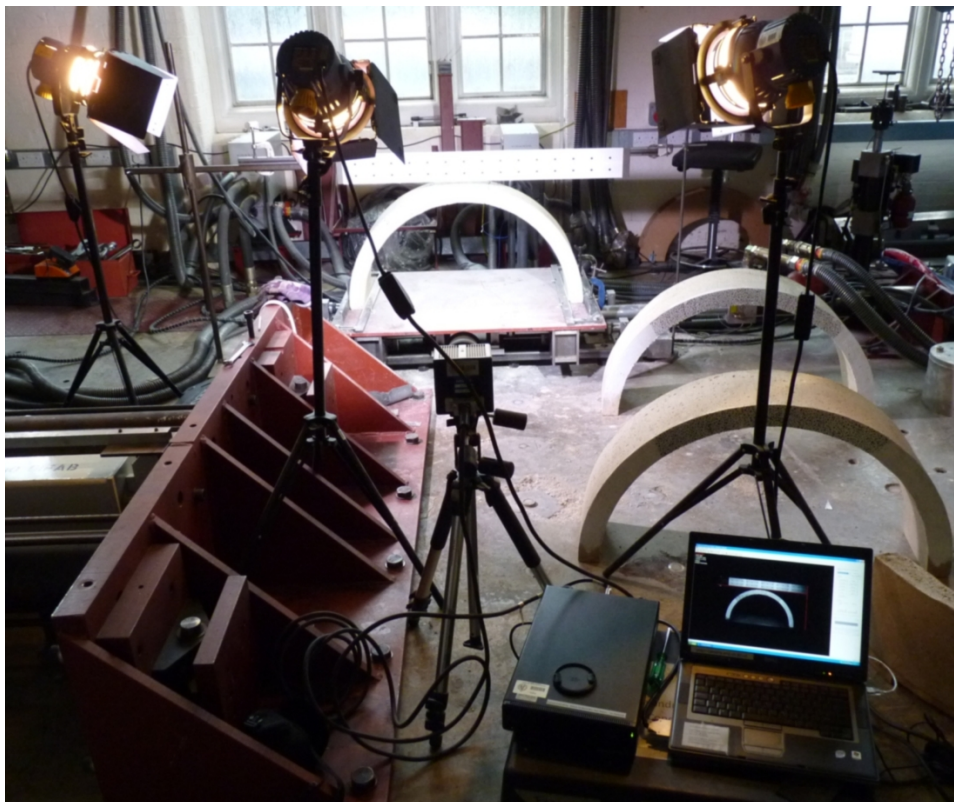
Fig. 5.15. Experimental set-up showing shaking table with arch specimen and high speed camera system.

The experimental set up is shown in Figure 5.15. The front elevation of the samples is the plane on which PIV analysis is performed. The horizontal dimension of this plane captured by the camera measured approximately 1.1 m. At the above resolution, 1 pixel = 1 mm.

Unlike granular soil against a glass wall, the smooth surface of the arch specimens –mortar finish against shuttering- did not provide a texture with high enough contrast for GeoPIV to track. It was necessary to apply a 2D pattern on the tracked surface, as shown in Figure 5.15. The pattern is printed on water slide decal paper, very thin and fragile film that adds no further strength, which is then fixed onto the specimen. The pattern is CAD generated and is comprised of triangles of different shapes and sizes printed in black over white, in order to maximise contrast. The size of the pattern is chosen to suit the resolution of the camera, so that the triangles occupy a small number of pixels each (see Figure 5.16B).

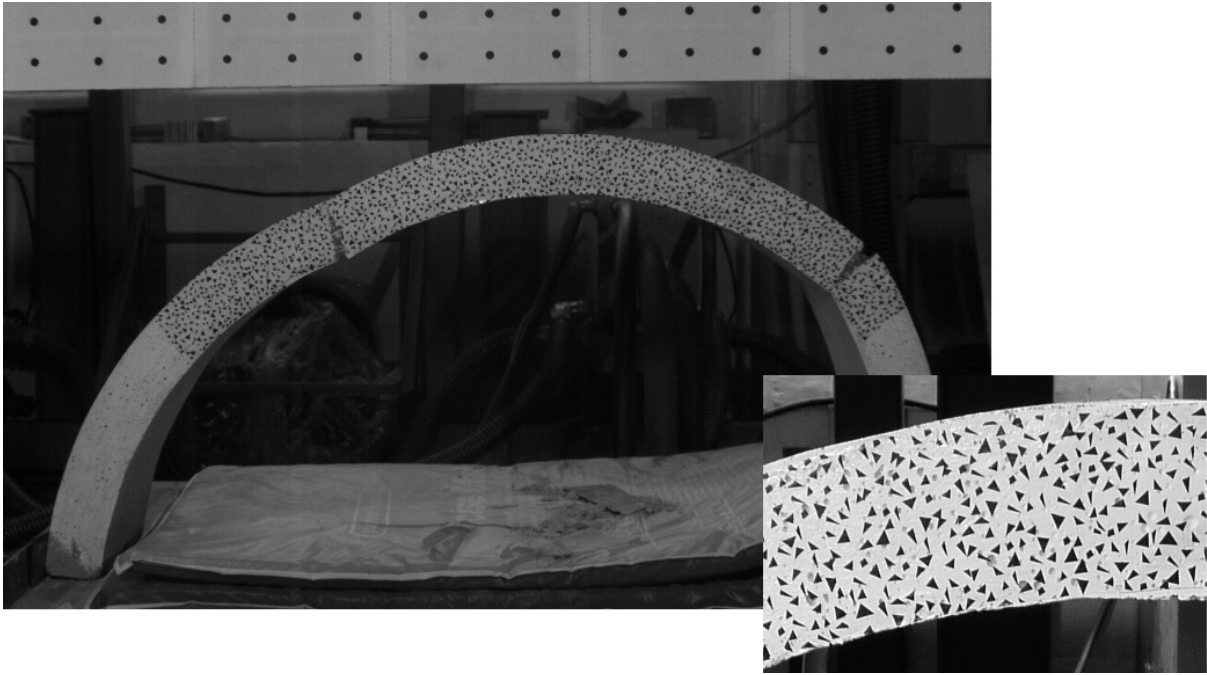
Fig. 5.16. Top left: Example of high speed camera image, at actual resolution, showing static reference points, along the top banner, for photogrammetric rectification and scaling of images. Bottom right: High resolution close up showing pattern devised for PIV tracking, a combination of rectangles of different shapes and sizes.

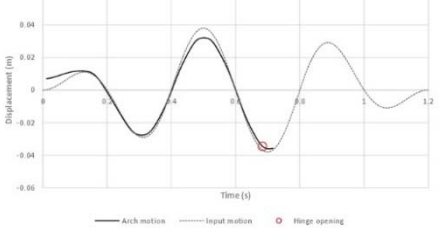
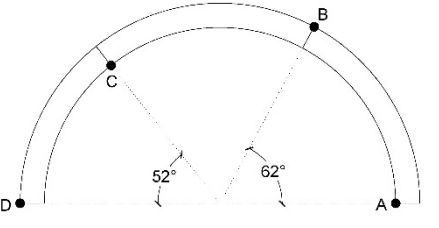
REF.	THICKNESS (mm)	MATERIAL STRENGTH (MPa)	MAX. ACCELER. (m/s ²)	ROCKING	DISPLACEMENT PLOT	ACCELERATION PLOT	FAILURE MECHANISM DIAGRAM
FL05	67mm	$\sigma_t = \text{N.A.}$	14.06	Yes	<p>Displacement (m) vs Time (s). Legend: Input motion, Arch motion, Hinge opening.</p>	<p>Acceleration (m/s²) vs Time (s). Legend: Arch acceleration, Input acceleration, Hinge opening.</p>	<p>Failure mechanism diagram showing a semi-circular arch with points A, B, C, D. Angles are 61° and 67°.</p>
FL06	67mm	$\sigma_{t1} = 0.358$ $\sigma_{t2} = 0.320$	8.98	No	<p>Displacement (m) vs Time (s). Legend: Arch motion, D form Mètre, Hinge opening.</p>	<p>Acceleration (m/s²) vs Time (s). Legend: Arch acceleration, Input acceleration, Hinge opening.</p>	<p>Failure mechanism diagram showing a semi-circular arch with points A, B, C, D. Angles are 32° and 69°.</p>
FL07	67mm	$\sigma_t = 0.440$	11.92	Yes	<p>Displacement (m) vs Time (s). Legend: Arch motion, Input motion, Hinge opening.</p>	<p>Acceleration (m/s²) vs Time (s). Legend: Arch acceleration, Input acceleration, Hinge opening.</p>	<p>Failure mechanism diagram showing a semi-circular arch with points A, B, C, D. Angles are 41° and 61°.</p>

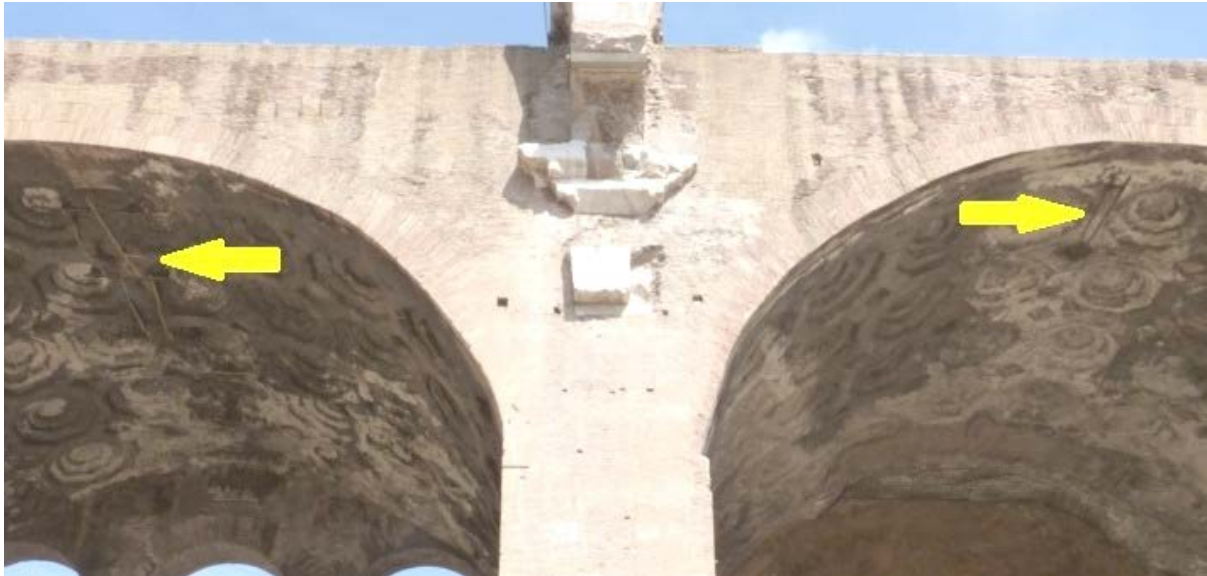
Fig. 6.7 West and central barrel vaults of the north nave of the Basilica of Maxentius showing visible repairs of existing crown cracks. Repairs dating from early 20th century (photo: Albuerne 2011).

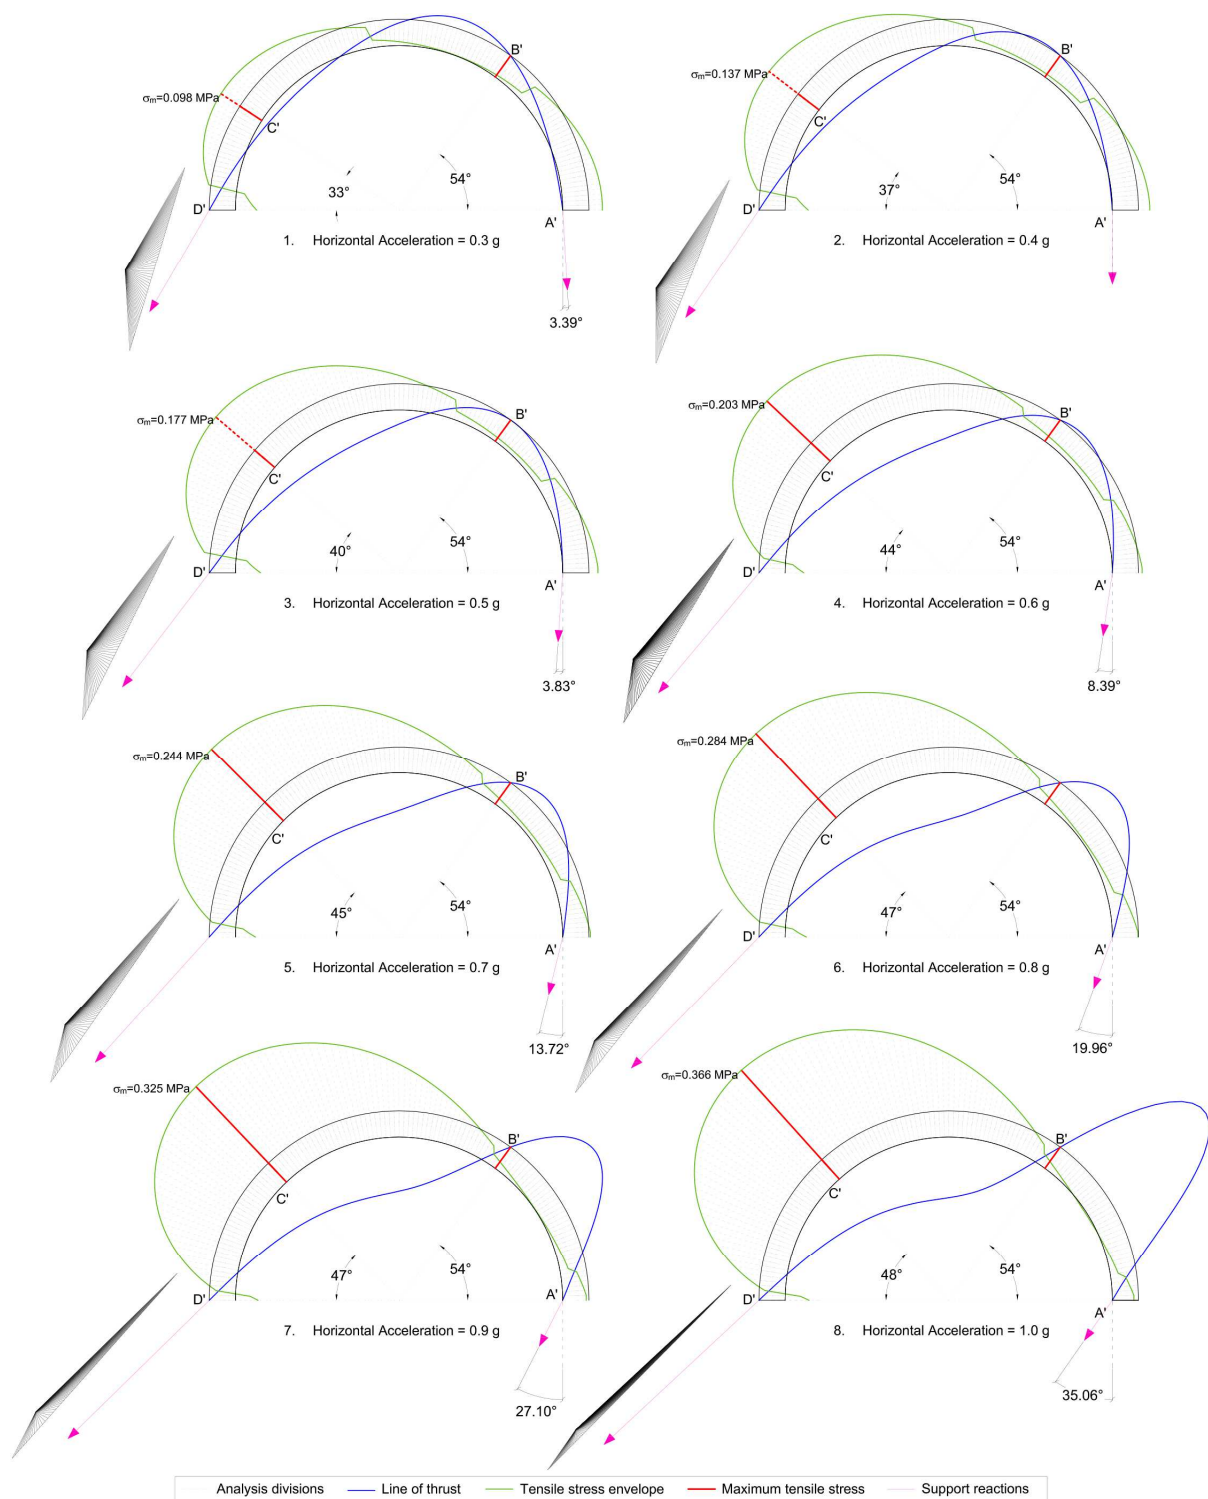
Fig. 6.19. Thrust line for reversed motion after formation of slider-crank mechanism, assuming the formation of the reversed four-link mechanism. Hinge B' will open where hinge C had formed, and crack C' will form at the maximum stress point between hinges B' & D'. Reaction at support A' has not been limited.
