In situ observation of compression damage in a 3D needled-punched carbon fiber-silicon carbide ceramic matrix composite¹

Short title: μ XCT of Compressive Damage in a needled-punched C-SiC composite

Fan Wan^{1, 2}, Rongjun Liu¹, Yanfei Wang¹, Yingbin Cao¹, Changrui Zhang¹ and Thomas James Marrow^{*2}

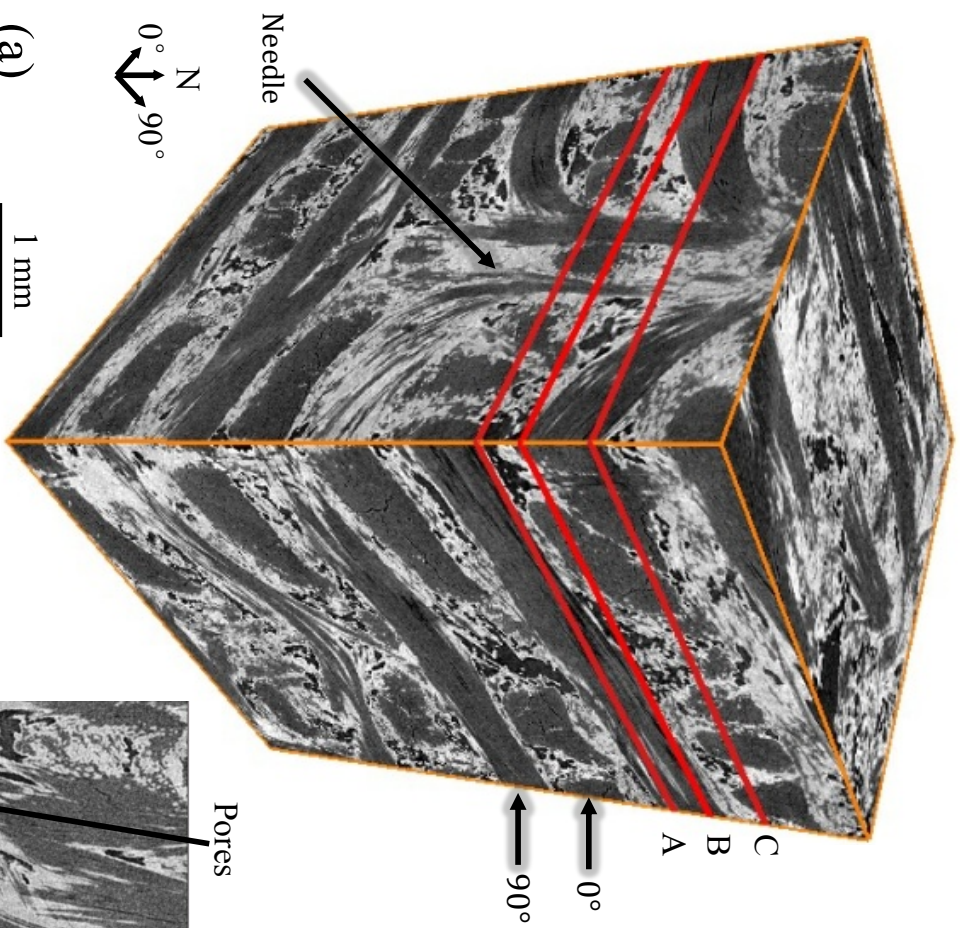
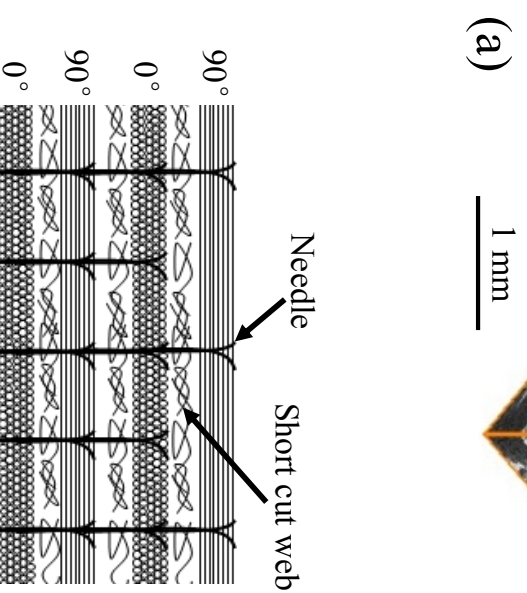
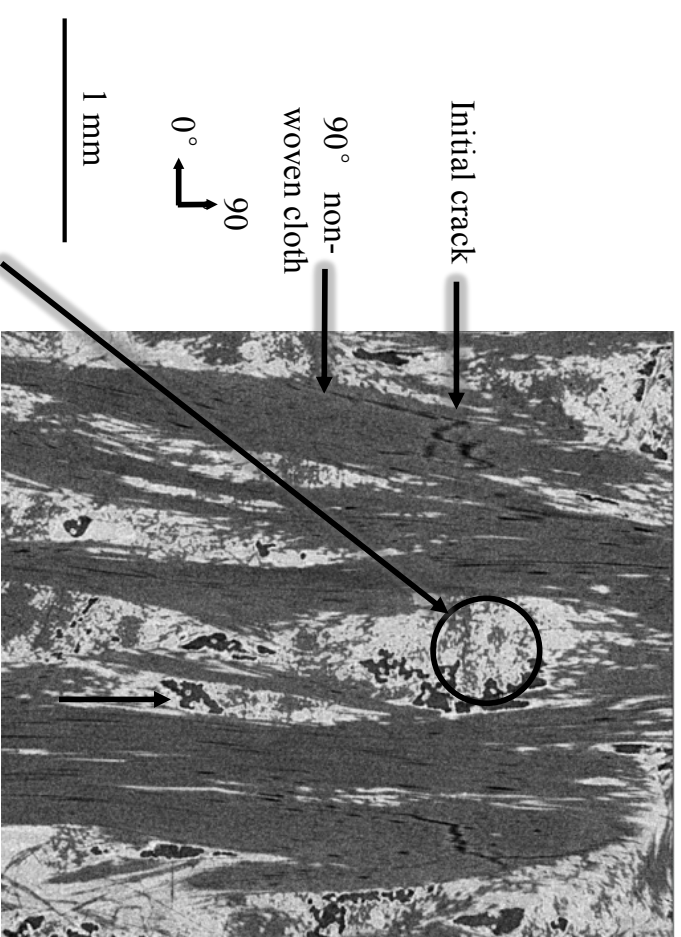
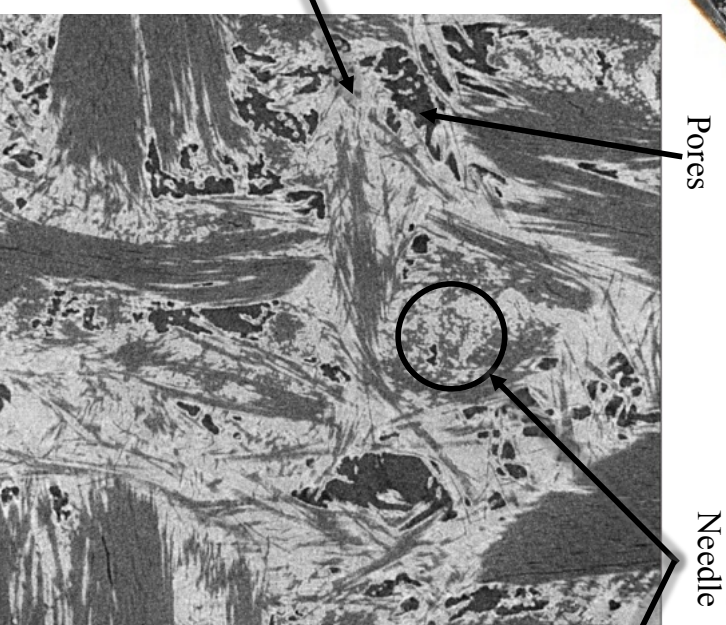
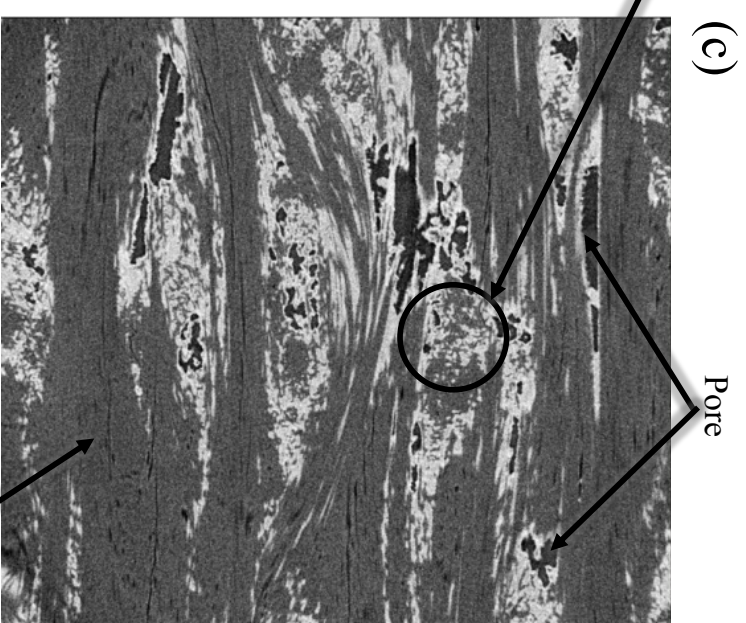
Figure 1: Microstructure of the C/C-SiC composite: a) tomograph (voxel size 5 μm); b) schematic arrangement of microstructure; c) to e) slices of the tomograph at layers A to C.

An example tomograph (5 μ m voxel) of the 3D needle-punched microstructure is shown in Figure 1a, with the non-woven fiber cloth directions (0° and 90°, according to the fiber direction in the cloth) and the orthogonal needle direction (N) defined. The layered structure of non-woven cloths is clearly seen, with the fiber bundles in the cloths separated by the introduction of the needle-punch. A schematic of the microstructure is shown in Figure 1b. Parallel slices (A-C) of the tomograph, perpendicular to the needle direction (Figure 1c-e) show the characteristics of the 0° cloth, the 90° cloth and short-cut web that is between them. Some initial cracks can be observed within the fiber cloths, between the fibers.

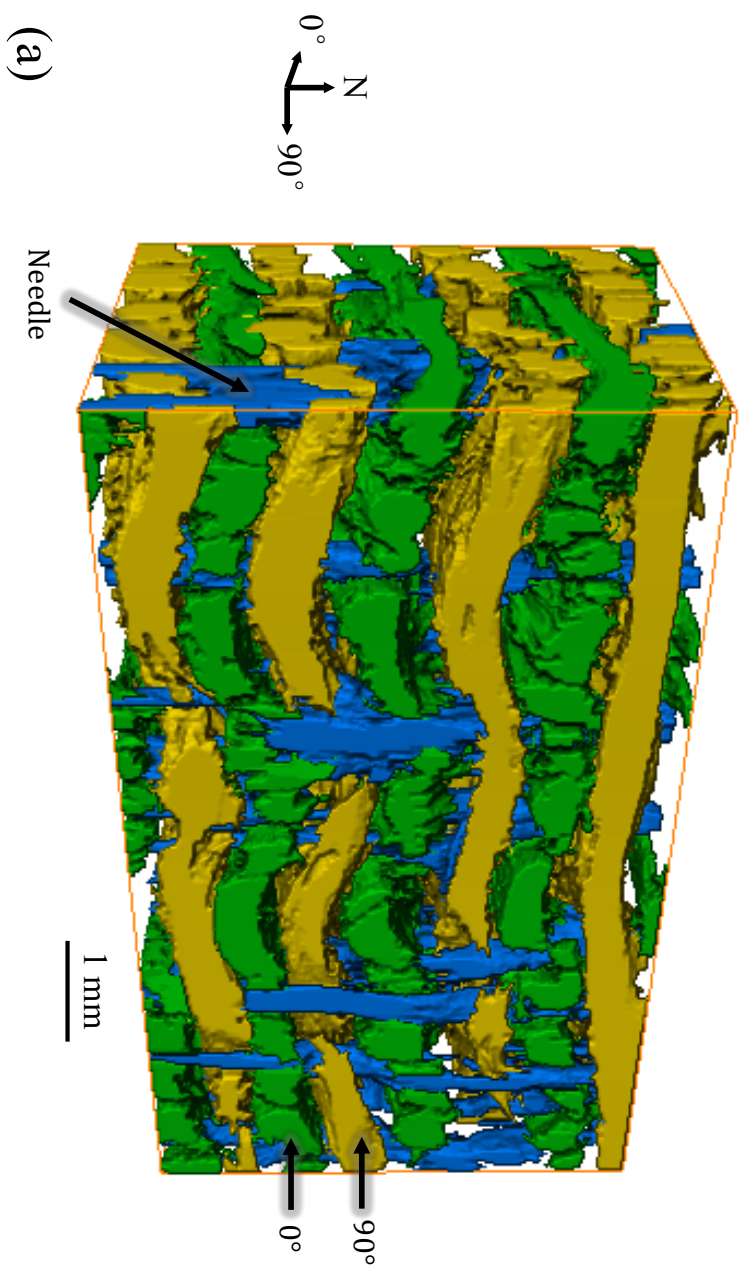
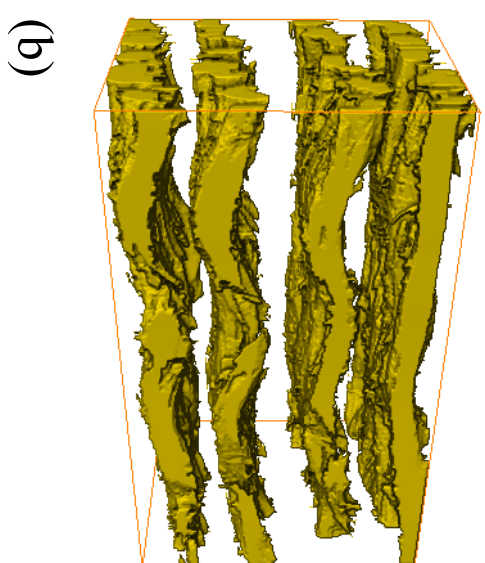
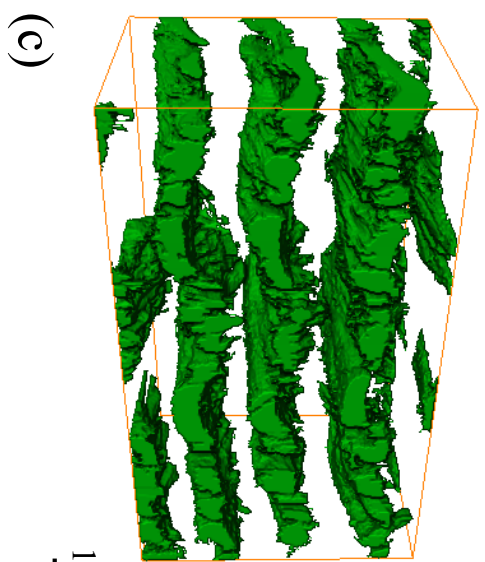
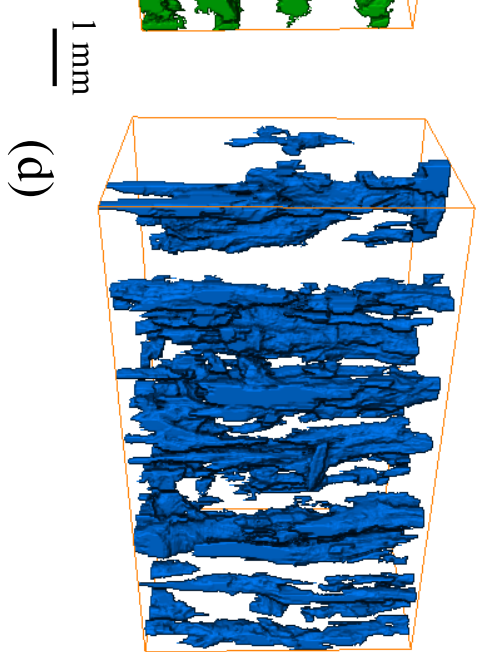
Figure 2: Segmented image of microstructure (5 μm voxel tomograph): a) complete structure, separated in b) 90° non-woven cloth; c) 0° non-woven cloth and d) stitched needles.

Porosity are observed, especially in the short-cut web area and needled area, with some pores having a linear dimension up to 1 mm. The main fiber bundles of the 0° and 90° cloths and the stitched needles were segmented using greyscale thresholding and their arrangement (Figure 2) shows how the cloth layers are affected by the punched needles.

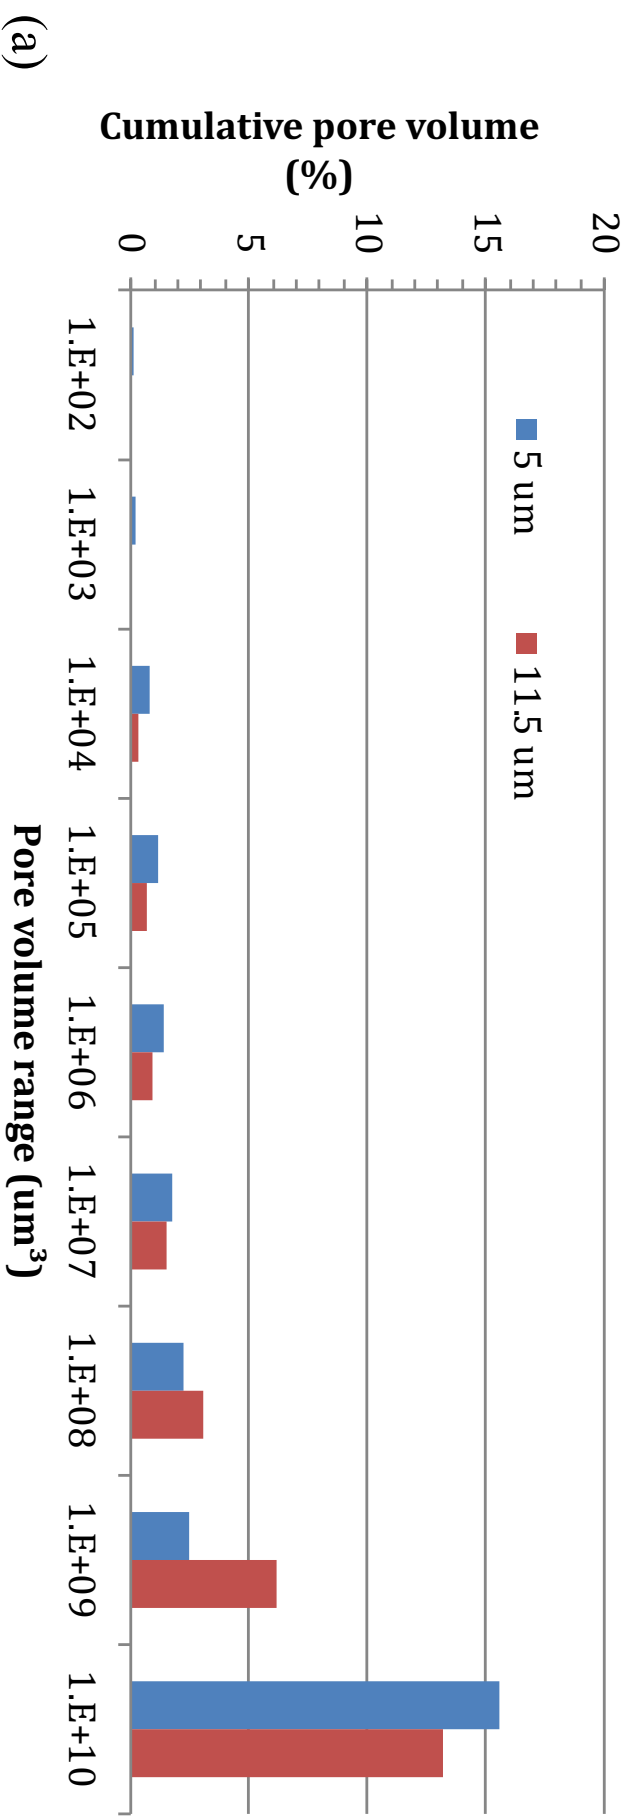
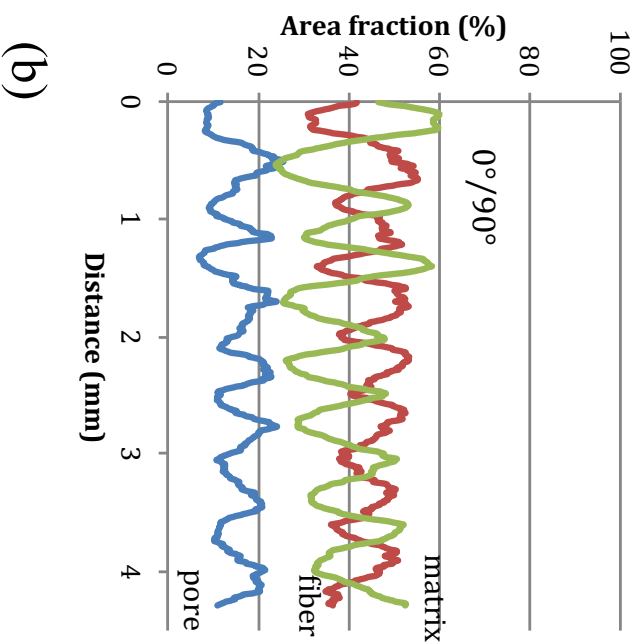
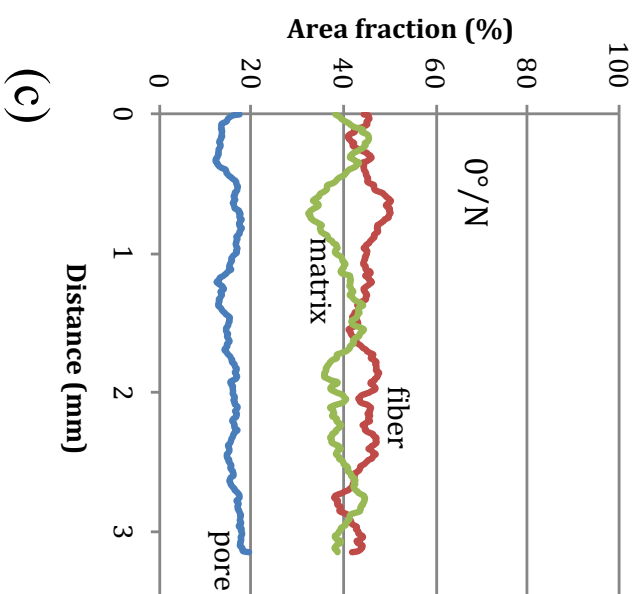
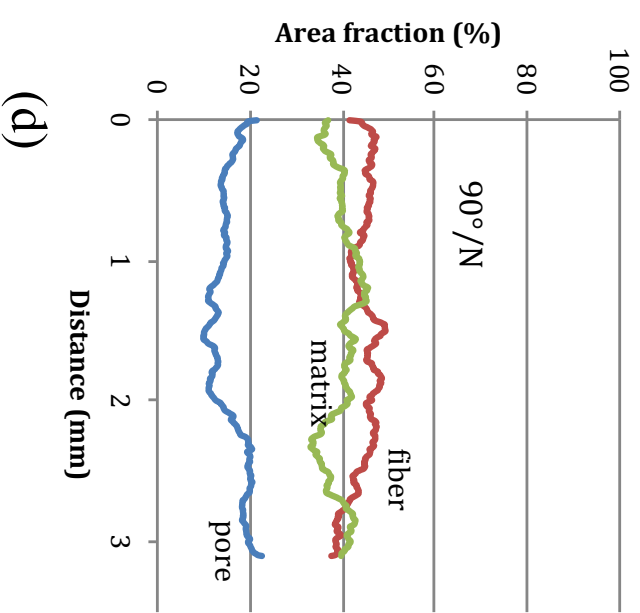
Figure 3: Measurement of the observed porosity: a) contribution by size to the total porosity observed at 5 μm and 11.5 μm voxel resolution; average porosity per slice as a function of distance parallel to the fiber directions in the b) needle; c) 90° and d) 0° non-woven cloths.

Segmentation by greyscale thresholding was also used to measure the pore volume (Figure 3a). Similar data were obtained at the two image resolutions, with smaller pores better resolved at high resolution. A good agreement is obtained with the ~16% porosity measured by gravimetric analysis [2], and also the fiber and matrix volume fractions (Table 1). The spatial variation of pores, fiber and matrix was measured along the orthogonal directions in a series of 2D slices of the tomograph from Figure 1a. The layered structure causes periodic correlated fluctuations of the constituents (Figure 3b) with a wavelength of ~1.1 mm, with the proportions of fibers, matrix and pores along the orthogonal 90° (Figure 3c) and 0° (Figure 3d) cloth directions being approximately constant.

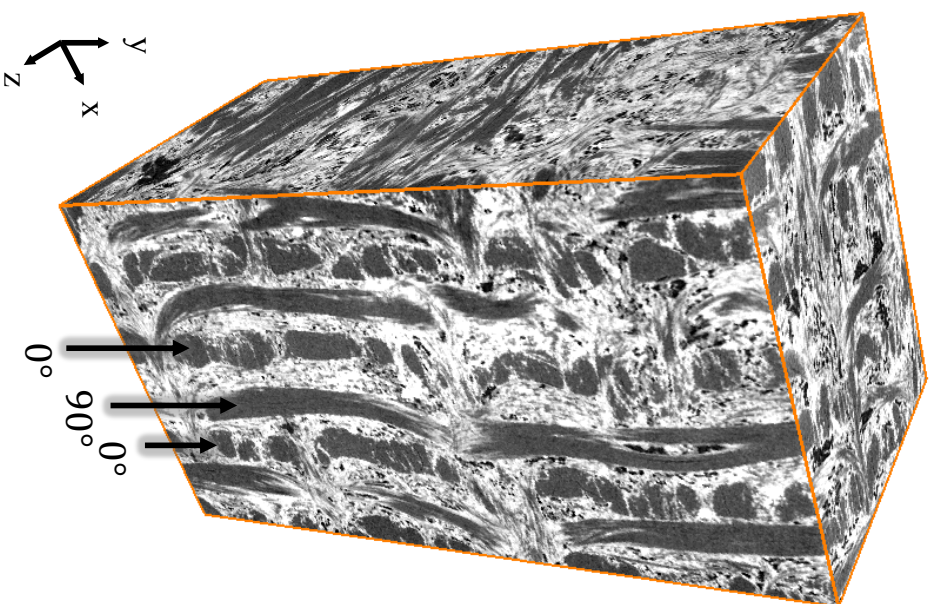
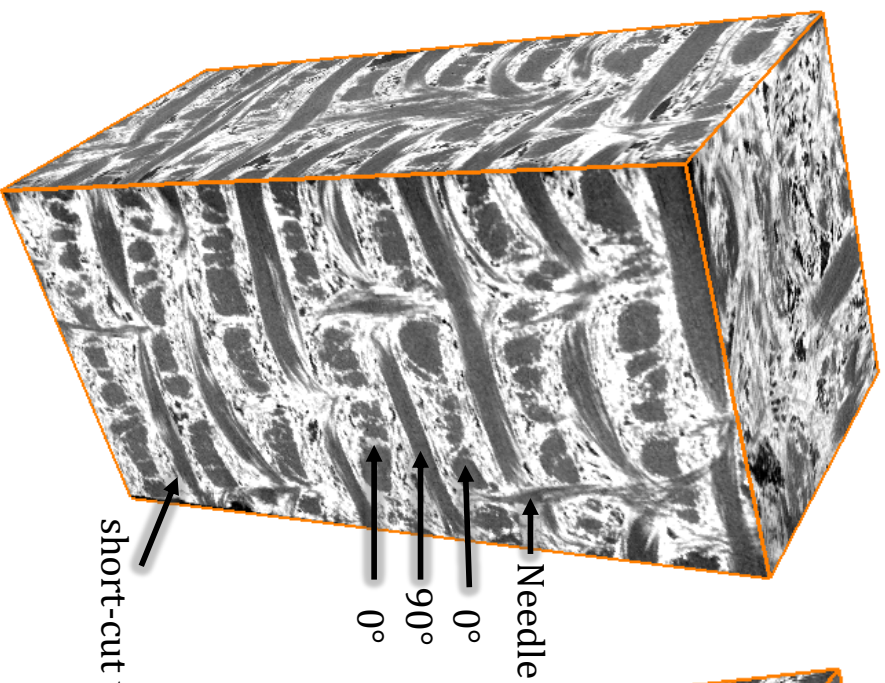
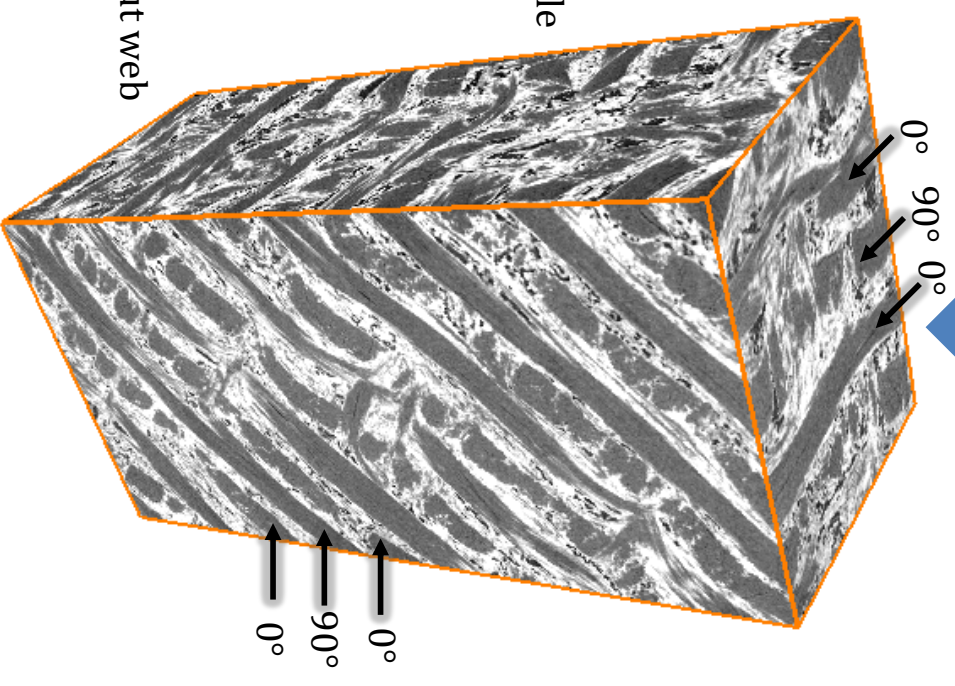
Figure 4: Tomography visualisations (11.5 μm voxel) of the specimens before testing for a) longitudinal; b) transverse and c) oblique loading orientations.

Tomographs of the specimens, recorded prior to testing, are shown in Figure 4 with the y-axis loading direction indicated. The cloths directions of 0° and 90° are defined, using the fiber axes, to simplify the discussion when considering the longitudinal and oblique loading tests. In principal, they are exactly equivalent for the transverse loading case. The load-crosshead displacement curves (Figure 5) are marked with the loads at which tomographs were recorded; loading was paused to record each tomograph, during which a small amount (~5%) of relaxation occurred. The final fracture of the longitudinal and oblique specimens was catastrophic, with more graceful failure of the transverse specimen. The peak loads in the longitudinal, transverse and oblique tests were 4020 N, 2950 N and 2050 N respectively, corresponding to compressive stresses of 225 MPa, 180 MPa and 117 MPa. Tomographs recorded after failure, at 11.5 µm voxel resolution, are shown in Figure 6, with the main cracks identified by image segmentation. The longitudinal specimen has mostly vertical major cracks,

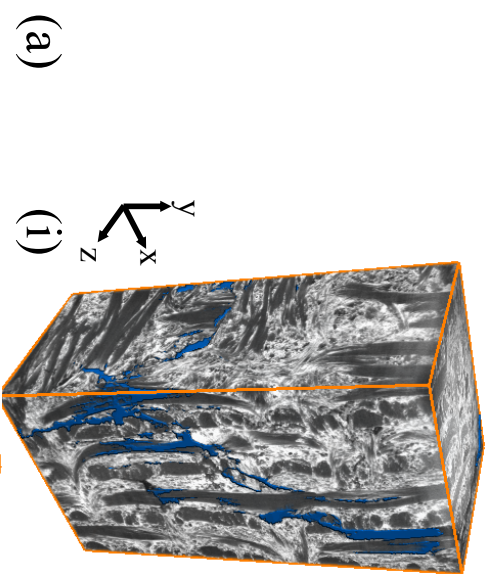
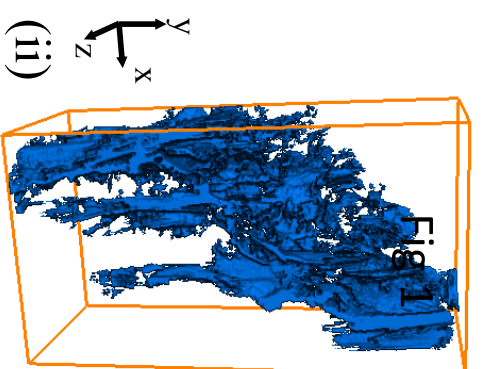
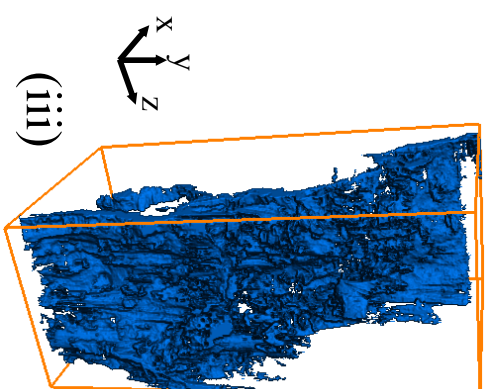
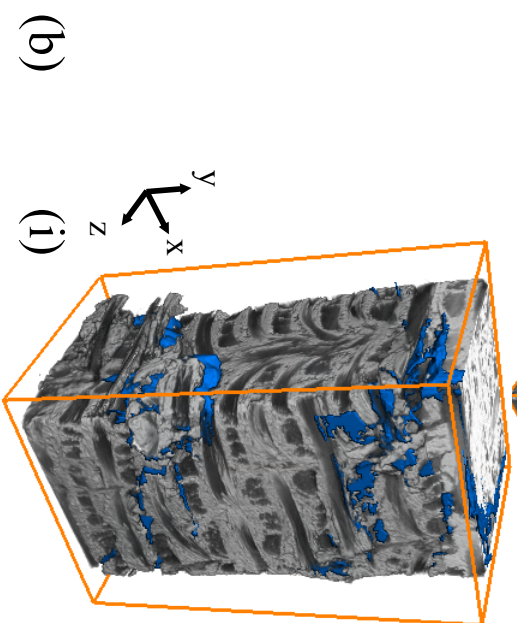
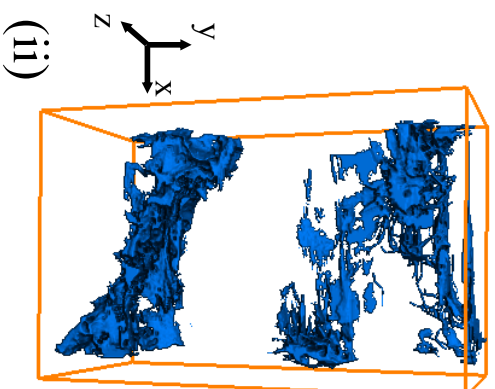
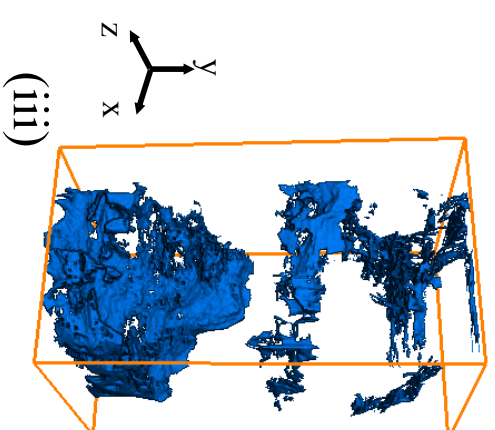
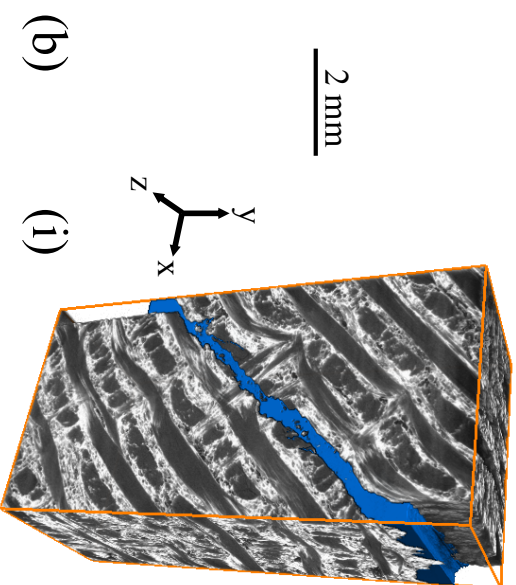
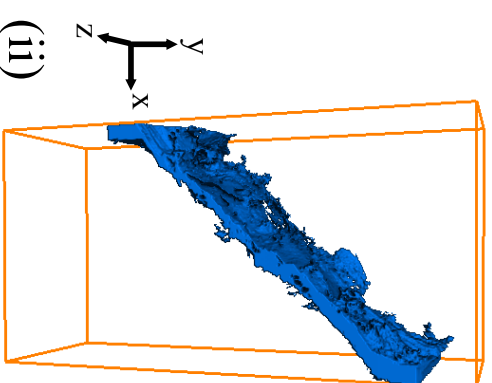
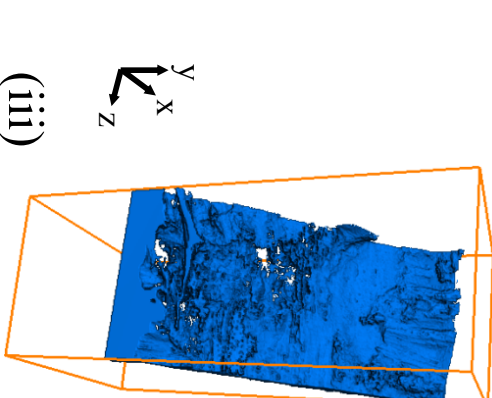
Figure 6: Tomography visualisations (11.5 μm voxel) of the specimens after testing for a) longitudinal; b) transverse and c) oblique loading orientations. The microstructure and major cracks are shown in i) and the segmented cracks are shown from different viewing positions in ii) and iii).

parallel to the cloth layers, connected by a shear failure. The transverse sample has developed quite complex damage throughout its volume, also generally parallel to the cloth layers. The oblique specimen has sheared along the plane of a 0° cloth layer.

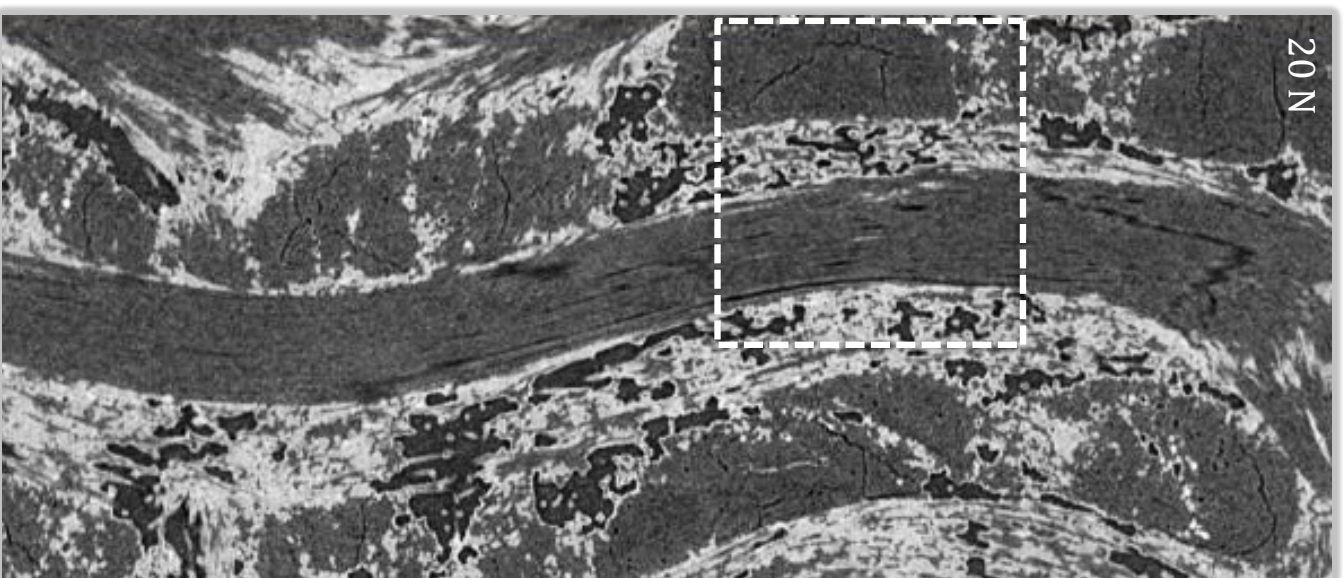
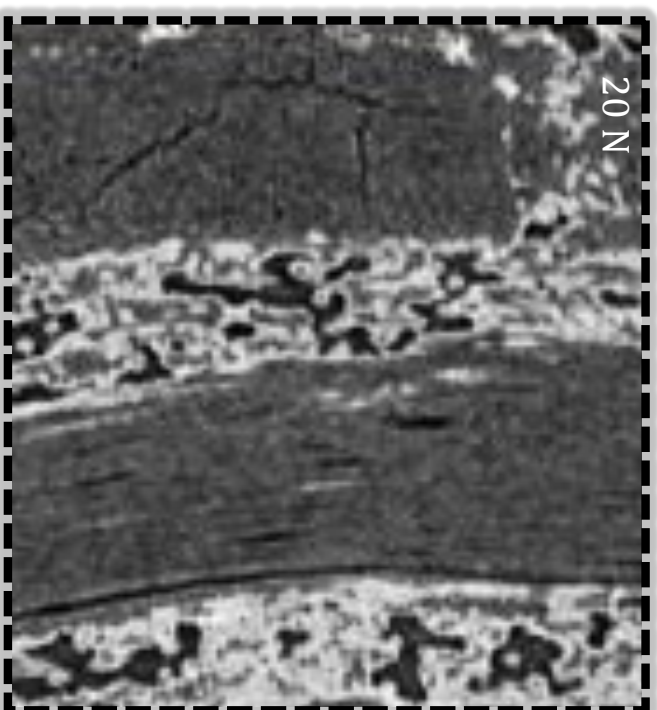
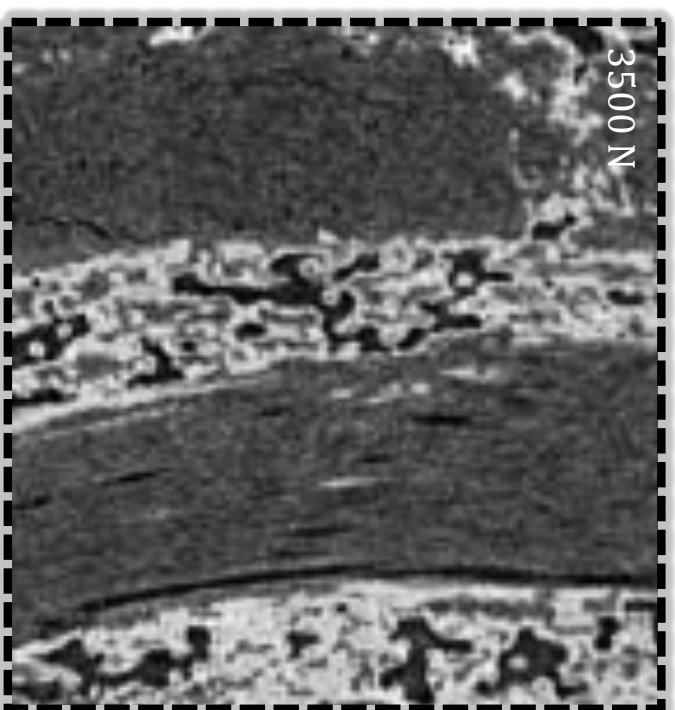
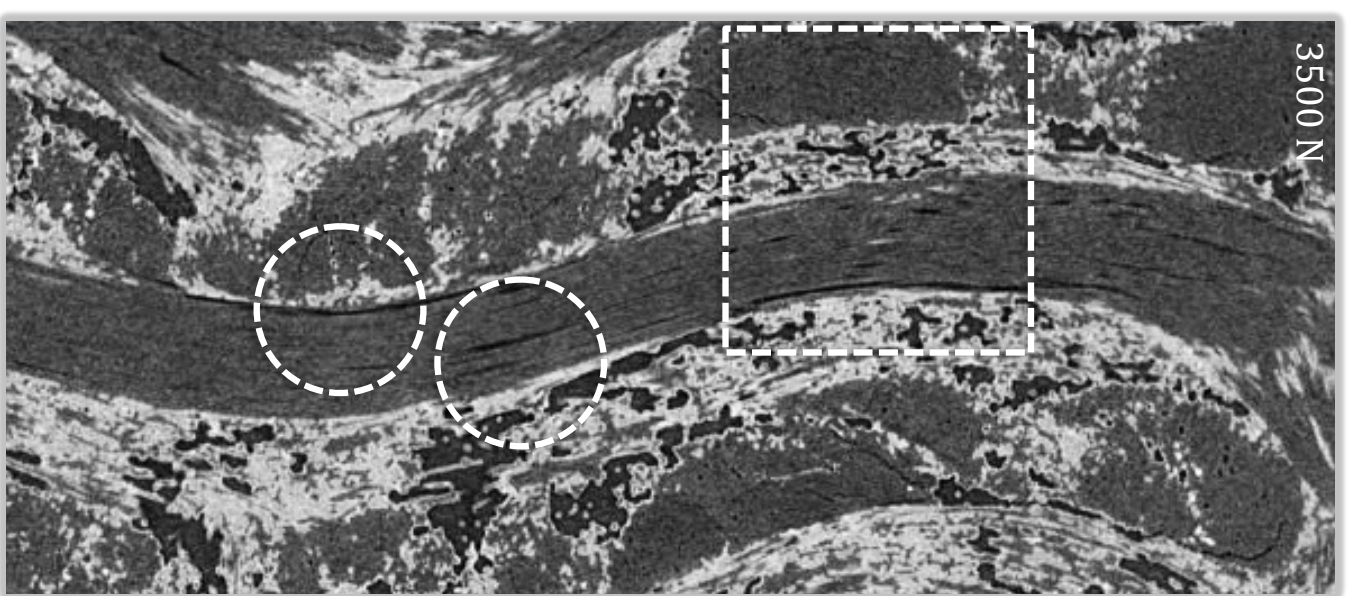
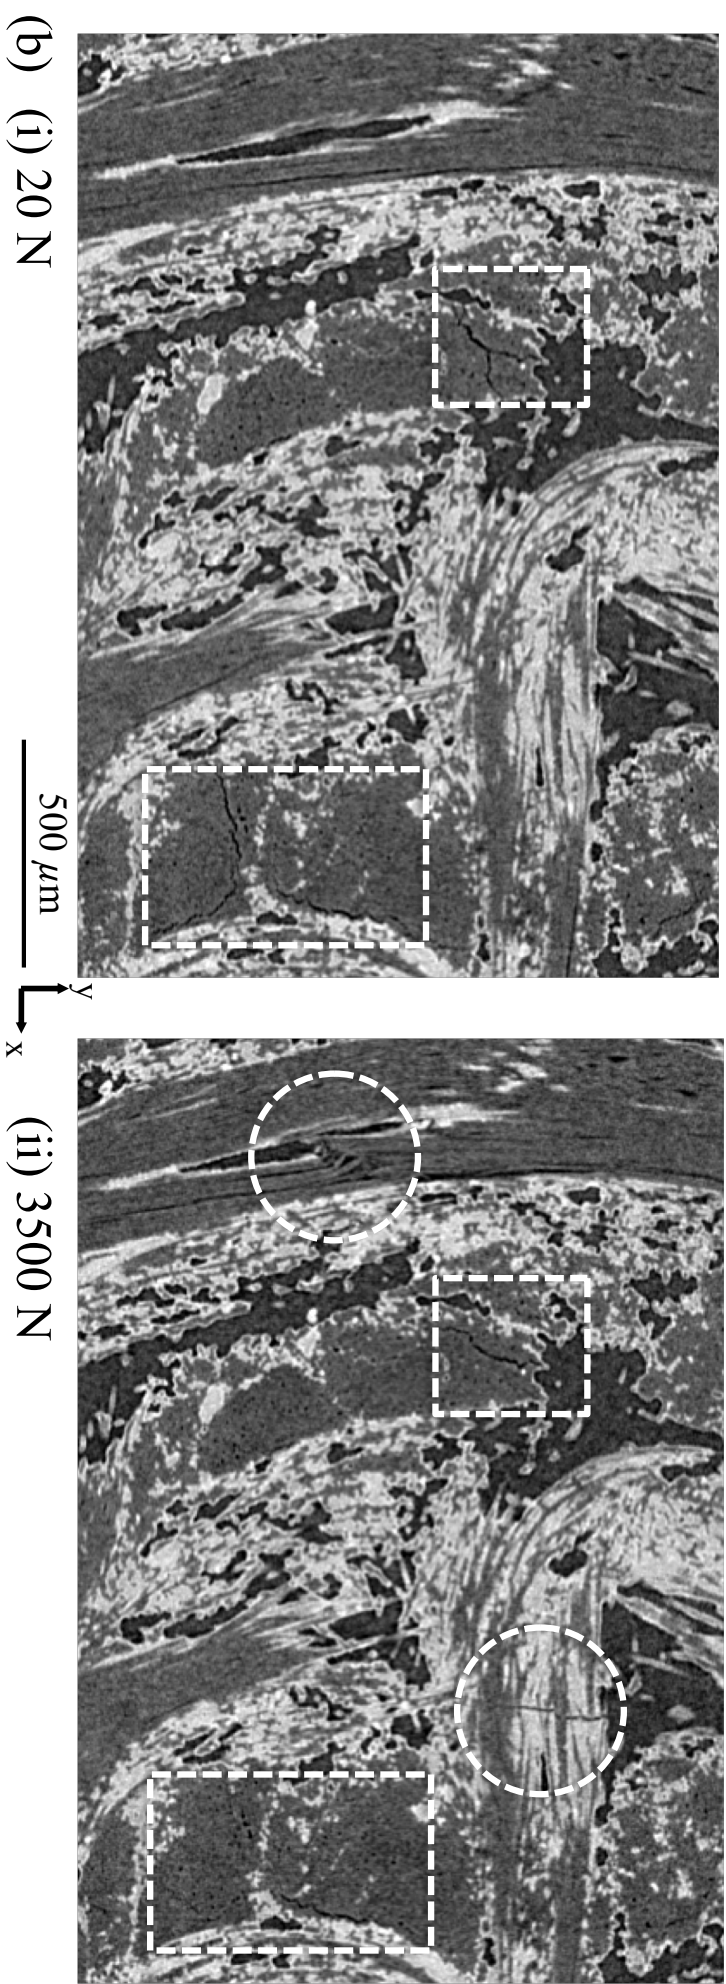
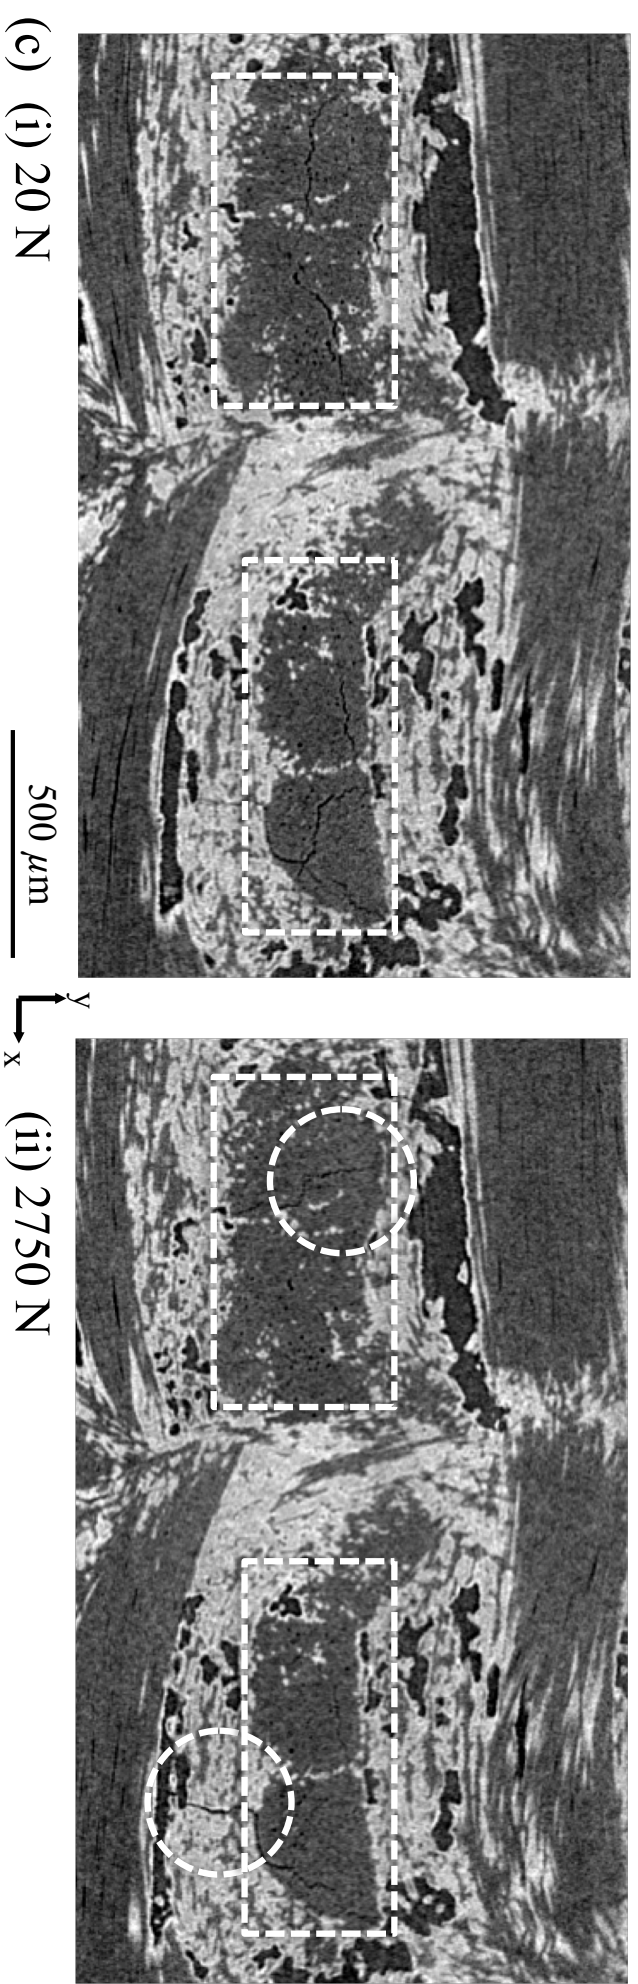
Figure 7: The development of damage with load, viewed in vertical orthoslices of 5 μm voxel tomographs: a) longitudinal specimen at i) 20 N and ii) 3500 N load (inset zoomed images show the dotted boxes, and dotted circles indicate damage within and at the interface of the non-woven cloth; b) longitudinal specimen at i) 20 N and ii) 3500 N load (dotted circles indicate fiber kinking at a pore within the non-woven cloth, and matrix failure within a

stitched needle); c) transverse specimen at i) 20 N and ii) 2750 N load (dotted boxes show crack closure, and the dotted circle indicates damage within the short cut web matrix).

Internal cracks within the carbon fiber cloths can be observed in the tomographs recorded at 20 N (Figure 7). These cracks are between the fibers, and on loading tended to close when the fibers are perpendicular to the applied compressive load. This is illustrated by several examples, highlighted by dashed rectangular boxes, for longitudinal compression (Figure 7a and Figure 7b) and transverse compression (Figure 7c). In regions where the fibers of the cloth are parallel to the load, splitting and interface failure (Figure 7a) and kinking (Figure 7b) occurred; these are indicated by dashed circles in the figures. Cracks that are parallel to the applied load are observed to have developed in the matrix of both the needle punched regions (Figure 7b) and short cut web (Figure 7c).

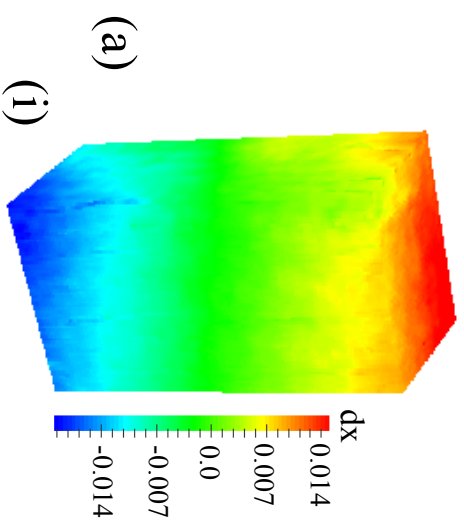
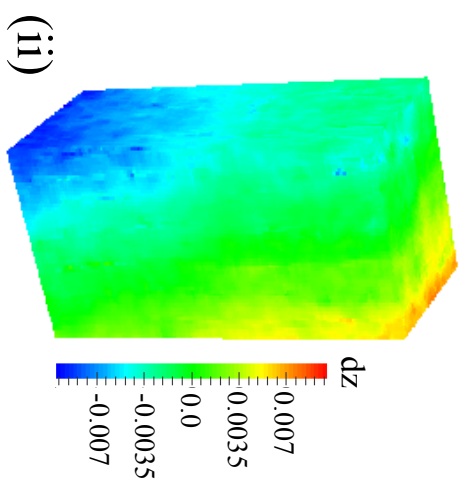
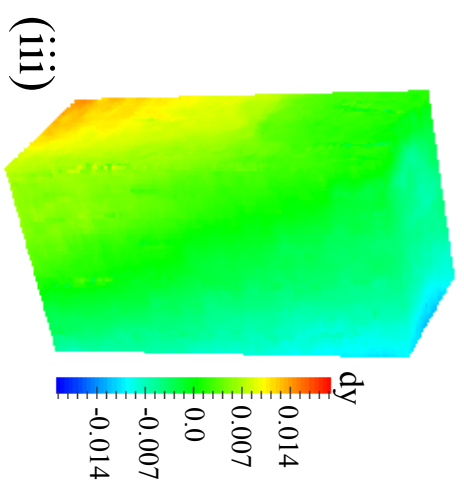
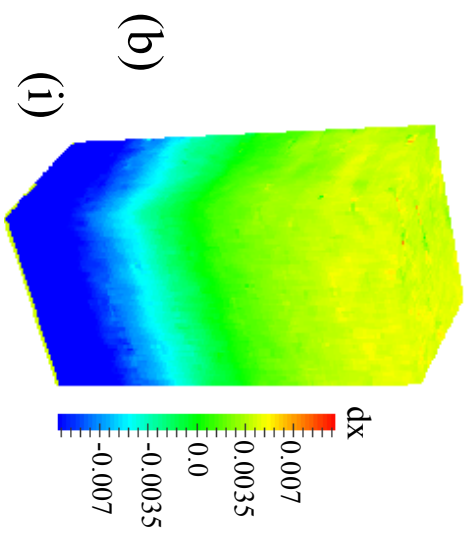
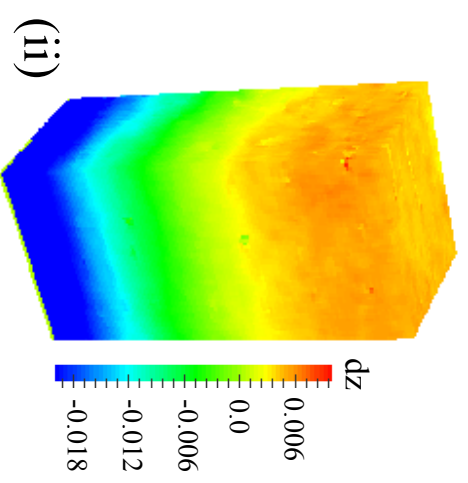
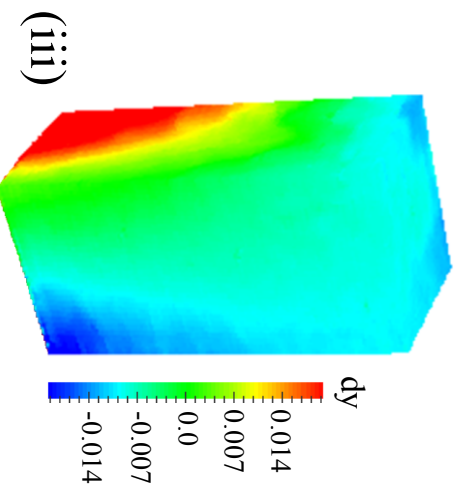
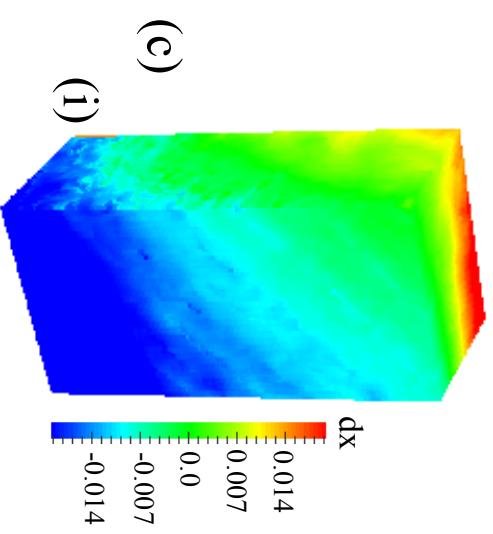
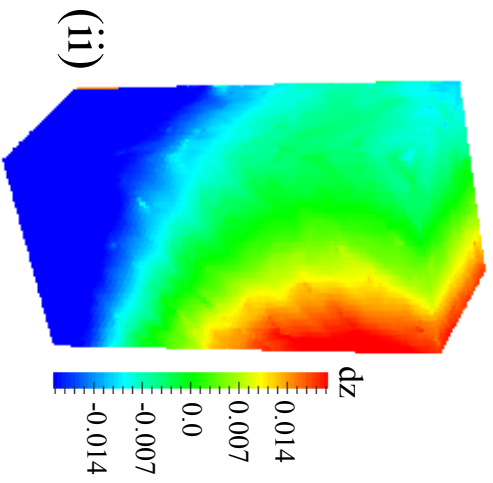
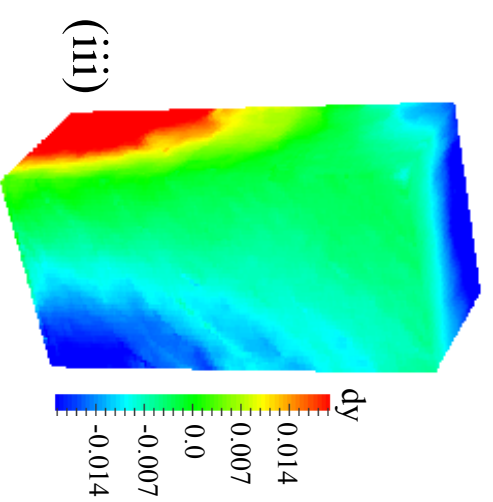
Figure 9: Displacement maps (3D visualization) at 750 N, relative to the preloaded tomographs at 20 N for a) Longitudinal; b) Transverse and c) Oblique loading. In each case, the loading axis is parallel to the y-axis. The data have been registered by translation (no rotation) with zero relative displacement at the center of each volume.

The digital volume correlation (DVC) analysis of the tomographs used the LaVision Davis software (version 8.4.0), with the initial tomograph at 20 N as the reference. Image correlation tracks the relative movements and deformations of subsets of the images, and to achieve high spatial resolution, a small final subset size ($24 \times 24 \times 24$ voxels, 75% overlap, 2 passes) was used after preliminary larger subset sizes $128 \times 128 \times 128$ (75% overlap, 2 passes) and $64 \times 64 \times 64$ (75% overlap, 2 passes) that used FFT (fast Fourier transform) correlation. The center of the volume was made the origin for the relative displacements by applying a uniform rigid body displacement with no rotation. The data were cropped to approximately $4.1 \text{ mm} \times 3.4 \text{ mm} \times 7.8 \text{ mm}$, $3.8 \text{ mm} \times 3.4 \text{ mm} \times 7.8 \text{ mm}$ and $4.0 \text{ mm} \times 3.4 \text{ mm} \times 8.3 \text{ mm}$ for the longitudinal (Figure 9a), transverse (Figure 9b), and oblique (Figure 9c) specimens respectively by removing the potentially inaccurate displacement vectors calculated from subsets that approached the edges of tomographed volume. Example displacement fields measured at 750 N, before significant damage occurred, are presented in Figure 9 and show the quite complex deformations; for instance, shearing parallel to the non-woven cloths in both the transverse (Figure 9b) and oblique (Figure 9c) specimens.
