In situ observation of compression damage in a 3D needled-punched carbon fiber-silicon carbide ceramic matrix composite¹

Short title: μ XCT of Compressive Damage in a needled-punched C-SiC composite

Fan Wan^{1, 2}, Rongjun Liu¹, Yanfei Wang¹, Yingbin Cao¹, Changrui Zhang¹ and Thomas James Marrow^{*2}

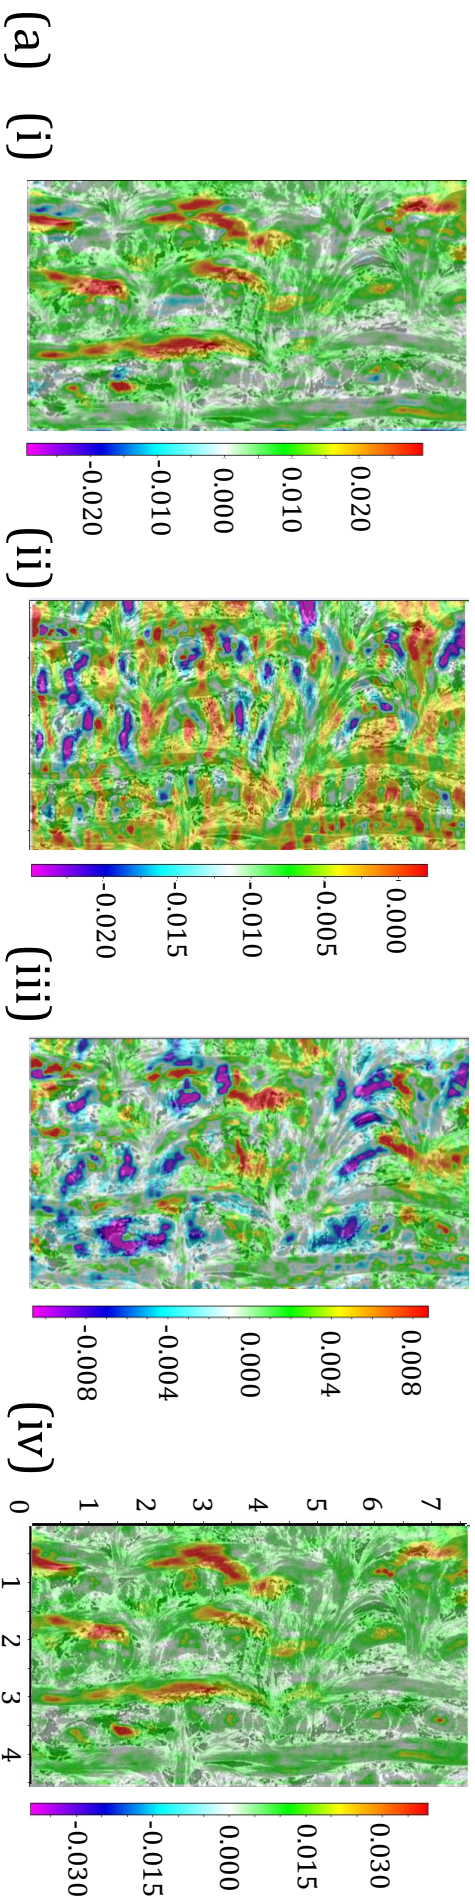
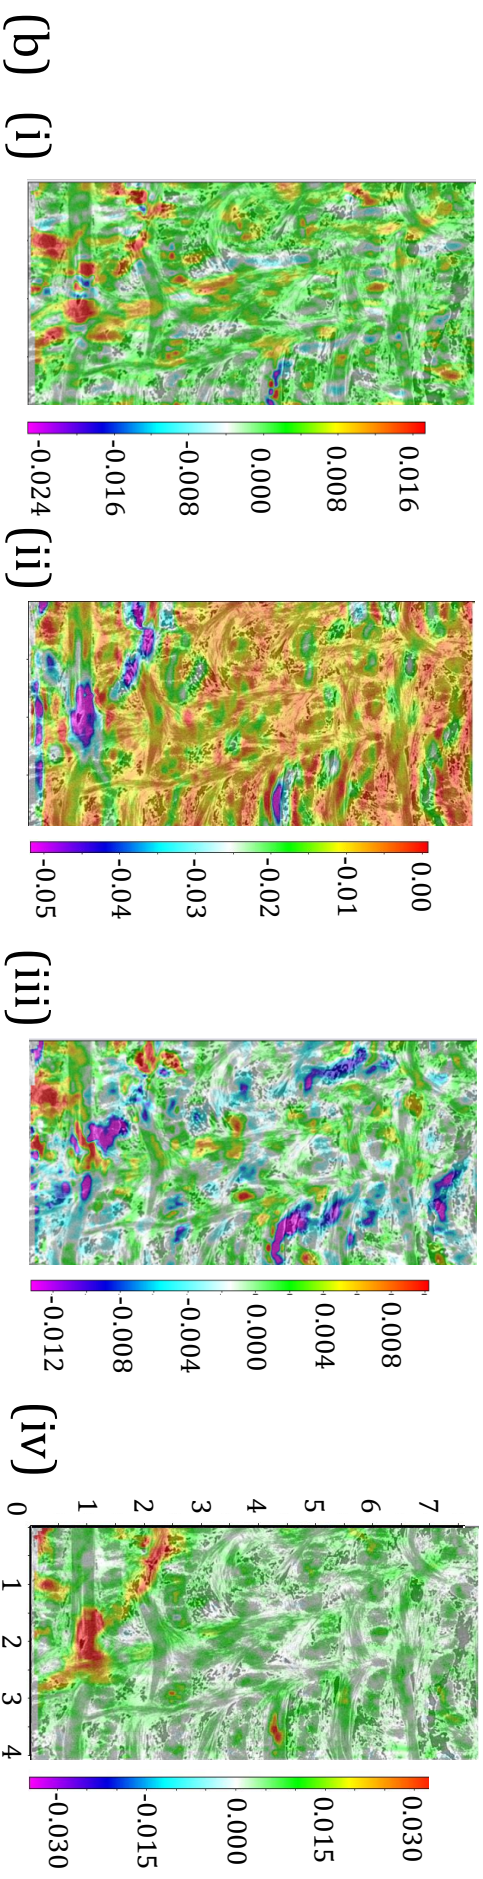
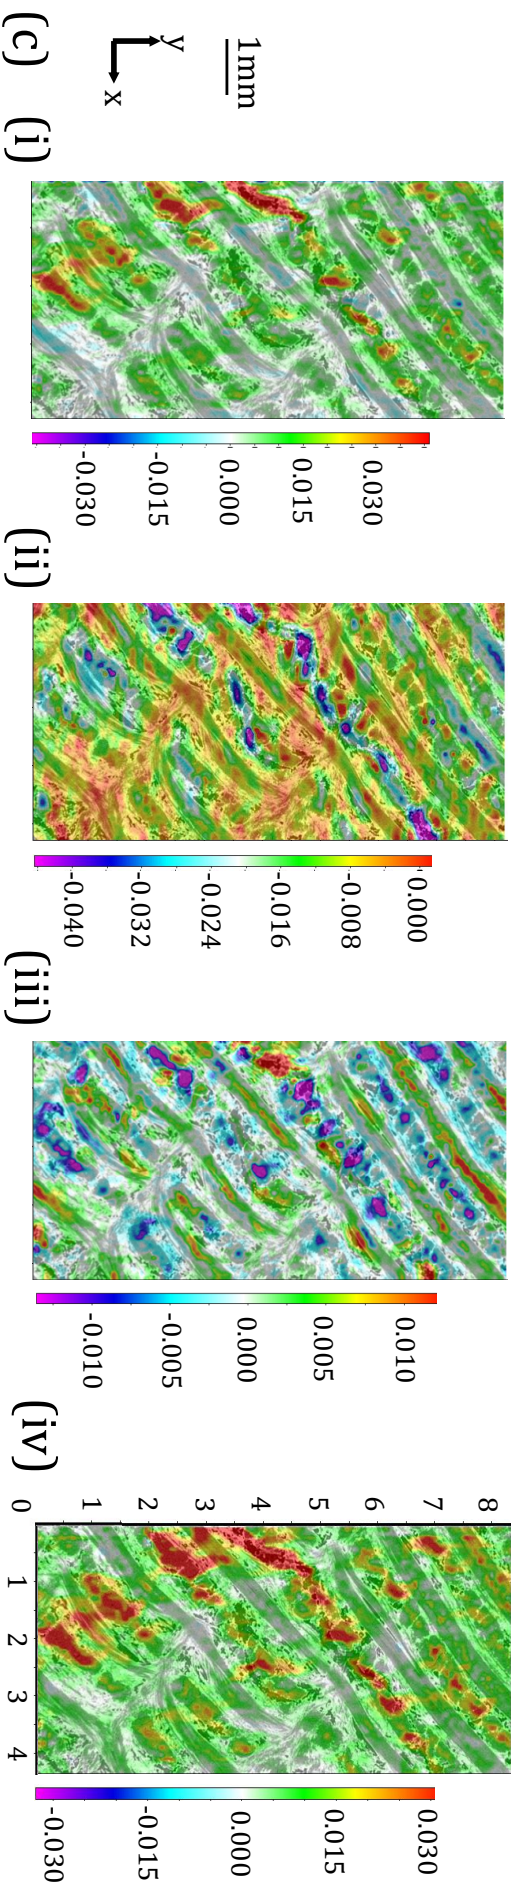
Figure 10: Strain maps (displacement field gradients) for a) longitudinal; b) transverse and c) oblique loaded specimens, measured at the largest recorded loads (3500N, 2500N and 1500N for longitudinal, transverse and oblique samples respectively). The principle strains ϵ_{xx} and ϵ_{yy} are shown in (i) and (ii), with (iii) shear strain (ϵ_{xy}) and (iv) maximum principle strain (ϵ_{\max}).

To illustrate how the deformation has been accommodated by the microstructure, gradients of the three-dimensional displacement field, at the highest observed loading (3500 N, 2500 N and 1500 N for longitudinal, transverse and oblique samples respectively), are presented in Figure 10 as normal strains (ϵ_{xx} , ϵ_{yy}) that are parallel to the x and y axes, shear strain (ϵ_{xy}) in the same plane and the maximum three-dimensional principal strain. The compression of the longitudinal specimen, in which the cloths were vertically aligned, was applied parallel to the fibers of the 90° non-woven cloth and perpendicular to the fibers of the 0° cloth; there are local tensile strains (ϵ_{xx}) that develop perpendicular to the 90° cloths (Figure 10a i), whilst local compressive strains (ϵ_{yy}) parallel to the applied load occur within the 0° non-woven cloth (Figure 10a ii). This is consistent with the observed opening of internal cracks between the fibers in the 90° cloths (Figure 7a) and short cut web matrix (Figure 7b) and the closure of pores and internal cracks between the fibers of the 0° cloth (Figure 7a and b). The transverse specimen shows concentrations of compressive strain (ϵ_{yy}) in the 0° and 90° cloths, which are both horizontal and perpendicular to the applied load (Figure 10b ii). Tensile strains (ϵ_{xx}) perpendicular to the applied load also develop (Figure 10b i). These strains are in agreement with the observation of compressive closure of pre-existing defects in the cloths (Figure 7c) and the orthogonal opening of cracks between fibers and initiation of cracks within the short cut web (Figure 7c). For the oblique loaded specimen, compressive (ϵ_{yy}), tensile (ϵ_{xx}) and shear strains (ϵ_{xy}) are all concentrated within the 0° cloth layers (Figure 10c), and this is consistent with shear propagation of damage between the fibers that are aligned perpendicular to the load. The detection of cracks by tomography alone is less sensitive than the measurement of strain by digital volume correlation of tomographs; cracks can only be observed by tomography when the crack opening approaches the voxel size, whereas digital volume correlation can detect sub-voxel displacements and the cumulative effects of microcracking, such as may occur between fibers.

The maximum 3D principal strain identifies the location of the characteristic damage mechanisms, which are: internal fracture and debonding of the vertical 90° cloth (Figure 10a iv and Figure 8a) under longitudinal loading; internal fracture of both cloths and matrix under transverse loading (Figure 10b iv and Figure 8b); and internal fracture and debonding of the 0° cloth under oblique loading (Figure 10c iv and Figure 8c). Consequently, the maximum principal strain can be used to visualize the damage. Figure 11 illustrates the relationship between the needle stitching and the final damage distribution in the longitudinal compression test; the figure shows the positions of the cracks relative to the needles. The images (1) to (4) show slices through the three-dimensional data. This shows the effect of the needles on damage propagation. The maximum principal strain (Figure 10a) reveals that damage occurs in planar features that are coincident with the 90° cloths, at which internal splitting and interfacial debonding were observed by tomography (Figure 6a). The propagation of damage within the cloths is clearly restricted by the needles (Figure 11). This restriction in the propagation of damage is considered to be responsible for the higher strength and high failure strain in the longitudinal test (Figure 5).

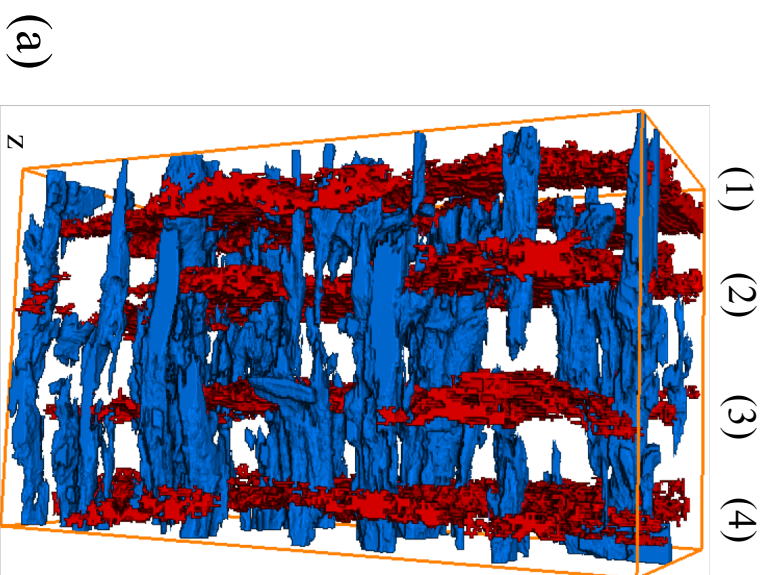
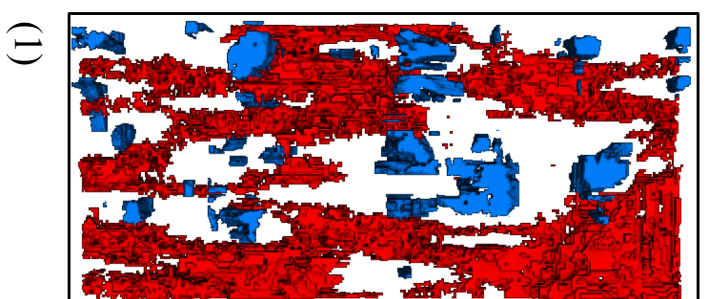
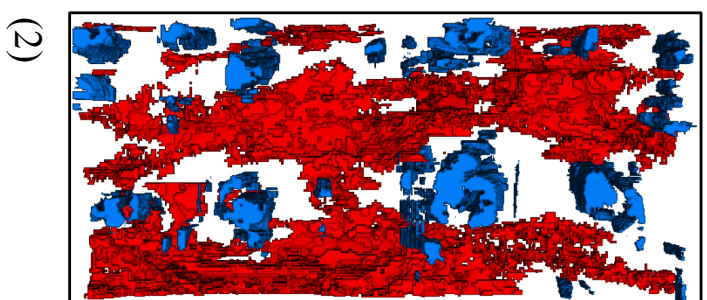
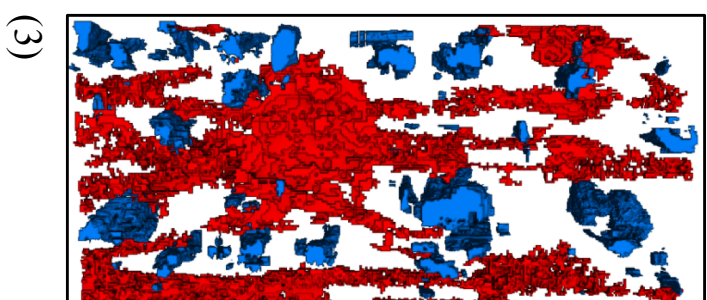
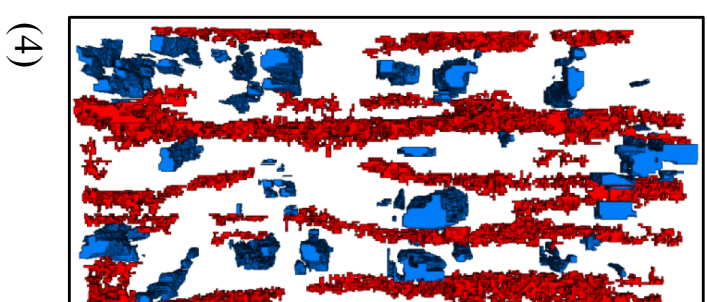
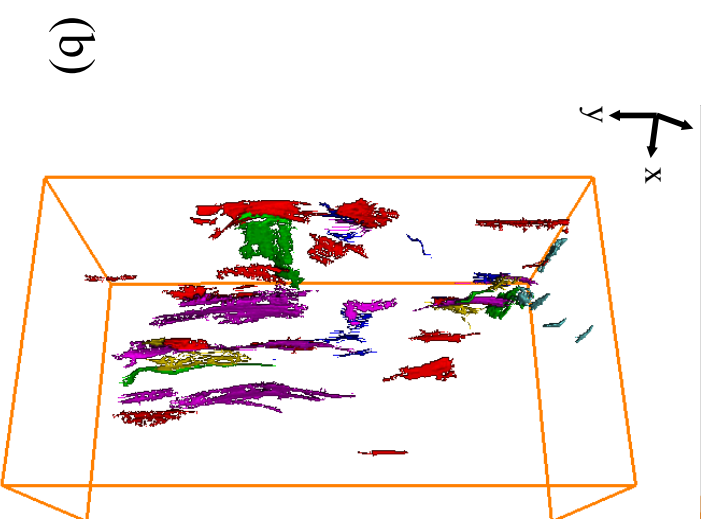
Figure 11: Three dimensional visualization of the effect of needles on the final damage evolved under longitudinal compression: a) maximum principal strain (red) and needles (blue), with slices of the data at the positions of the 90° cloths in (1) to (4); b) observed cracking compared with needles in the same locations.

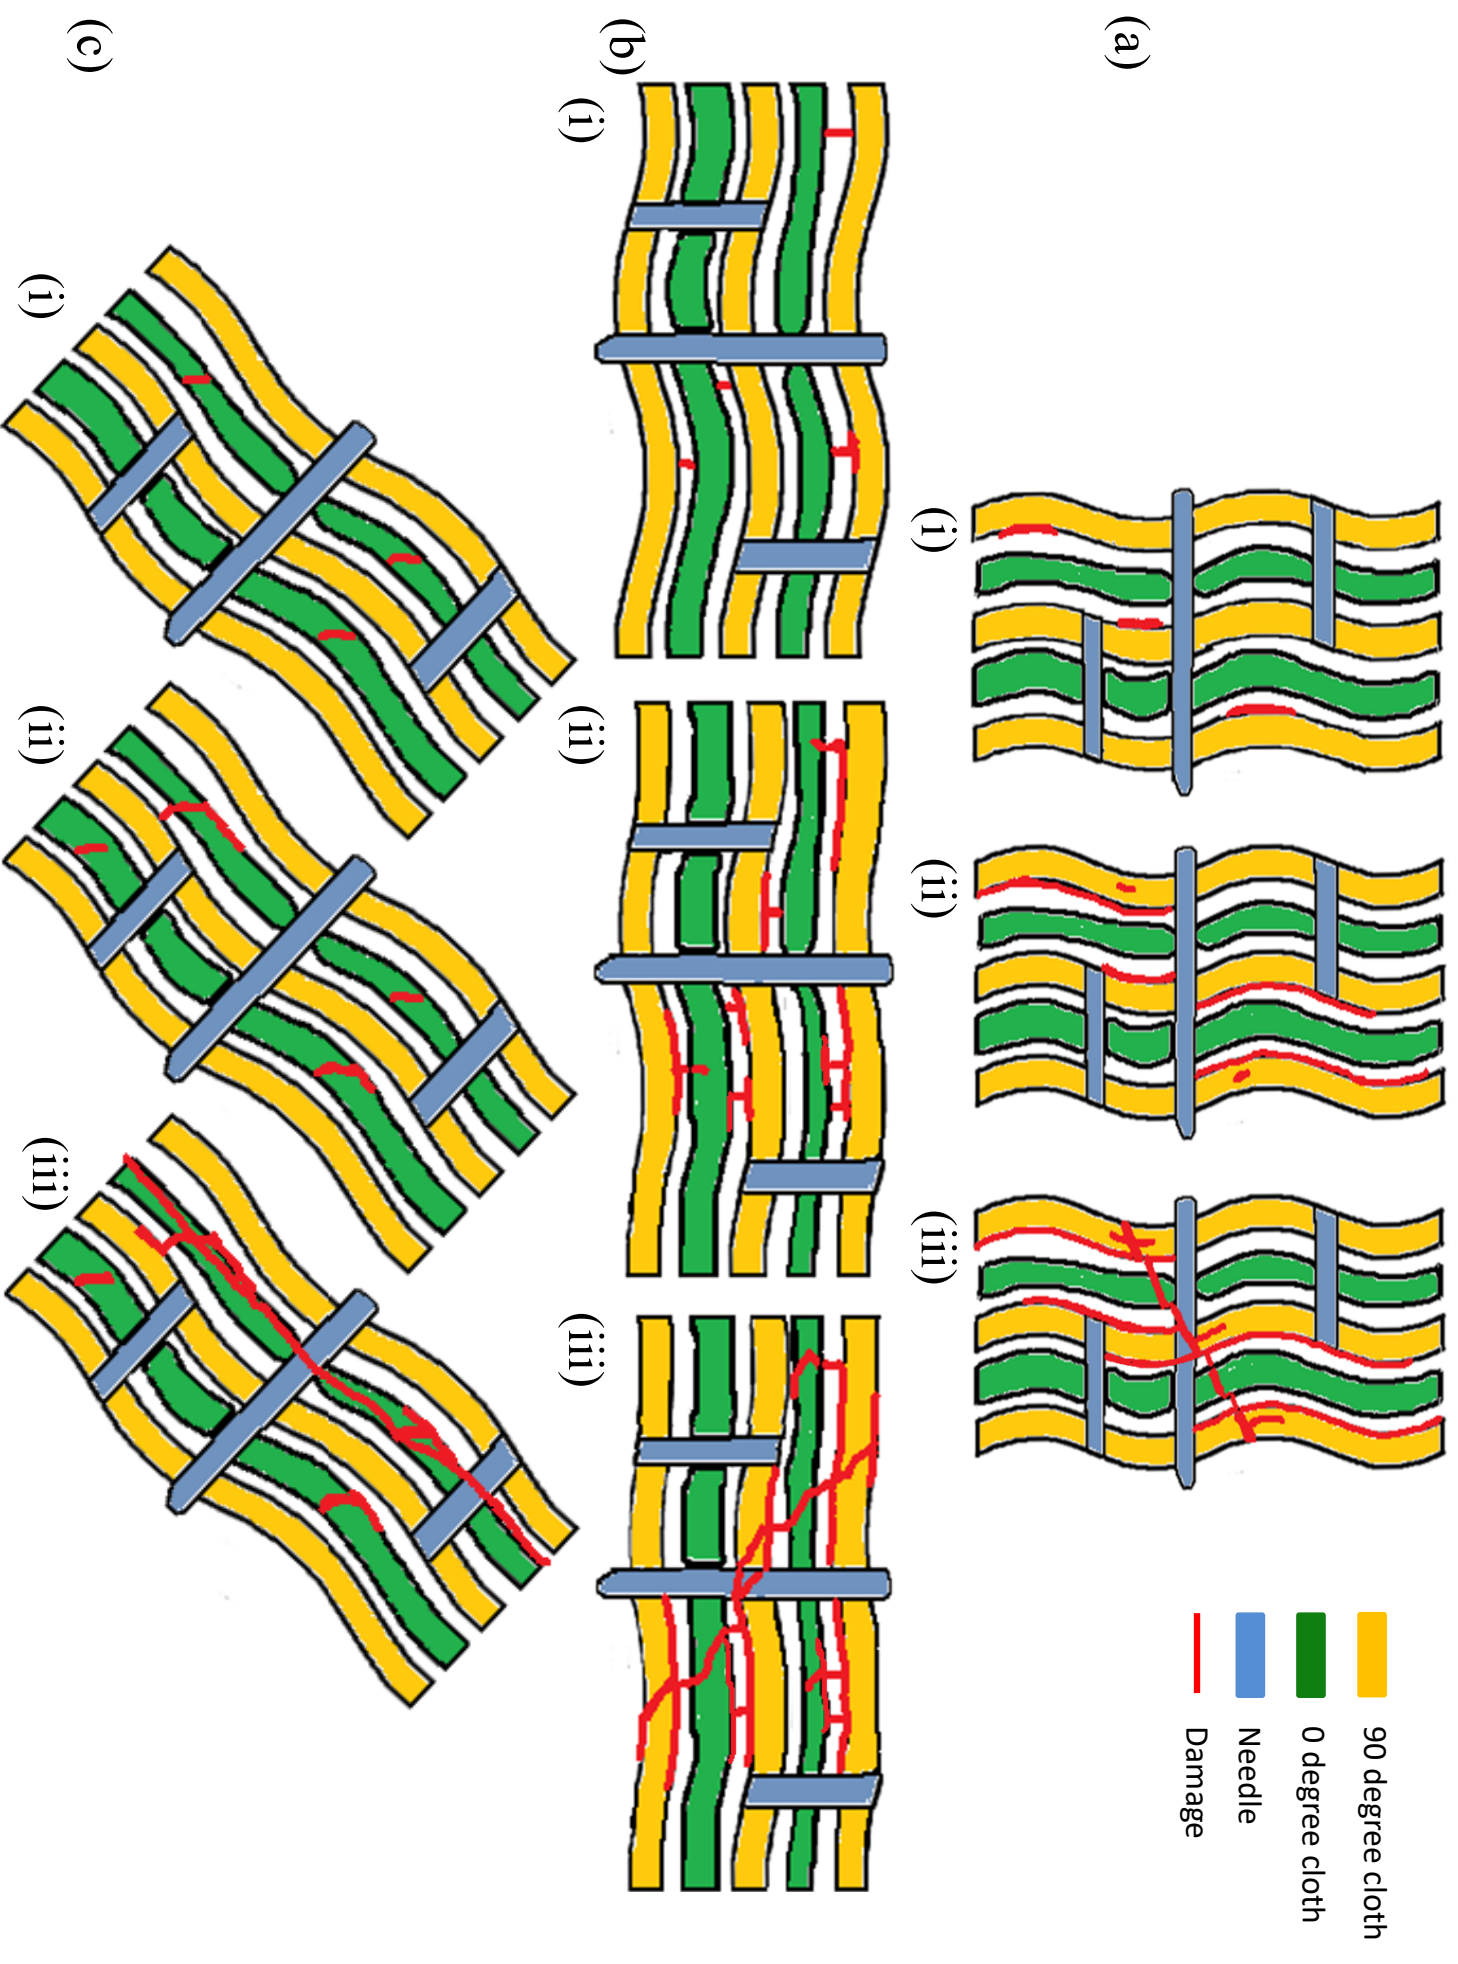
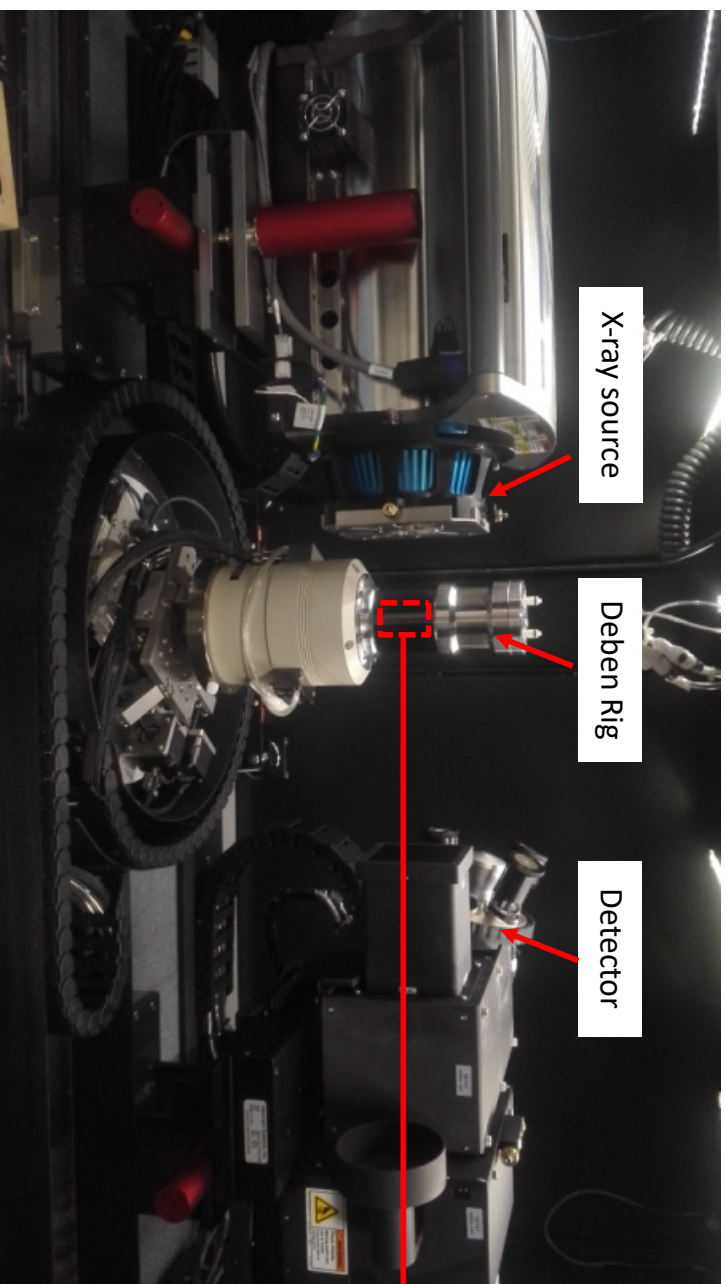
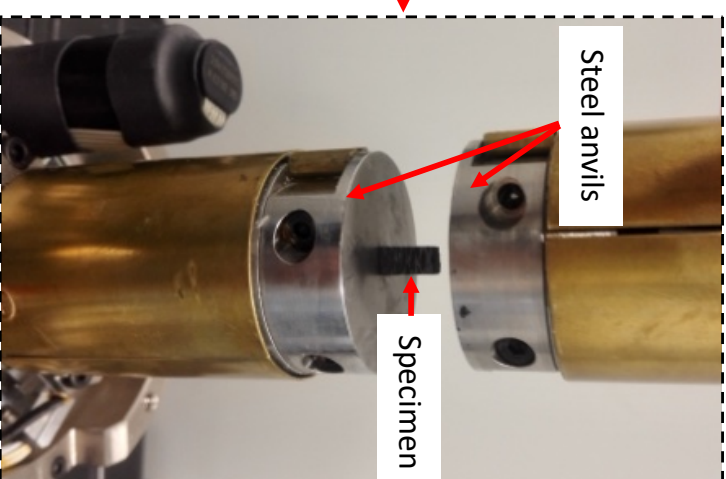
Figure 12: Schematic diagrams for the progressive development of damage under a) longitudinal; b) transverse and c) oblique compressive loading.

The observations of the intrinsic defects in the microstructure, their propagation under load and the effects of the needles on damage are used to propose sequences for the development of the main failures under different loading states, which are shown schematically in Figure 12. Under longitudinal loading (Figure 12a), (i) interfacial cracks predominantly propagate along the 90° cloths due to the splitting effect of the Poisson strains, but (ii) are limited by the pinning effect of the needles; (iii) final shear failure occurs when the extensive damage coalesces. For transverse loading (Figure 12b), the effect of the needles is less significant as (i) the propagation of tensile damage under action of the Poisson strains is limited by the fiber cloths; so (ii) interfacial fractures are driven by stress concentrations from the distorted cloths and heterogeneities of the elastic moduli; until (iii) final shear

by coalescence occurs. Under the action of the oblique load (Figure 12c), (i) the fractures that propagate most readily are those between the fibers within the 0° cloth, which offer a weaker resistance to shear than the 90° cloth in which the long fibers are parallel to the shear loading; (ii) these internal fractures then propagate along the cloth interface to accommodate the shear loading. The needles would be expected to retard damage development, but this was not observed as the localized damage in the small specimen leads to instability and then (iii) localized shear failure from a dominant crack.
