UNIVERSITY OF OXFORD

DPHIL IN MATERIALS SCIENCE

Oxide Based Ceramic Matrix Composites For
High Temperature Aerospace Sealing
Applications

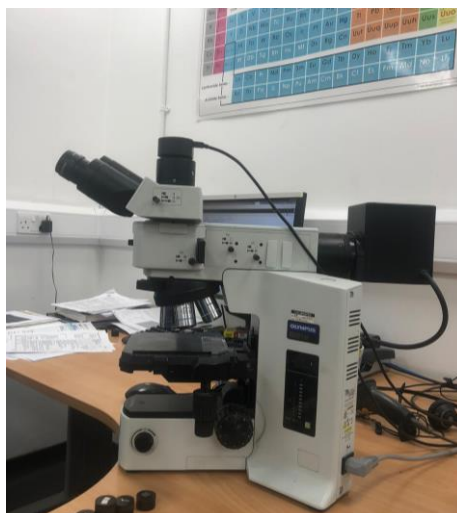
Figure 57: Olympus BX 51 optical microscope.

Optical microscopy of the polished Nextel720/alumina samples, prepared by polishing with 1200 grit SiC paper, then 6 μm , 3 μm , and 1 μm diamond paste, finish with 0.05 μm colloidal silica, studied in **CHAPTER 4**, were undertaken using an Olympus BX51 Metallographic Microscope, **Figure 57**. An extended depth of focus was used, which is part of the inbuilt software, to combine images in z to provide extended depth of focus. A Nomarski contrast objective lens of 10X was used in bright field

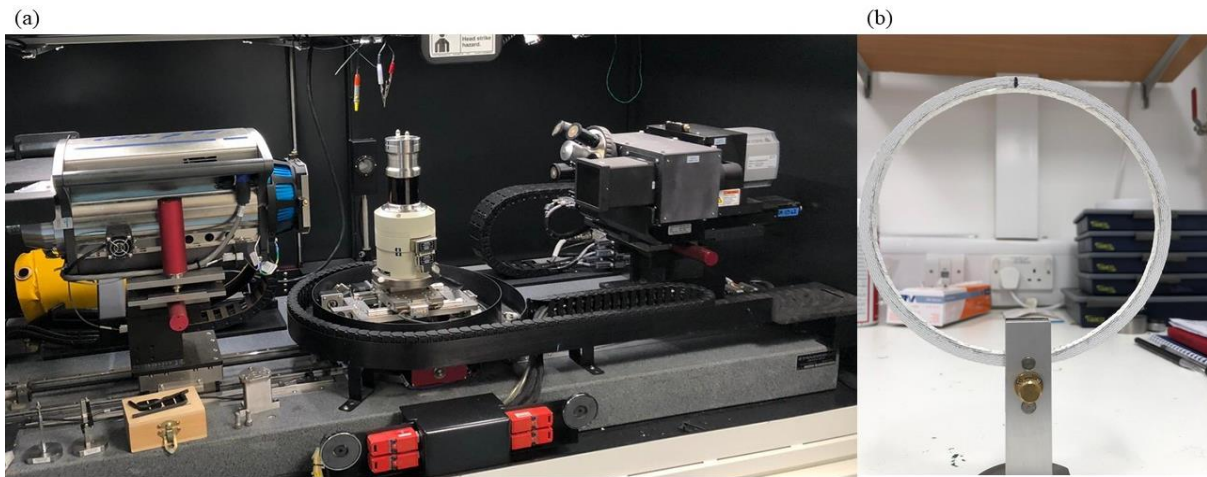
Figure 60: (a) Zeiss Xradia 510 Versa 3D X-ray tomography microscope used to carry out lab based μ CT analysis (b) a ring sample loaded in a μ CT holder.

The microstructure of the Nextel312/SiCO specimens, **CHAPTER 4**, were examined by computed tomography with an Xradia Versa 510 X-ray microscope, **Figure 60**, operated at 80 kV energy, and 7 W power. The analysed specimens were 15 mm long with a cross-section of 4 x 5 mm. Each tomograph was reconstructed from 2001 projections recorded over a 360° rotation about the specimen's longest axis, with 2x binning of the 2048 x 2048 pixel camera, to obtain an image volume with a voxel size of $3.1 \mu\text{m}^3$. The tomographs were reconstructed (16-bit greyscale) using the Xradia software. The Avizo 9.5 image visualization software was used to quantify the observed porosity using segmentation by greyscale thresholding. Measurements and post-processing were done by the author.

Nextel 720/Alumina EF 19 and EF 20 sealing ring specimens, as seen in **Figure 60 (b)**, approximately 140mm in diameter, having a cross-section of size ($\sim 5 \times 5 \text{ mm}$), were μXCT scanned, before and after creep tests, CHAPTER 6, with laboratory tomography using a Zeiss Xradia 510 Versa 3D x-ray microscope, operating at 100 kV energy with 7 W power. The tomograph was reconstructed from 2001 projections (14 seconds per projection) recorded over a 360° rotation, with $2\times$ binning of the 2048 × 2048 pixel camera, to visualise a section of $20 \times 5 \times 5 \text{ mm}$ at a voxel size of $6.9 \times 6.9 \times 6.9 \mu\text{m}^3$ 180° away from the gap. Measurements were taken of the area opposite the gap. Table 1 shows the parameters used to carry out the X-ray tomography measurements. All measurements and processing were carried out by the author.

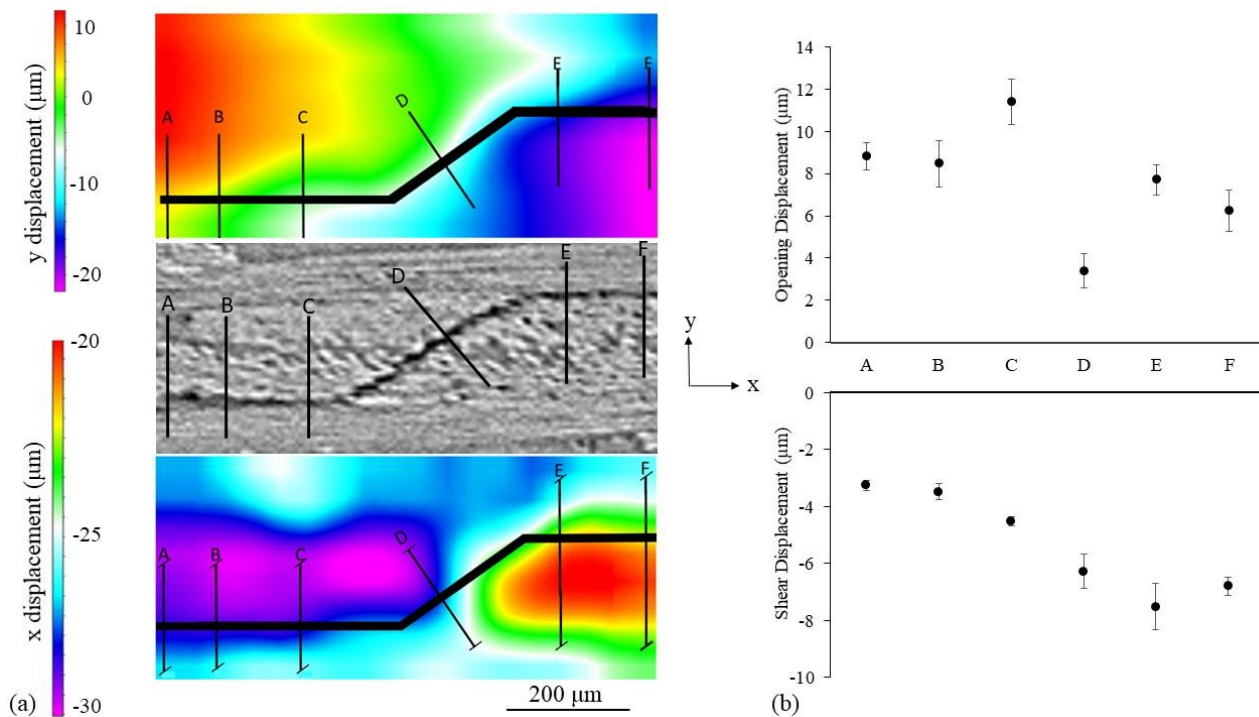
Figure 105: Analysis of the relative displacements, calculated at $R\sigma$ relative to the pre-load, across a major crack developed at room temperature, identified in **Figure 103 b**; (ii): a) sections of the 3D displacement field, showing the components of x - and y -displacement; b) the relative opening and shear displacements measured parallel and perpendicular to traces A to F, which are labelled in (a). The error bars are the sample standard deviation from measurements over a z -distance of $75\ \mu\text{m}$.
