Towards Autonomous Inspection of Concrete Deterioration in Sewers with Legged Robots

Abstract

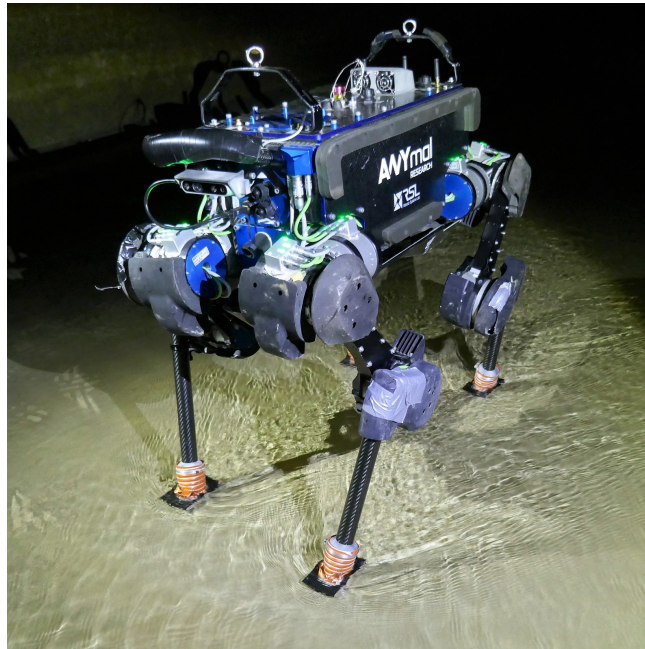
Figure 1: Depiction of *ANYmal* with custom feet deployed in the sewers of Zurich.

ANYmal (Figure 1) is a 30 kg quadruped robot driven by twelve series elastic actuators mounted at the joints. The dimensions of the robot are 800 mm x 600 mm x 700 mm when standing. With its legs tucked up, it is 800 mm x 600 mm x 400 mm which allows it to be deployed through a common utility hole. The kinematic structure of the robot is designed to achieve an extensive range of motion, allowing it to overcome obstacles and manipulate the environment. The structure is made primarily of aluminum and carbon fiber to minimize weight. Shock absorbers and Kevlar plates protect exposed components from impacts. *ANYmal* is designed in a modular fashion: each actuator unit consists of motor, gear, and drive electronics and is connected over the EtherCAT bus. The connection between sub-assemblies such as the legs are easily accessible, and water-proof quick connectors are used for power and communication lines. This allows component-level ingress protection as well as fast and simple maintenance in case of hardware failure.

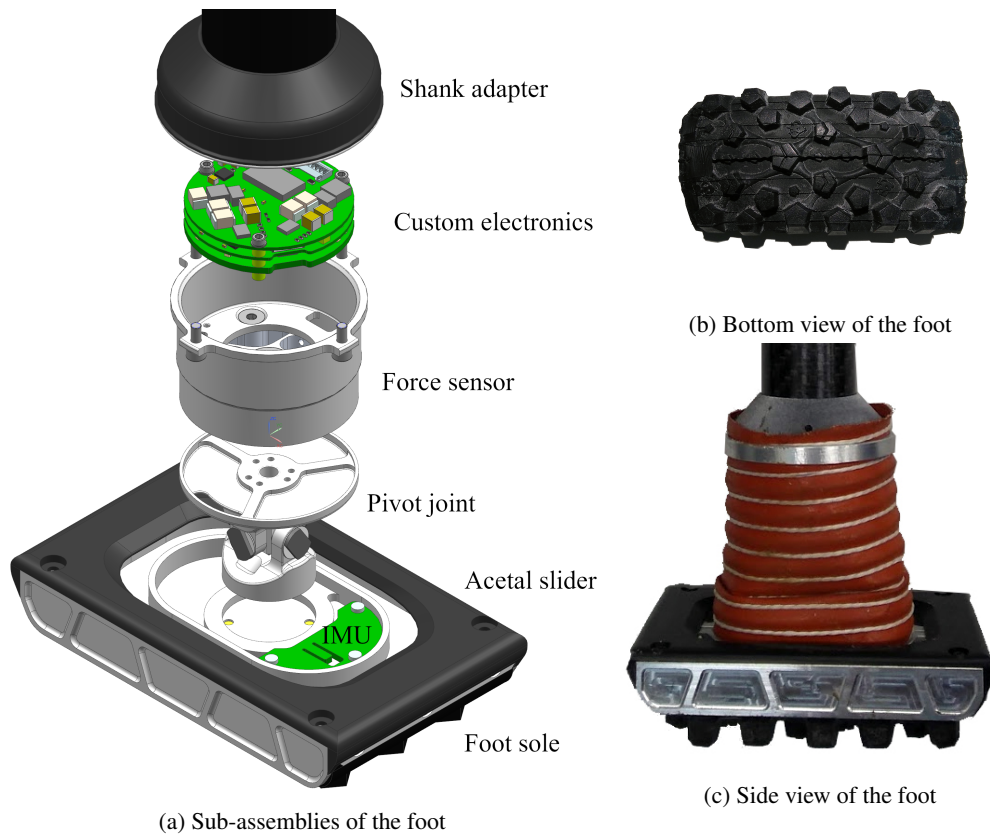
Figure 2: Overview of the newly developed foot for sewer inspection.

1) *Foot sole*: The sole has a surface area of 60 cm^2 (100 mm x 60 mm) and is made from an off-road rubber tire featuring 5 mm studs for increased traction (Figure 2b). The sole is connected to a metal rim by clamping, which avoids

peeling and gluing issues. Damping foam is placed between the rubber sole and the metal structure to reduce the peak loads resulting from impact forces during walking. An acetal slider avoids the foot getting stuck on overhanging edges and retains the metal rim.

2) *Pivot joint*: The pivot joint features a lightweight universal joint with integrated end stops to provide the required ground compliance. It is surrounded by an Ester Polyurethane rubber tube of Shore A70 that provides the retaining force to reset the foot to its initial position after deflection.

3) *Force sensor*: A custom, in-house developed 6-axis force/torque sensor is placed above the pivot joint to measure the forces acting on the foot. It consists of a force sensing element with strain gauges. The sensor is lightweight and robust and allows sensing up to 1000 N along the z-axis and 400 N along the x and y-axis. The maximum torque the sensor can sense is specified as 10 Nm. The accuracy lies within 1.5% of the measured value while the repeatability lies below 0.05%⁴. The measurements are filtered at 800 Hz by an integrated sinc filter with cut-off frequency of 1255 Hz. The sensor is temperature compensated to minimize drift during operation.

4) *Custom electronics*: The electronics of the foot consists of two IMUs (MPU-9250), a force sensor and a microcontroller board. One of the IMUs is located in the sole, while the other is integrated with the PCB in the shank. The IMU's linear acceleration is filtered with a cut-off frequency of 460 Hz while the angular velocity is filtered with a cut-off frequency of 184 Hz. Both the IMUs and the force sensor are connected to the microcontroller via the serial peripheral interface bus (SPI). The IMUs are read out with 1 kHz and force measurements are obtained with 400 Hz. The microcontroller board is connected to the robot via EtherCAT and powered through the auxiliary 12 V power line. The custom 6-axis force/torque features a PCB with analog-to-digital converters (ADCs) and a microcontroller that processes the analog signals of the strain gauges. Sensor data is recorded on the high-level side at 400 Hz.

5) *Shank*: The carbon fiber shank connects the foot to the knee of the robot. The shank is sealed and features a conical slider for protection of the force sensor.

6) *Sealing*: The joint is protected by thick bellows (visible in Figure 2c), mechanically clamped to the structure and sealed, which improves the ingress protection rating compared to previous work. O-rings and sealants have been used for all the matching surfaces. Water-proof cable glands and connector have been used for the cables.

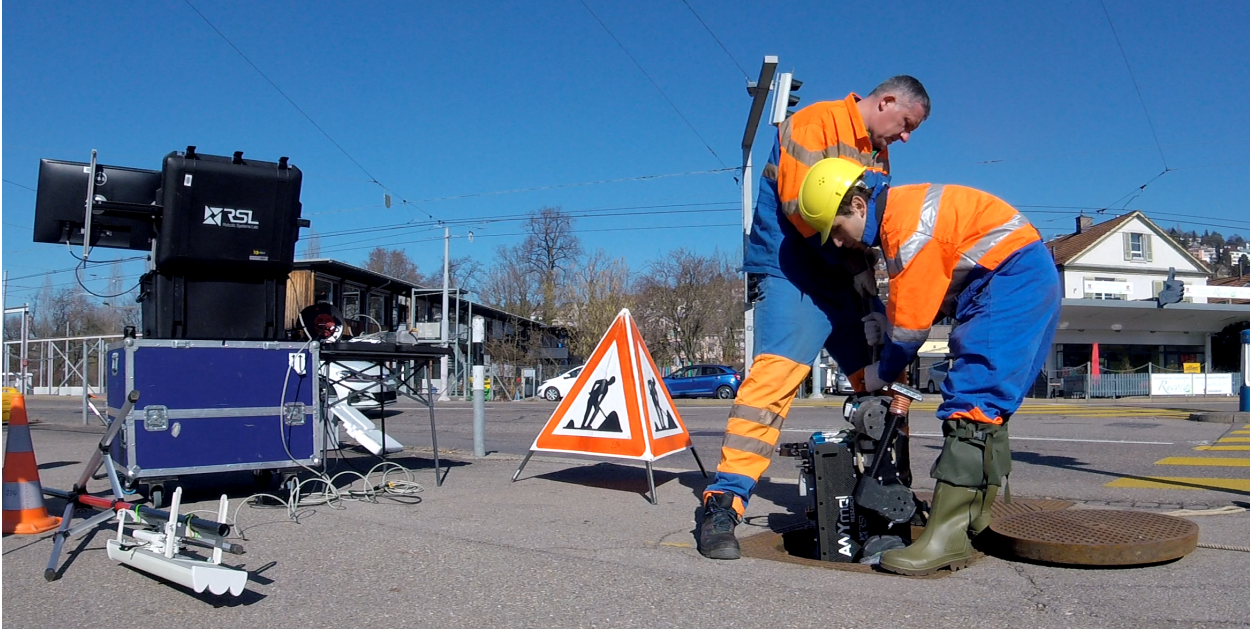
Figure 3: Depiction of the field test setup and the deployment of *ANYmal* into the sewer. The operator base station and warnings signs are visible in the background.

We conducted multiple field test campaigns in the sewage system of Zurich to iterate the hardware, practice operations, collect datasets, and execute inspection missions. The first test campaign with the robot took place during two days in February 2019 [Kolvenbach et al., 2019] the second campaign took place on three days in December 2019. Generally, the robot can be easily deployed through a standard utility hole ($d = 0.8$ m). To do so, the robot's legs are unpowered, tucked up, and the system is lowered into the sewer with a tether (Figure 3). During our tests, the robot was operated from a base station which was located outside the sewer, nearby the utility hole.

The base station consists of the operator PC, an additional screen, and outlets for electricity and communication links to the robot. The base station is easy to transport and quick to set up. We installed a gazebo to shelter the robot operator and desk during rainy testing days. We deployed directional Wi-Fi antennas (Ubiquiti airMAX, HyperLink HG4958DP-19P) into the utility hole via a tripod with reversed column to enable a reliable communication link to the robot. During the test, a safety operator stayed in the sewers with a professional inspector and communicated with the robot operator outside via two-way radios (Figure 4).

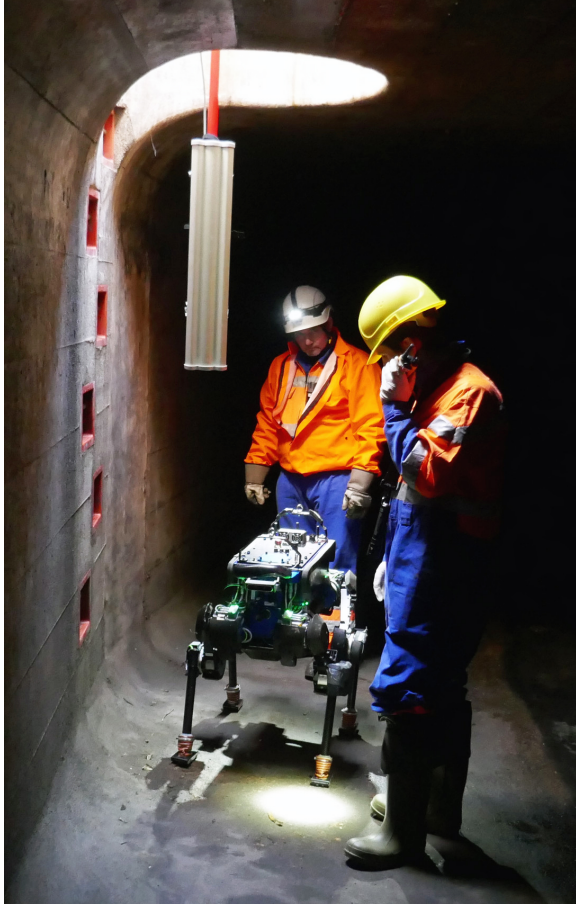
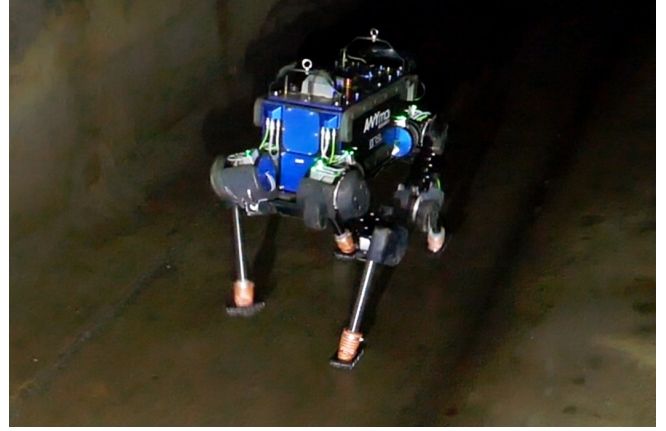
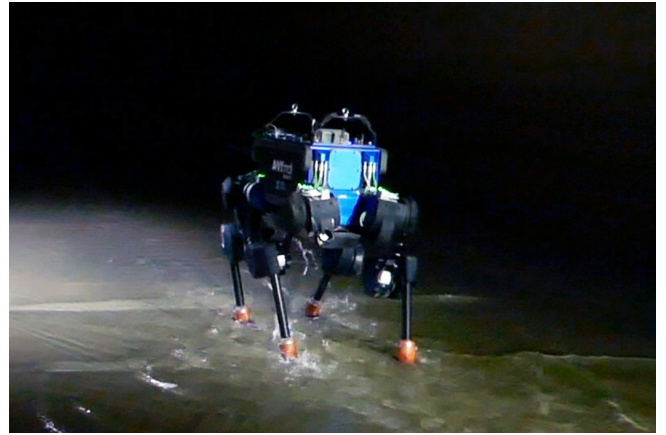
(a) *ANYmal* setup in the sewer

(b) Walking on biofilm

(c) Walking through wastewater

Figure 4: Depictions of *ANYmal* walking in the sewer. A professional sewer inspector accompanies the testing and assesses the state of the concrete.

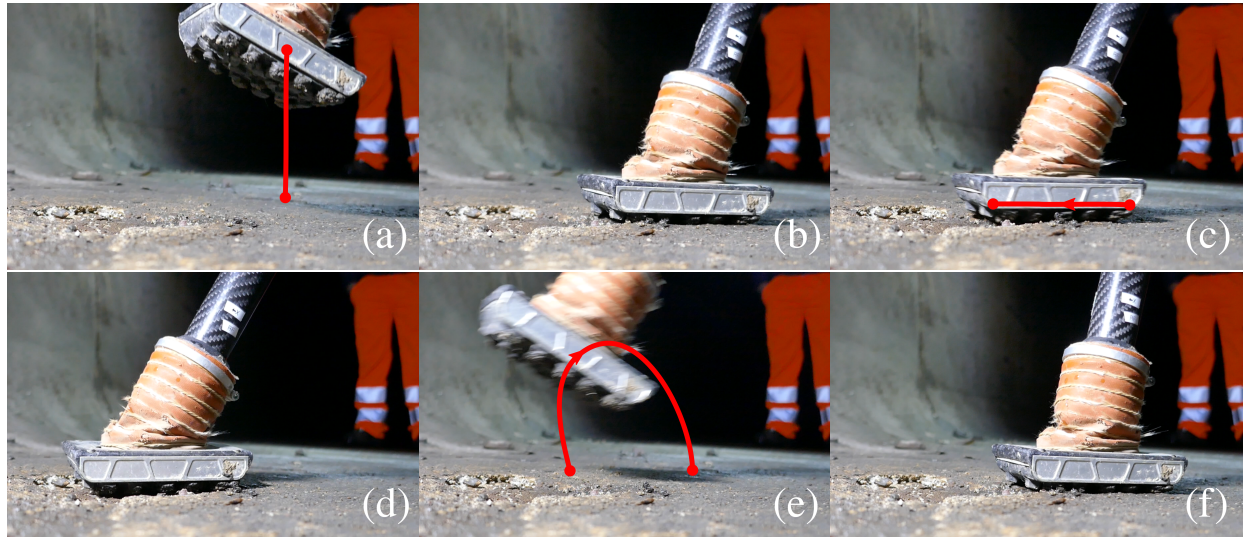
Figure 5: Picture sequence of the tactile inspection motion with the foot placement phase (a), inspection motion start location (b), main inspection phase (c), motion target (d), re-positioning movement (e), and final position (f).

The full sequence of the inspection motion, shown in Figure 5, can be split into several phases. A predefined position relative to the three stance legs is approached in (a) and contact is established in (b). In (c), a straight line trajectory is followed until a target location (d). In (e) and (f), the foot is re-positioned to return to a nominal stance on four feet. For the part (c) of the inspection motion, where data is collected, the desired end-effector force is computed as seen in the following equation.

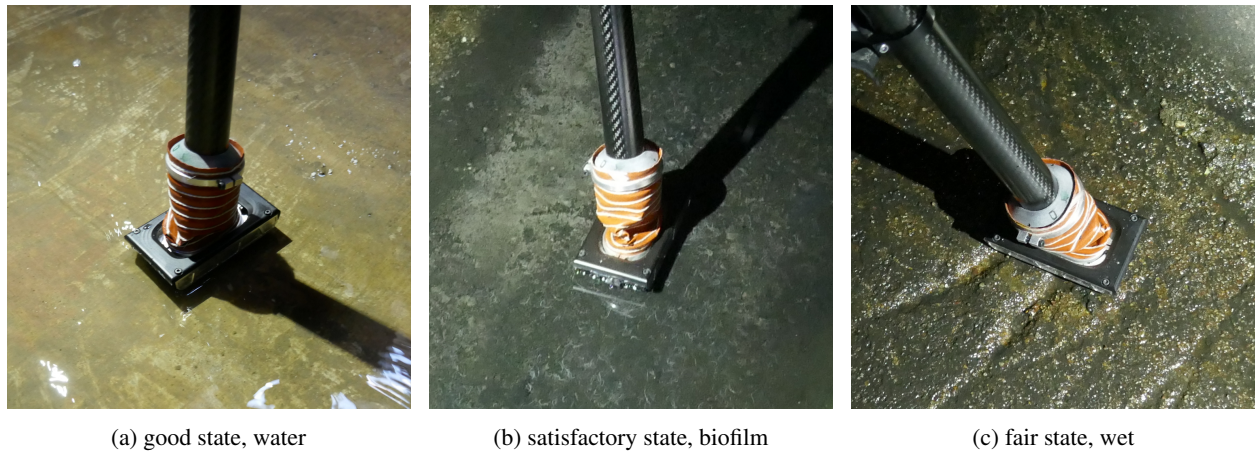
Figure 6: An exemplary set of pictures illustrating the various surface conditions encountered in the sewers.

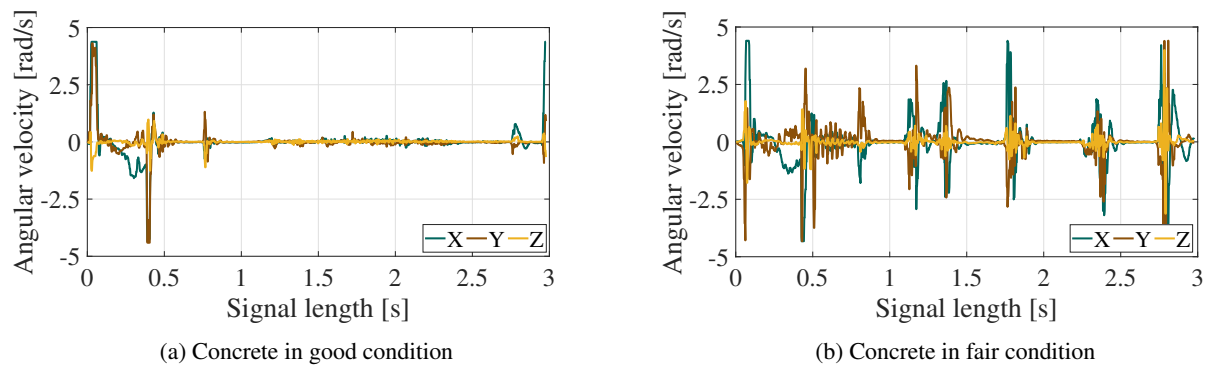
Figure 7: Comparing the angular velocities of two samples recorded by the foot sole IMU show a correlation between signal magnitudes and concrete deterioration (Complete sequence of the inspection motion).

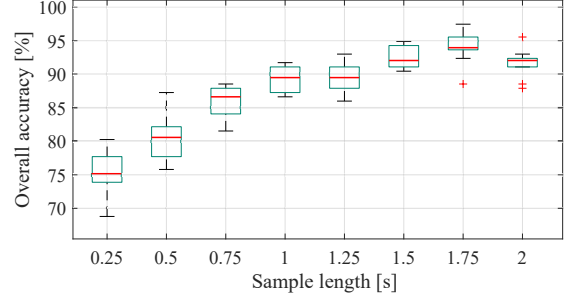
(b) Accuracy increase over signal duration

Figure 8: Few misclassification events occur between the *Satisfactory* and *Fair* class. Correlation between classification accuracy and signal length indicates that samples should be collected for at least a second after starting the scratching motion (Average performance over ten evaluations).

Performing the classification with all sensors resulted in the highest accuracy, and further investigations were performed with this selection. A confusion matrix showing the truly and wrongly classified samples was derived by training and evaluating the model for ten successive trials (Figure 8). Misclassification occurs mostly between the *fair* and *satisfactory* class, which are also fairly similar in terms of roughness compared to the smooth, *good* class. More samples were available for the *fair* class compared to the *satisfactory* and *good* class, which might explain the generally lower classification performance on the *satisfactory* class of the validation set. Investigating the sampling time shows that the signals should be captured for at least for one second for high classification accuracy. A small drop in performance is seen when taking the full sample length, which might be explained by small deviations in the duration of the scratching motion. Generally, an increase in performance might be realized by increasing the size of the dataset, further optimize the feet for vibration response, or utilizing alternative classifiers, such as neural networks [Bednarek et al., 2019].

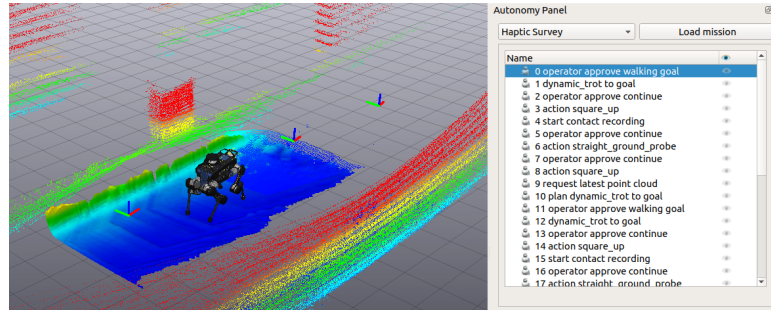
Figure 9: Screenshot of the Director mission interface [Marion et al., 2017], showing three inspection waypoints and the associated task queue.

We utilized the trained SVM model to perform complete inspection missions in the sewer. The missions were planned and executed using the Director user interface (Figure 9) and system architecture, initially designed by MIT during the DARPA robotics challenge [Marion et al., 2017]. It features a shared autonomy system where the user can provide high-level commands to the robot, which are then executed autonomously. For the missions, the robot operator simply provides multiple waypoints in the online-generated map for inspection. The robot will then walk to these waypoints and perform the inspection motion autonomously.

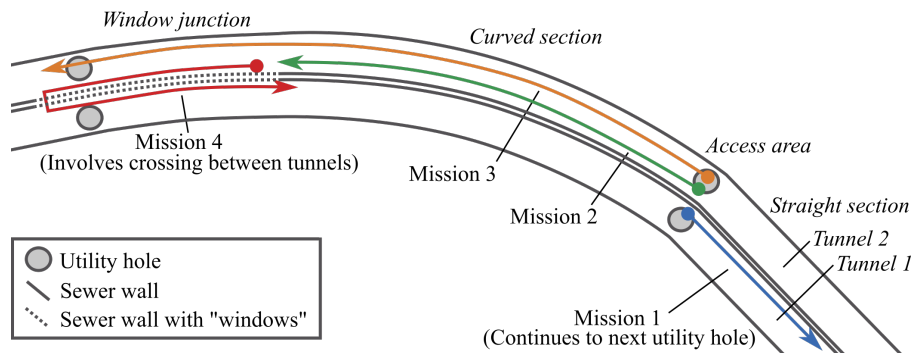
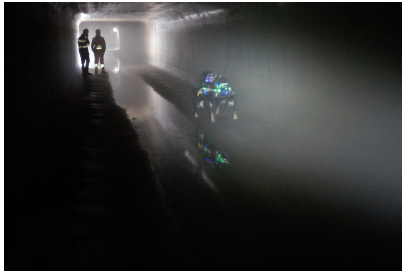
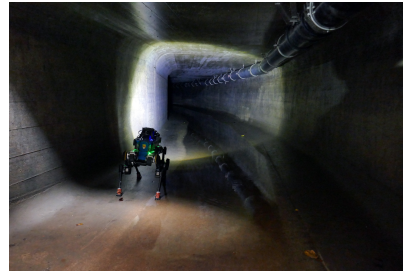
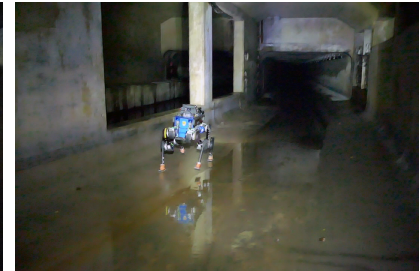
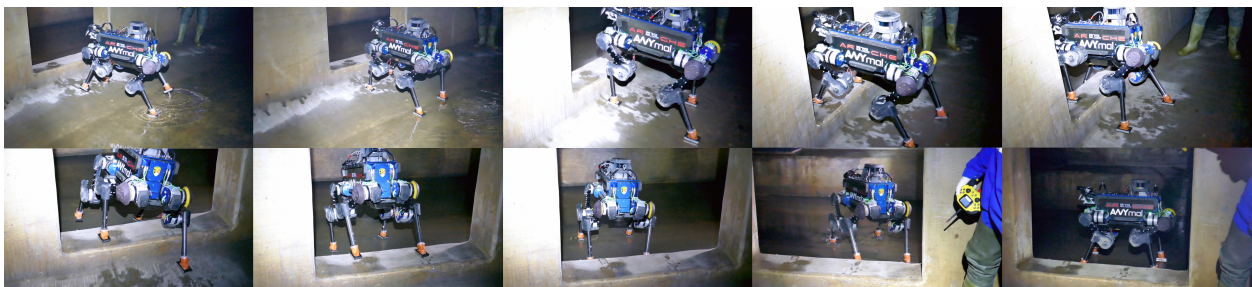
(a) Top-down diagram of the missions completed in the sewer.

(b) The robot during mission 1 as it walks down the straight featureless tunnel. Fog can be seen in front of the robot.

(c) Mission 2 in the second tunnel. Here the sewer is more curved and there is a large pipe suspended from the ceiling.

(d) View of second tunnel in direction of the window junction during mission 3. Two large windows are visible to the robot's left.

(e) The robot performing the crossing maneuver during mission 4. The robot has climbed onto the threshold and is transiting from tunnel two to tunnel one to continue the inspection.

Figure 10: Photos taken during each robot deployment.

Using the shared autonomy framework, we completed four missions as described in Figure 10a and Table 2. For missions 1-3, the robot was deployed through a utility hole and commanded to inspect a section of the tunnel (of length 145 m). The mission ended if either the final goal was reached or the robot slipped and could not recover. A safety operator was present at all times during the missions but did not intervene unless the robot fell. Mission 4 was designed to show the capabilities of using legged robots specifically. For this mission, the robot was placed near the window relief junction and directed by the robot operator outside the sewer to cross the window from tunnel two into tunnel one. A detailed breakdown of each mission is given below:

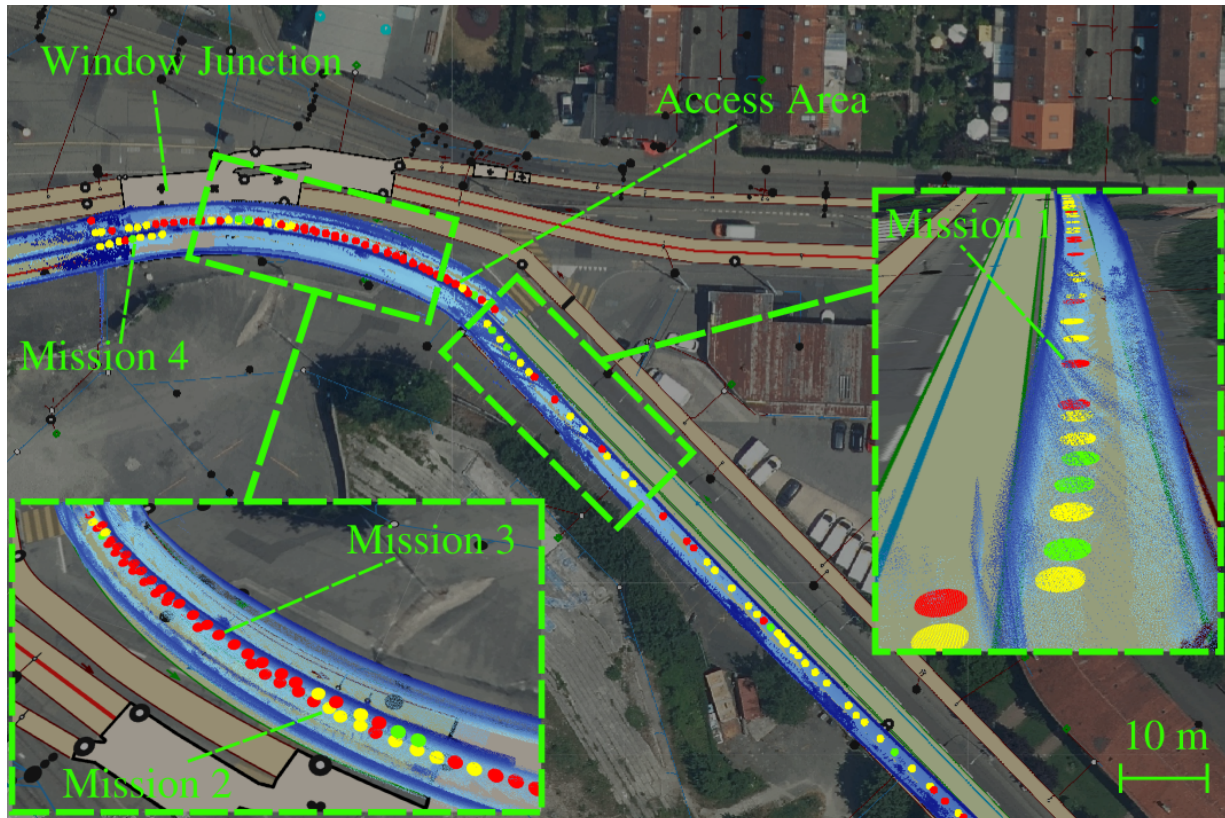
Figure 11: Overview of whole pointcloud map overlaid on sewer plans and satellite image (1:500 scale). Blue points represent the map generated by the robot's LIDAR and the color intensity indicates height with dark blue being the sewer floor. Concrete classifications are colorized as: Red (*Fair*), Yellow (*Satisfactory*) and Green (*Good*). In green boxes we highlight two areas of interest: the curved section where missions 2 & 3 occurred and the straight section of mission 1. In the curved section we have raised the mission 3 contact maps above the ground to improve visibility.

The outcome of the inspection mission results are projected in Figure 11. In total, we were able to take 130 samples over 294 m to which we assigned a deterioration class in post-processing. There are several sections of the sewer with different levels of concrete degradation, which matched our qualitative impression. For example, the worst conditions were found between the sewer access area and window junction, while the straight portion of the tunnel and the tunnel window junction (where the robot crossed between tunnels) are less degraded. The robot generally inspected areas close to the center of the sewer where smooth terrain is not likely to be found. Mission 2 and mission 3 covered the same area in the sewer, and the classification results reflect this. Areas that have been investigated twice show a high level of consistency in the degradation estimate. Out of 45 samples that have been collected at the same patch of 43 m, just five samples show a difference in their classification result. Of the five outliers, four showed a deviation by one class and one sample by two classes. Due to the small investigated footprint of 0.005 m^2 during the inspection, it might be that the areas are not necessarily misclassified but are rather capturing a general change in deterioration of the concrete. The high spatial resolution of the measurements combined with the location in the map make it easy to visualise clusters of good or worse concrete. Generally, several inspection walks over the same areas have increased the statistical power of this approach. A possible extension of this work would be to perform the evaluation online and increase the amount of samples taken in an area with noticeable change in degradation estimates.

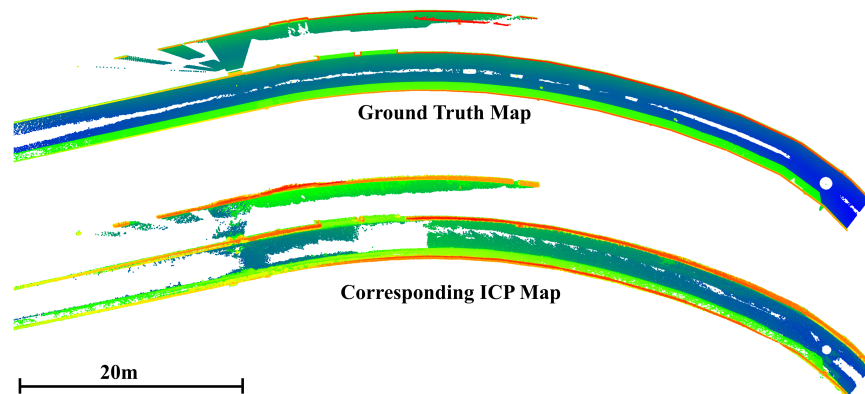
Figure 12: Comparison of the ground truth point cloud and the ICP map generated by the robot. The ICP map shown contains only the points that lie within 20 cm of the ground truth, showing the accuracy of the ICP map. The point clouds are colorized by height for clarity.

The ICP map was most accurate around the window junction due to the strong geometric features and missions 2 and 3 generated almost identical maps in independent runs. The poorest performance was during mission 1 in the long, straight portion of the tunnel. As described in Figure 10, this portion of the tunnel is almost perfectly symmetric along the direction of travel, and there were significant artifacts in the point clouds caused by dense fog, leading to an overestimate of tunnel length by 42.8 %. To analyse the quality of the ICP mapping further we compared it to a ground truth point cloud collected by tripod-based commercial 3D laser scanner (Leica BLK-360). The majority of the points in the ICP map lie within 20 cm of the ground truth as shown in Fig. 12, showing the validity of this approach.

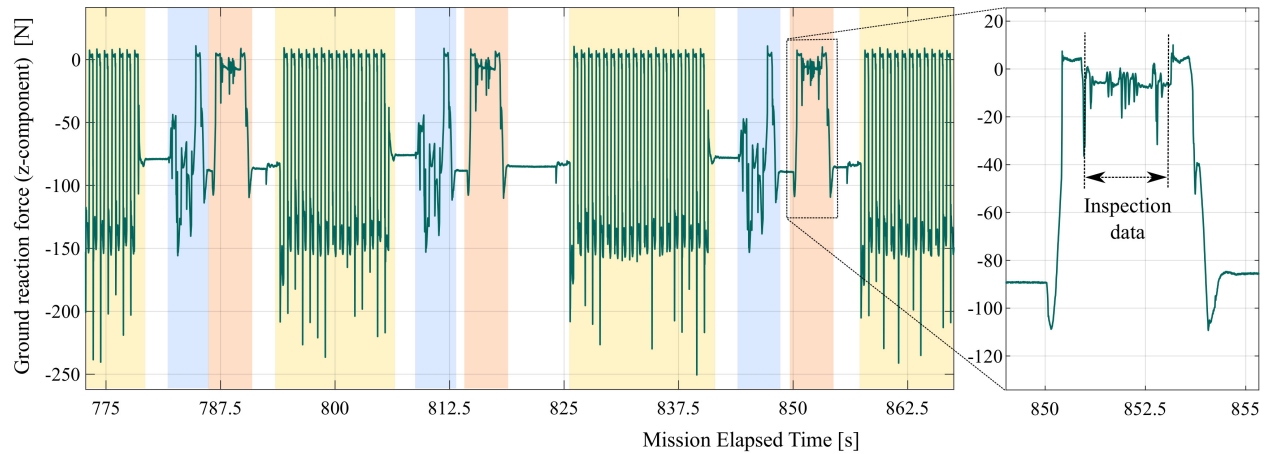
Figure 13: The vertical component of the ground reaction force of the front right foot as measured during mission 2. Walking episodes (yellow) can be easily distinguished from the “square up” reorientation maneuver (blue) and the tactile inspection motion (red). The inspection data is extracted from the sensor stream for classification.

An example of the raw data for contact classifications is provided in Figure 13, showing the vertical ground reaction force over three inspection motions. There is a clear pattern to the data, making it easy to distinguish between the three phases of the inspection task – walking, “square up”, and inspection motion. This shows the repeatability of the robot inspection, even during complex real-world missions.
