Investigation of Soil-Structure Interaction for Large Diameter Caissons

Ronan Royston
St. Catherine's College
University of Oxford

A thesis submitted for the degree of
Doctor of Philosophy

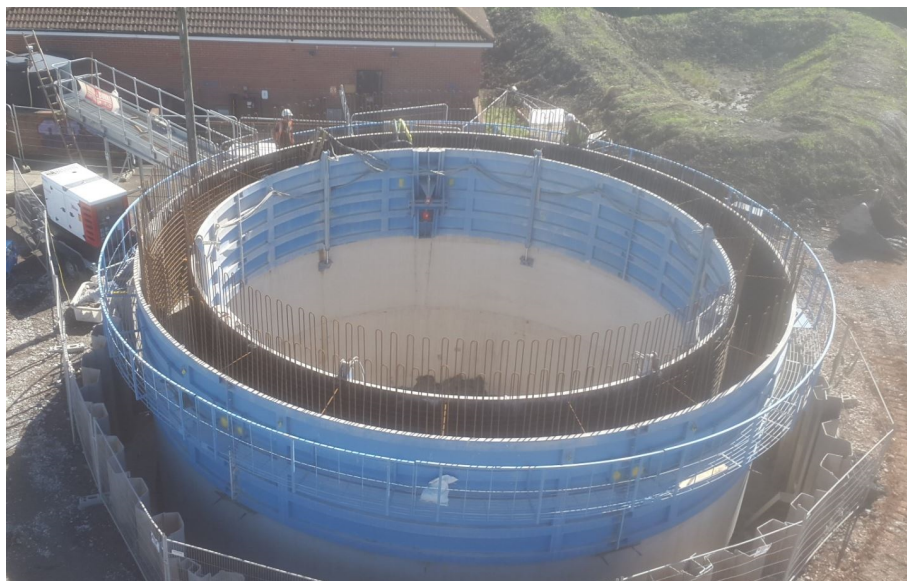
Figure 2.7: Sloway Lane caisson under construction.

A circular sheet pile cofferdam was created around the caisson, with 2 m clearance to the exterior face of the caisson wall. This protected the caisson from surcharge loading arising from the presence of the site crane. The cofferdam was excavated to 3 m depth, at which point caisson construction commenced, with two concrete wall pours, 2.4 m high each. A concrete bearing pad was formed to produce a 60° tapered

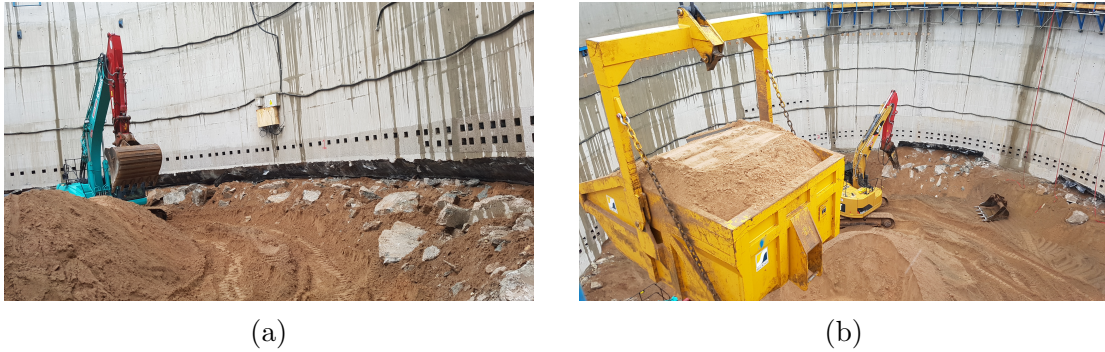
Figure 2.21: Excavation within the Anchorsholme caisson.

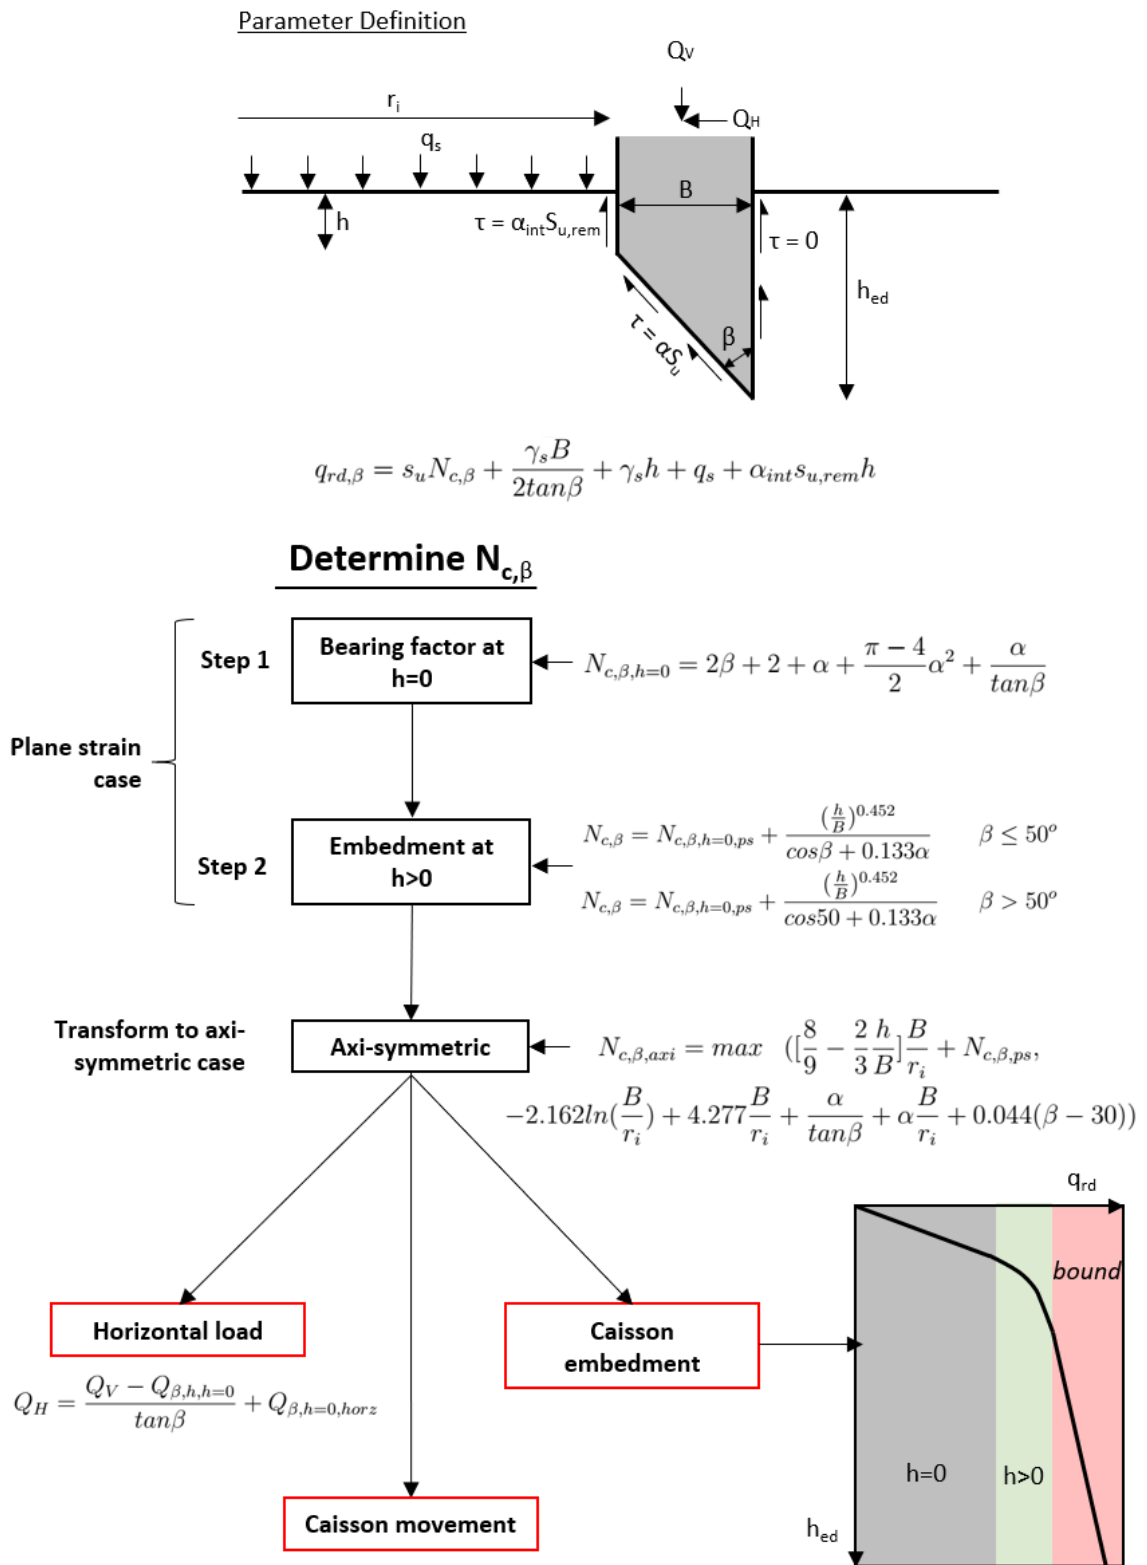
Figure 6.9: Flow Chart for estimating caisson bearing capacity.
