A holistic approach to diagnose
deterioration of rock-cut structures
in Lalibela, Ethiopia

A thesis presented for the degree of
Doctor of Philosophy
in
Science and Engineering in Arts, Heritage and Archaeology
April 2022

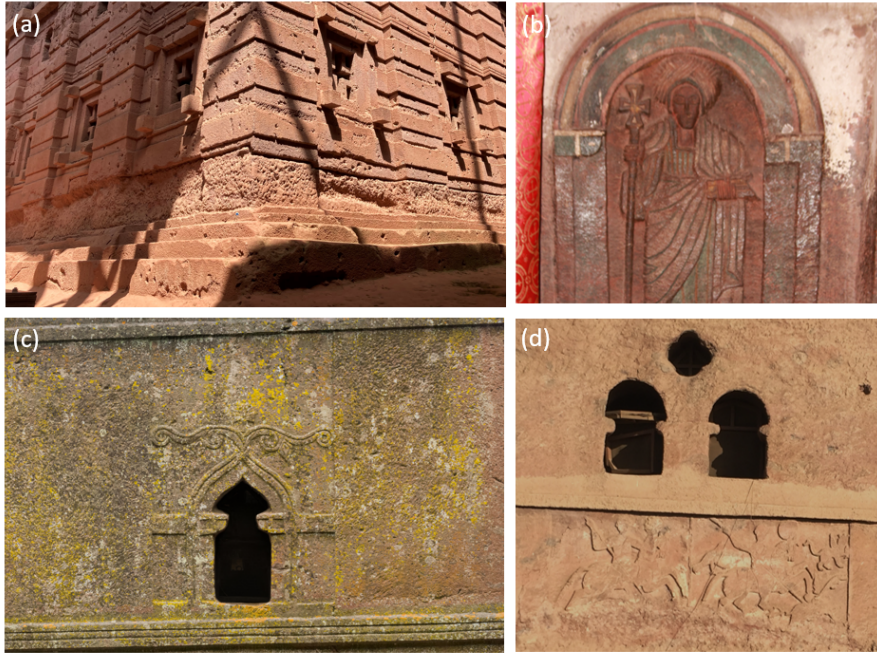
Figure 3.3: Architectural details of the churches at Lalibela.(a) monkey head styled facade at Bete Amanuel, (b) life sized bas-reliefs at Bete Golgotha, (c) pointed arch and string course at Bete Giyorgis and (d) frieze at Bete Mariam.

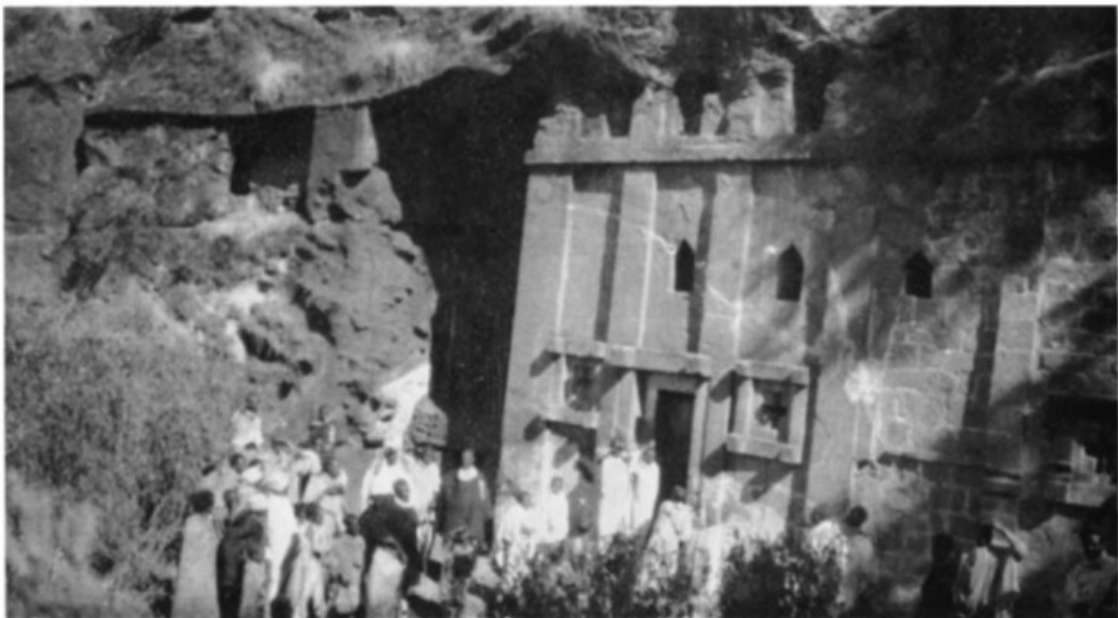
FAÇADE OF LIBANOS CHURCH, RECENTLY REPAIRED WITH MUD BRICKS

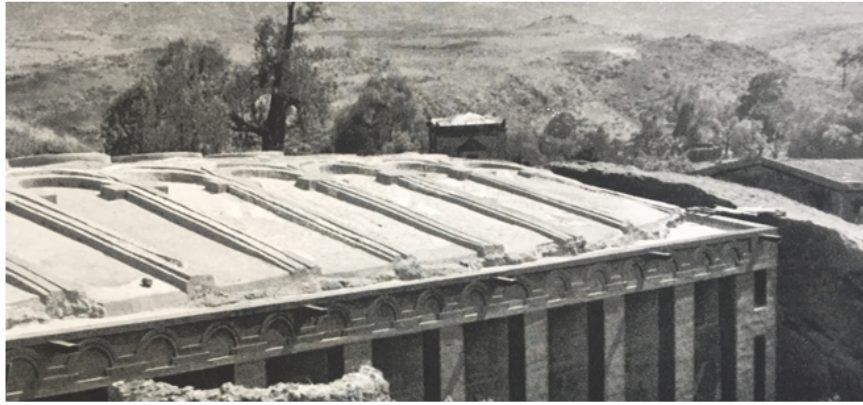
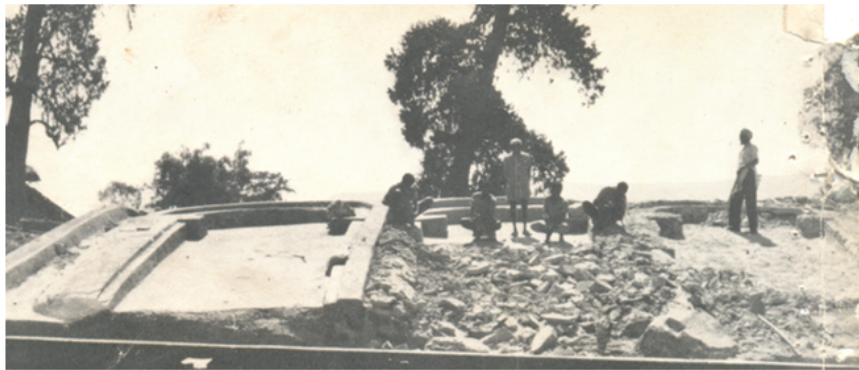
Figure 3.6: Bete Medhani Alem (a) after it was restored with Portland cement in 1959. *Source: Bidder (1959)* and (b) subsequent removal of cement layer in 1967. *Source: Angelini 1967*

tion campaign was to safeguard the churches from further deterioration, to remove ‘false’ additions and to re-establish the monolithic form of the structures. As such, the paint was removed from the churches and the cement layer on the roofs was also removed (Fig 3.6). While the materials used for restoration in the 1950s were incompatible, the process of removing them was also very destructive (Fig 3.6). Angelini, (1967) believed the principal agent in the deterioration of the churches was heavy rainfall. To protect the churches from rainfall, he applied a sacrificial mortar layer on the roof of Bete Medhani Alem and Bete Mariam and sealed the cracks on the roof. Water repellent solutions were sprayed on vulnerable facades to prevent further damage to the walls of the churches.

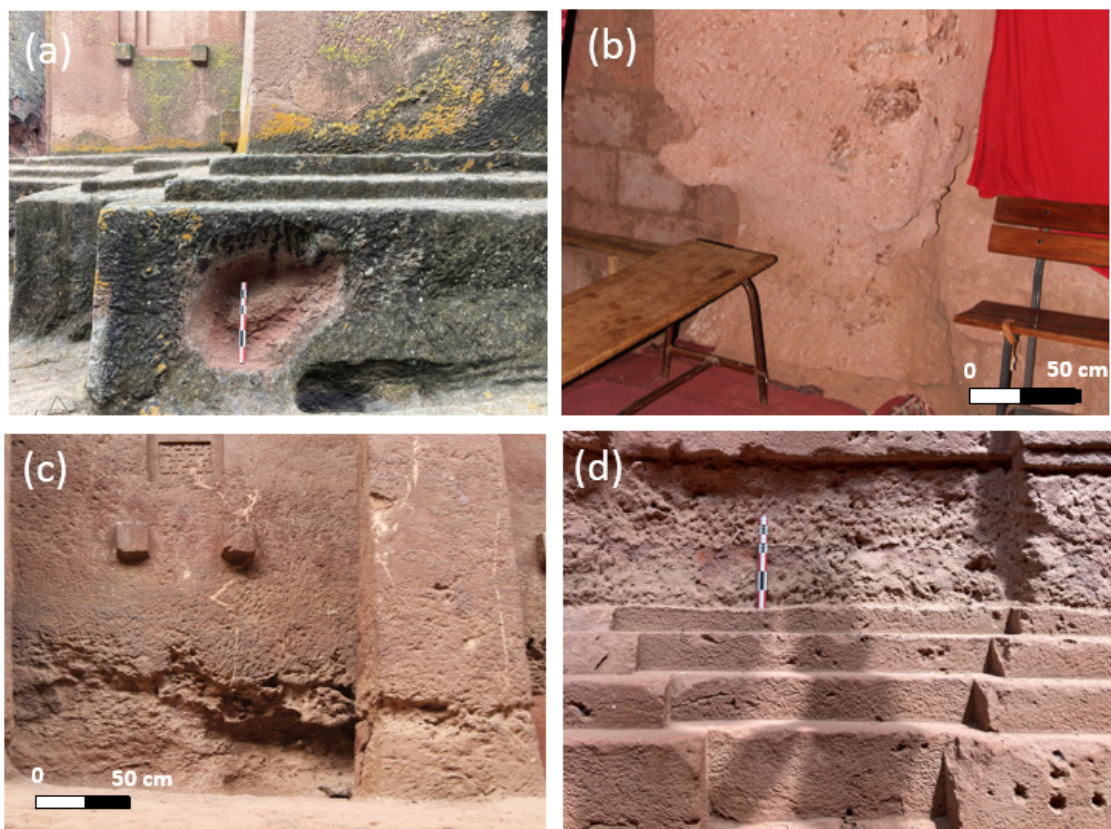
Figure 3.7: (a) South-facing wall at Bete Giyorgis showing a large cavity (> 60 cm). (b) Load bearing column in Bete Merqorewos eroded at the base. (c) Differential erosion on the base of the east-facing wall Bete Medhani Alem. (d) Deteriorated base of north facing wall at Bete Amanuel. *Source: Author's own.*

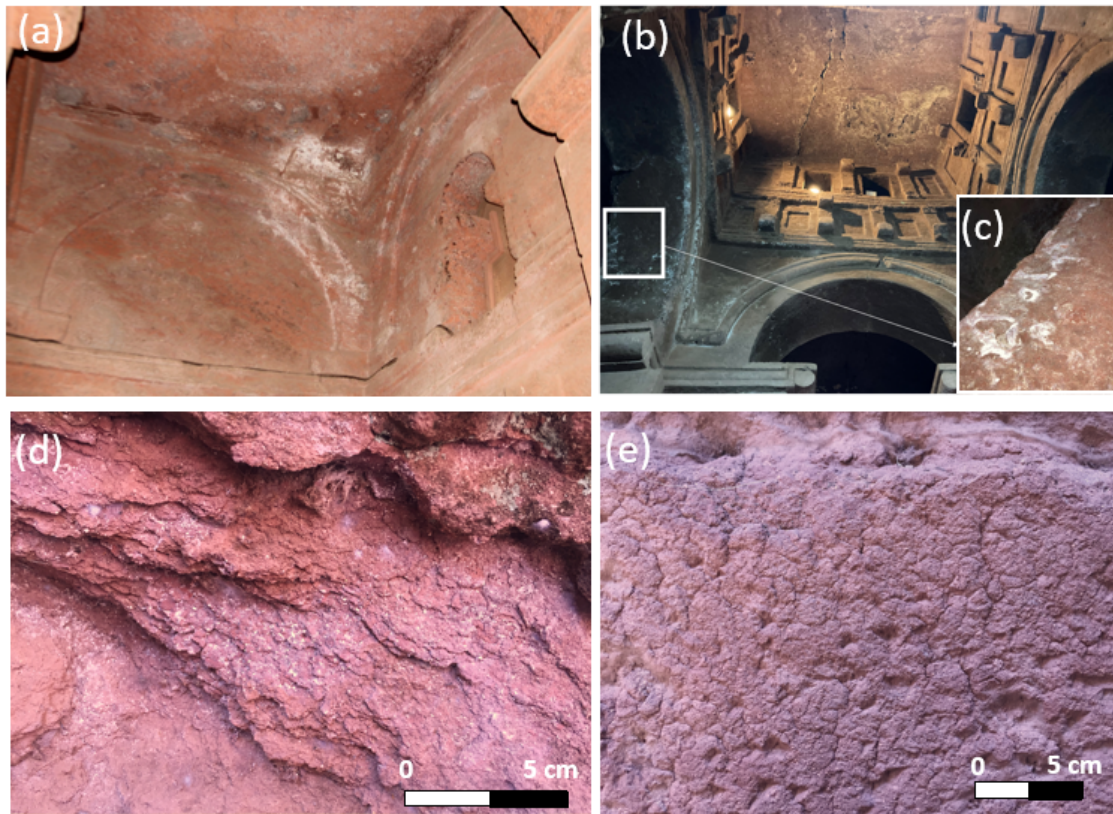
Figure 3.8: (a) Salt efflorescence on the ceiling of Bete Mikael/Golgotha (b) Salt efflorescence on the ceiling of Bete Mikael/Golgotha with an (c) inset showing salt rich areas. (d) Contour scaling and salt efflorescence on the entrance tunnel at Bete Giyorgis. (e) Craquele on the the south-facint wall at Bete Amanuel. *Source: Author's own.*

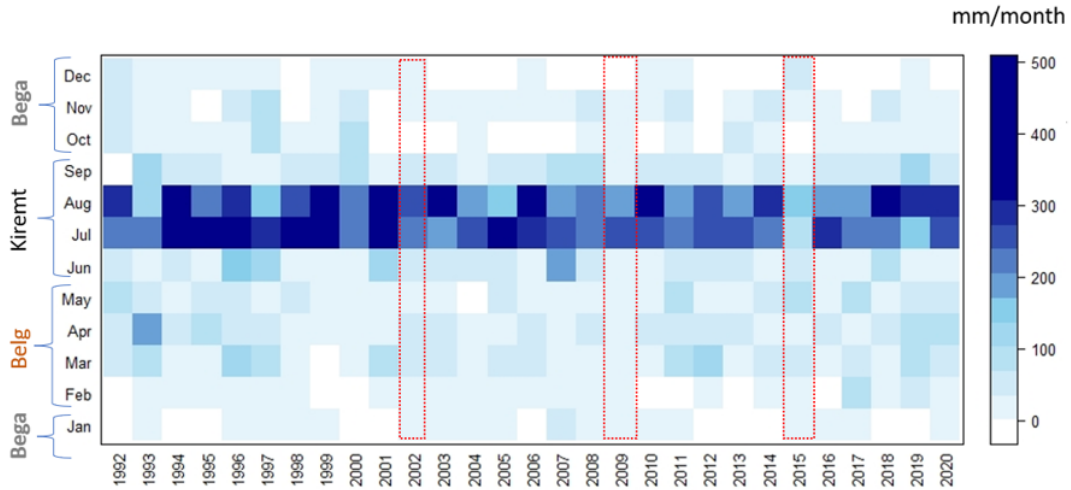
Figure 4.3: Monthly rainfall at Lalibela for the period 1992-2020 plotted as a heatmap. El Niño years are highlighted in red boxes.

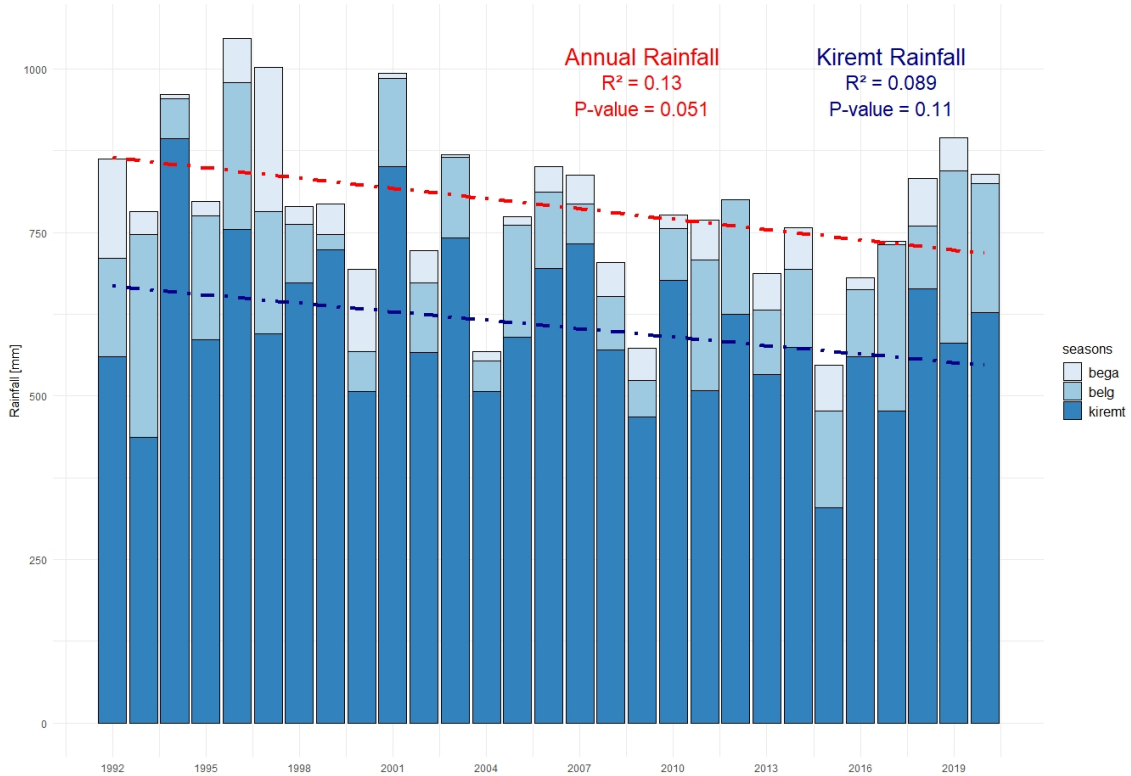
Figure 4.4: Seasonal rainfall at Lalibela, 1992 – 2020 with linear least squares regression line of annual rainfall (red) and Kiremt rainfall (dark blue).

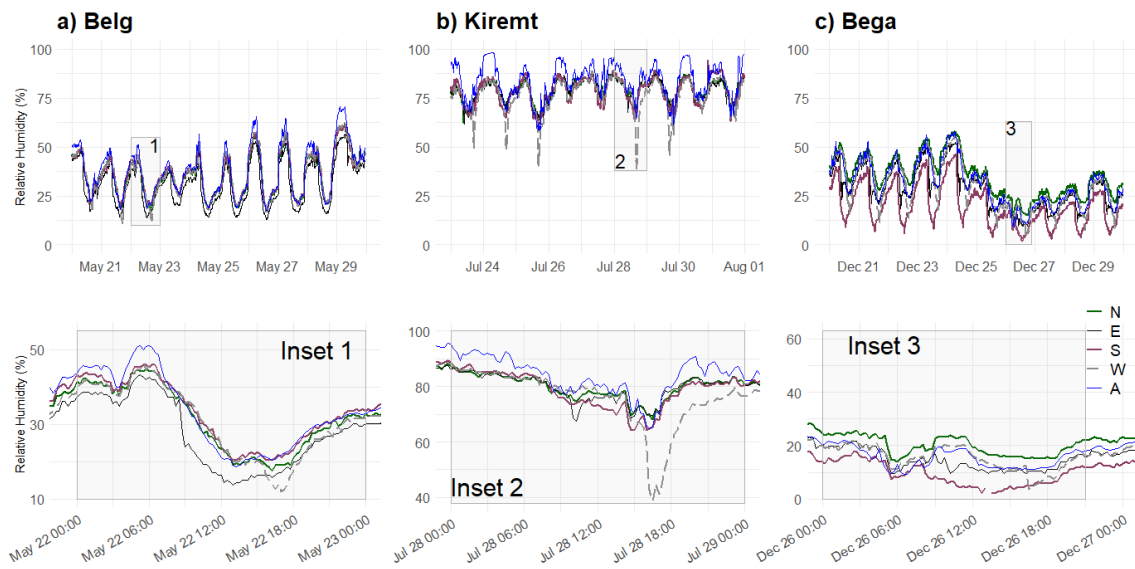
Figure 4.6: Relative humidity measured at the weather station (A-Ambient) and on the north (N), east (E), south (S) and west (W) walls of Bete Mariam during (a) Belg, (b) Kiremt and (c) Bega. Insets 1, 2 and 3 show one diurnal cycle taken from a, b and c, respectively. Note the difference in relative humidity scale in the data presented in the insets.

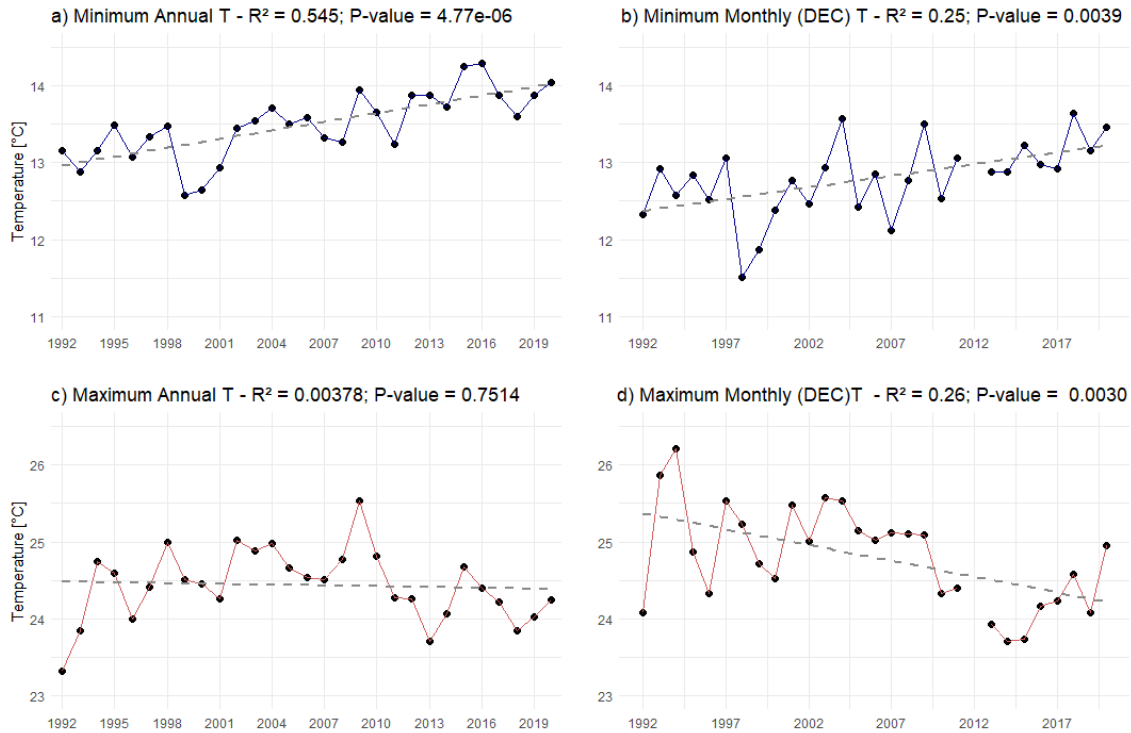
Figure 4.8: Comparison of time series plots (1992 -2020), with linear least squares regression lines of (a) minimum annual temperature, (b) minimum monthly temperature in December, (c) maximum annual temperature and (d) maximum monthly temperature in December. Note the different temperature scales between a) and b) and c) and d).

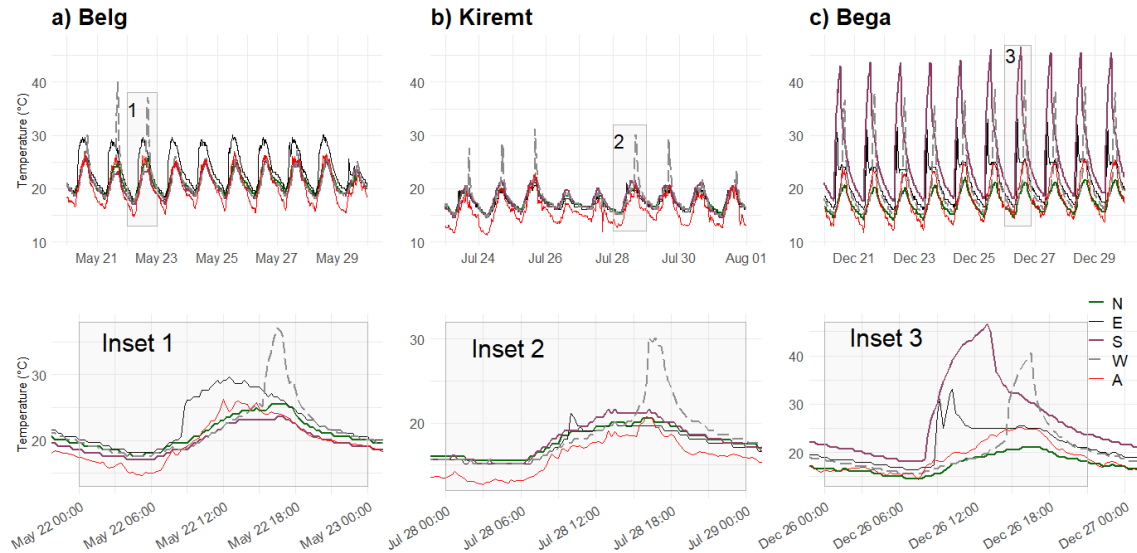
Figure 4.9: Temperature measured at the weather station (A-Ambient) and on the north (N), east (E), south (S) and west (W) walls of Bete Mariam during (a) Belg, (b) Kiremt and (c) Bega. Insets 1, 2 and 3 show one diurnal cycle taken from a, b and c, respectively. Note the difference in temperature scale in the data presented in the insets.

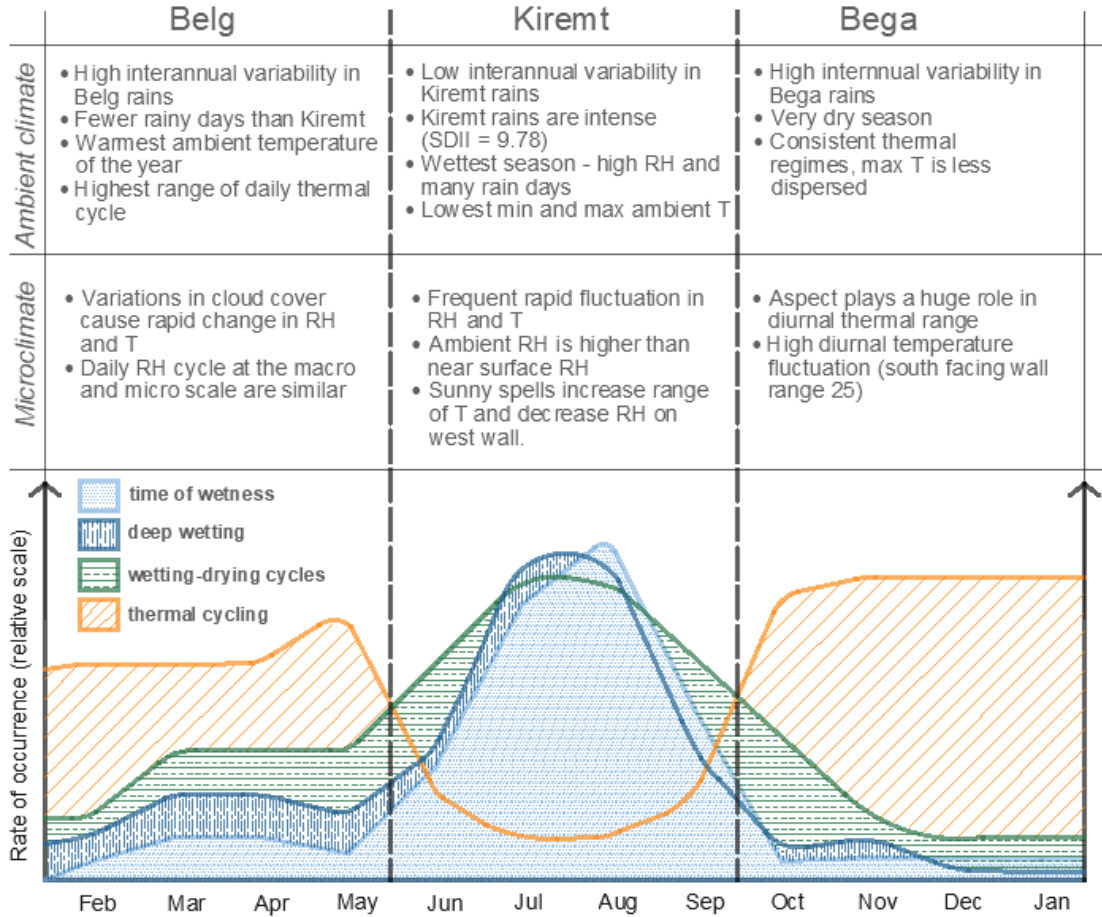
Figure 4.10: Summary of the main ambient and micro-climate trends in the three seasons (top) and (below), and a conceptual diagram showing the key weathering-related impacts of the seasonal climate trends – which are: wetting-drying cycles, deep wetting, time of wetness and thermal cycling.

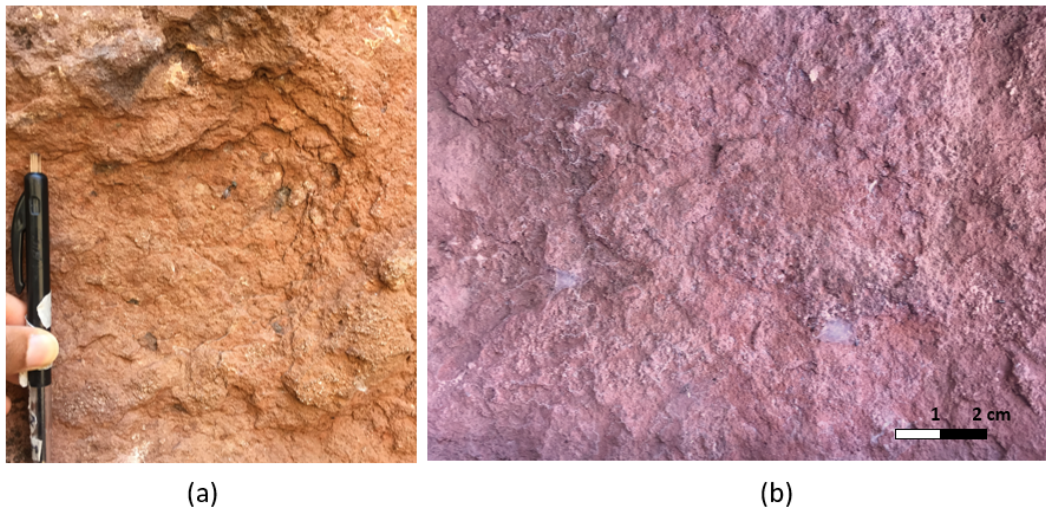
Figure 5.1: Macro (left) scaling at and micro (right) scaling on the church walls at Lalibela

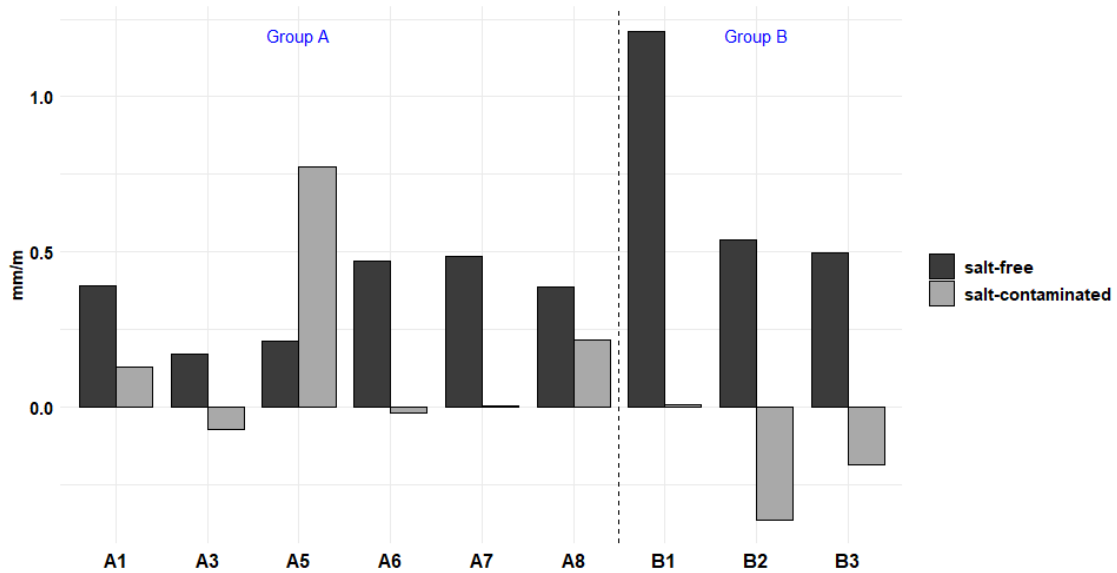
Figure 5.4: Salt-free (black) and salt-contaminated (grey) hydric dilatation.

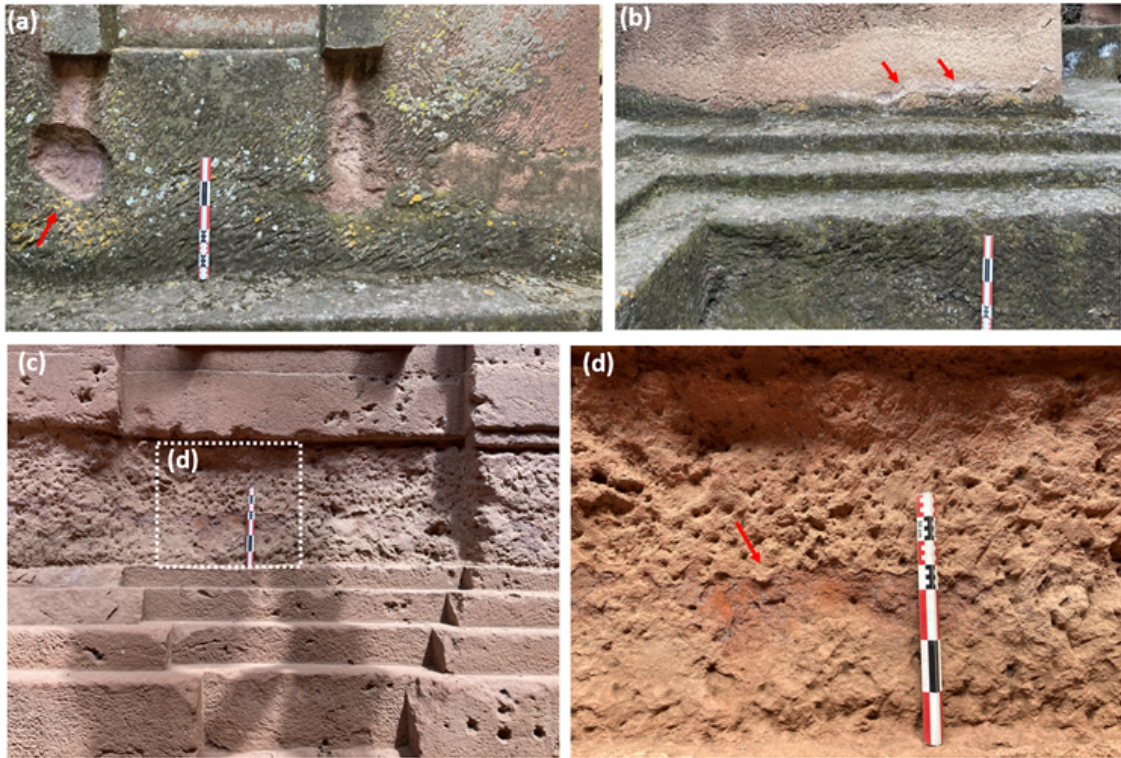
Figure 6.4: Images of Bete Giyorgis showing (a) coving and (b) restored area with salt efflorescence and images of Bete Amanuel (c) showing moisture-related damage and (d) granular disintegration and scaling. Note the scale in the images is 50 cm.

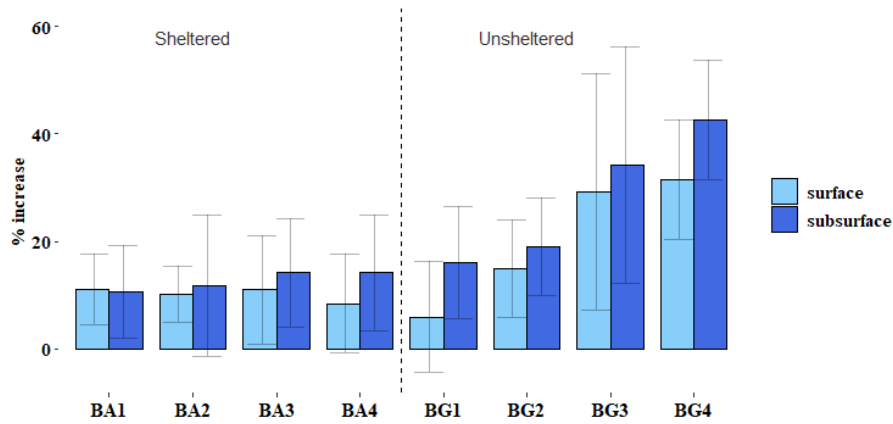
Figure 6.5: % increase from the dry to the wet seasons on the surface and subsurface of the zones measured at Bete Giyorgis (BG) and Bete Amanuel (BA).

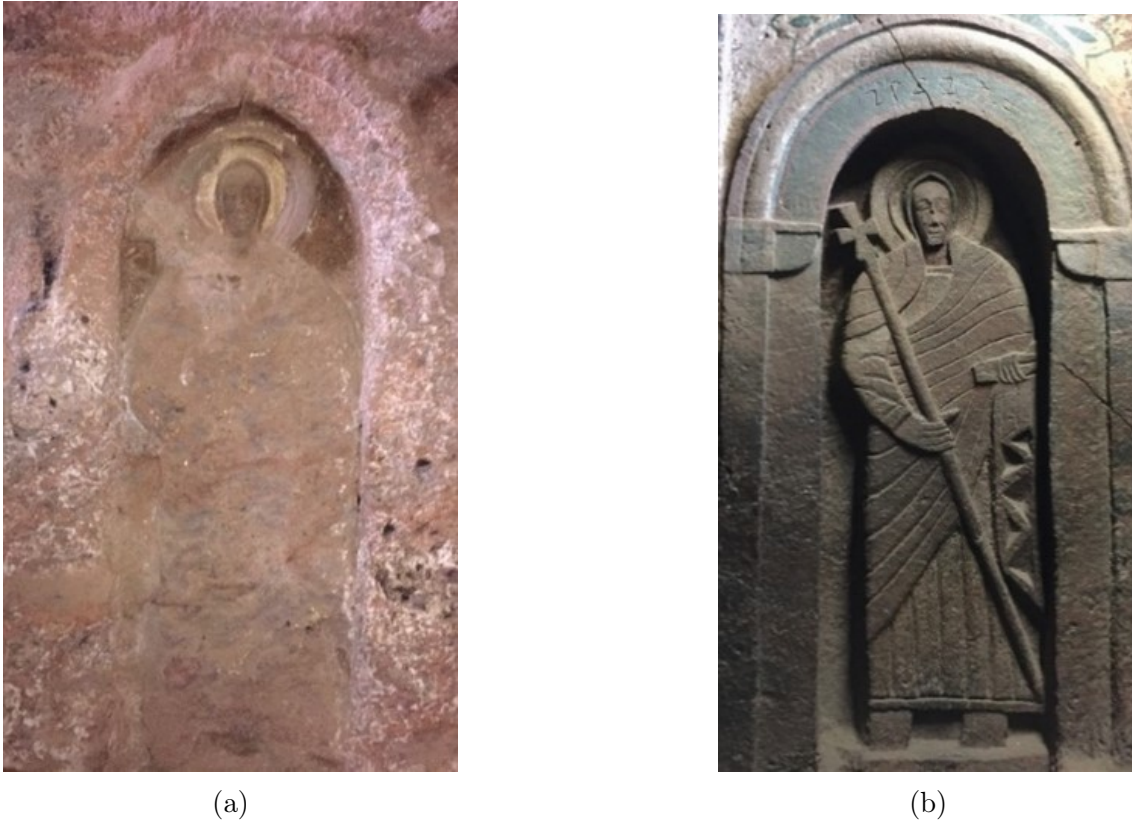
Figure 6.8: Bas-reliefs in Bete Golgotha: (a) N1 and (b) S1.

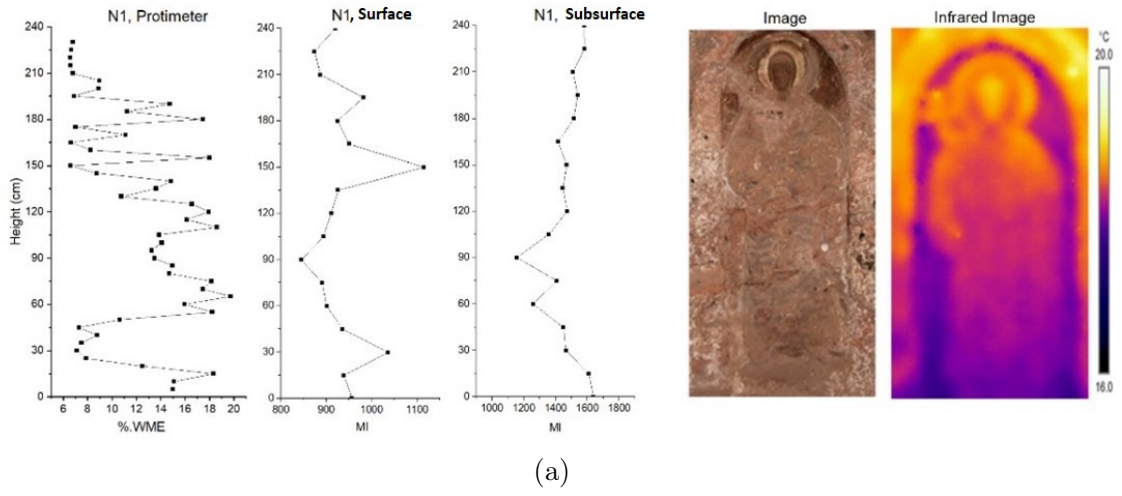
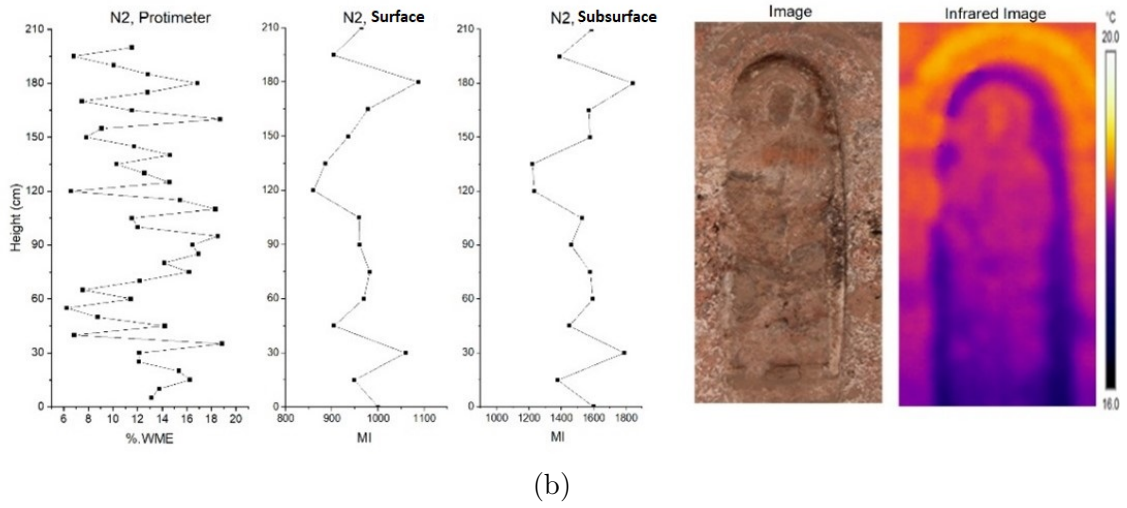
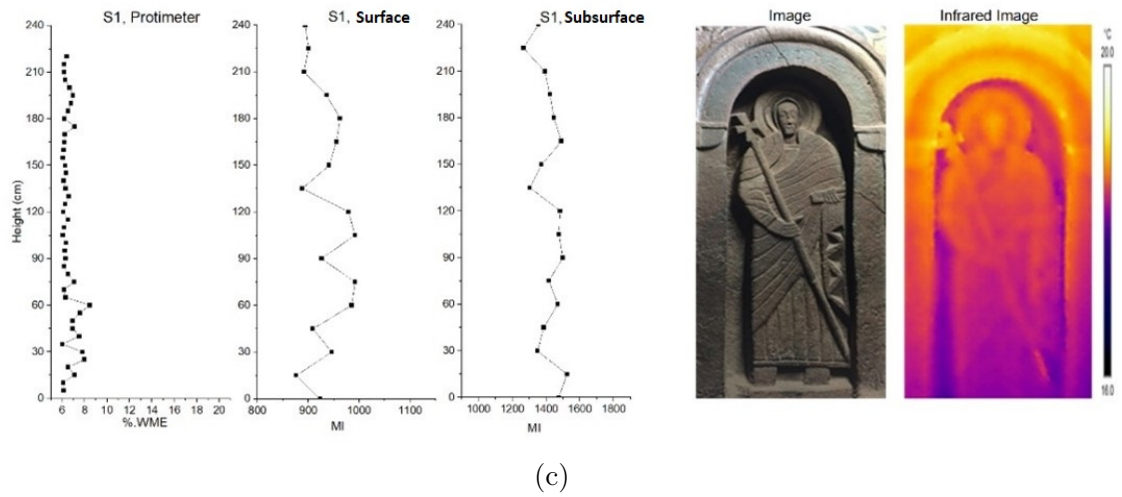
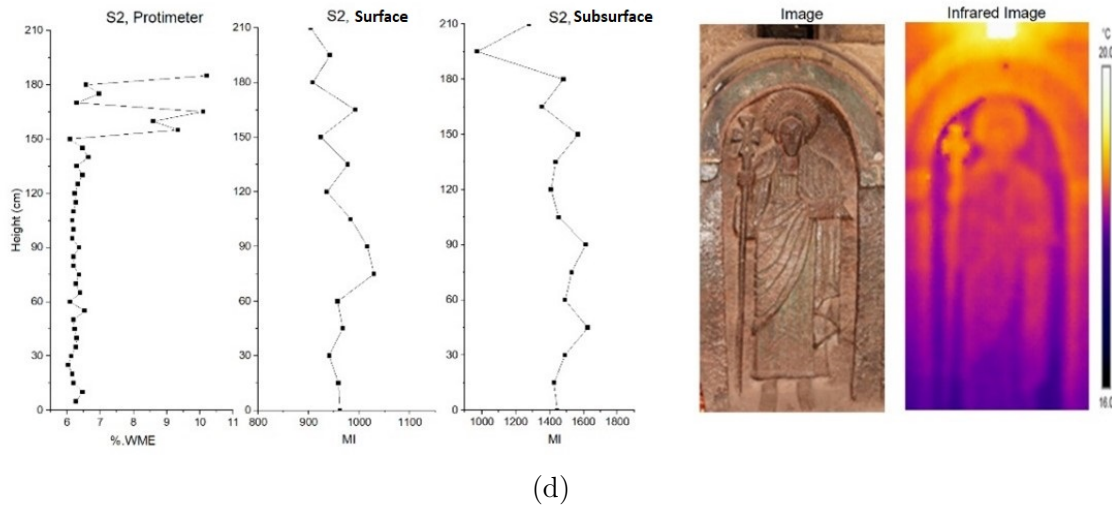
Figure 6.9: Moisture measurement results of bas-reliefs (from left) Protimeter, surface (MMMS), subsurface (MMMS), Image and IRT results of (a) N1; (b) N2; (c) S1; and (d) S2.

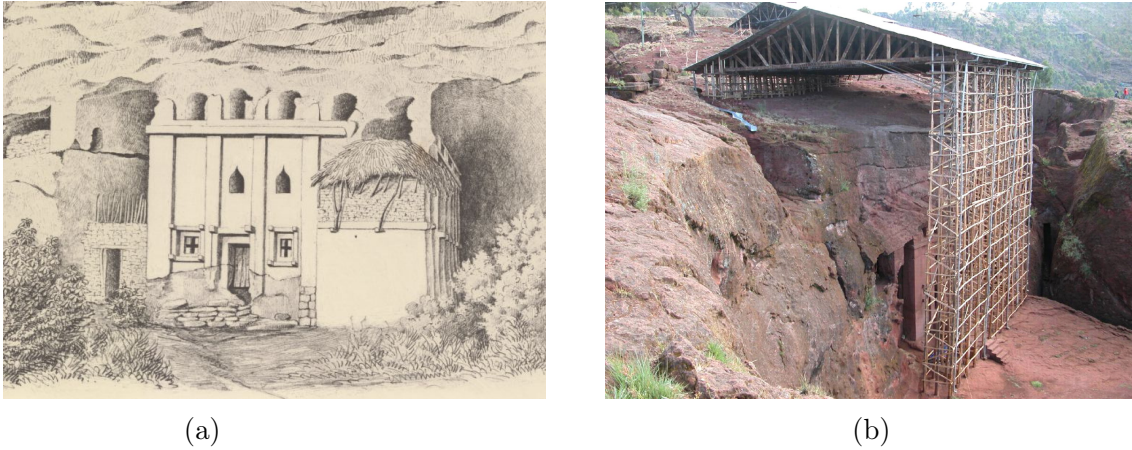
Figure 7.2: Bete Aba Libanos a) drawing showing thatched shelter in 1882 (Raffray, 1882 p.PL.17); b) photo of temporary shelter in 2010 (Delmonaco et al., 2010 p.15); c) photo of open shelter at Bete Aba Libanos in 2019

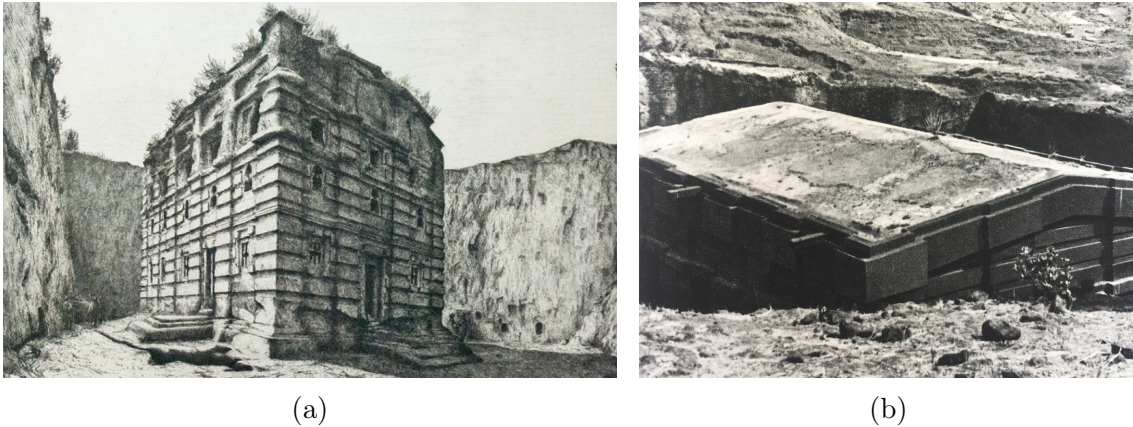
Figure 7.3: Bete Amanuel in a) drawing showing natural soft capping in 1940 (Manzato, 1988, p.56) and b) hard capped roof of Bete Amanuel in 1959 (Bidder, 1959, p.22)

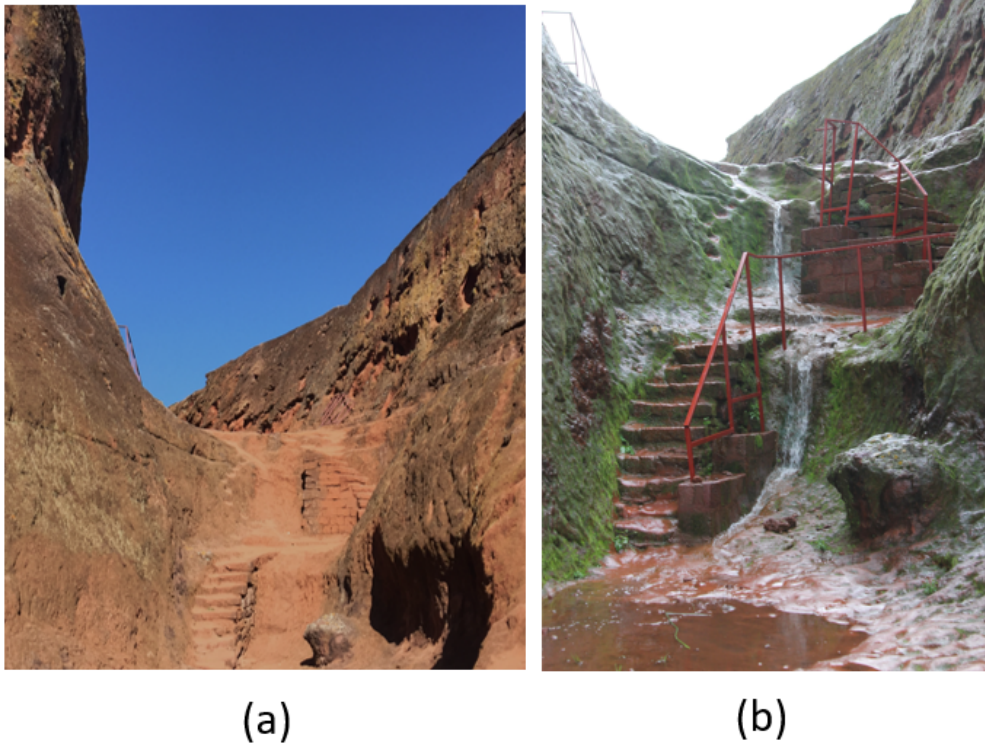
Figure 8.1: Image of trench that leads from Bete Amanuel to Bete Aba Libanos taken in (a) Dec 2018 (Bega) and (b) July 2019 (Kiremt). During Kiremt small the trench that is used as a foot path become a drainage channel. *Source: Author's own*

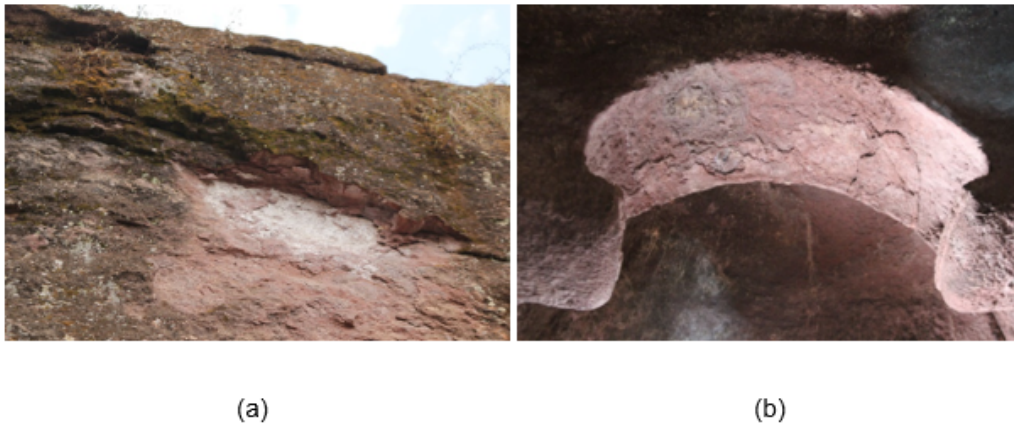
Figure 8.3: Contour scaling on (a) a trench wall Bete Aba Libnos and (b) in the interior Bete Gabriel Rufael

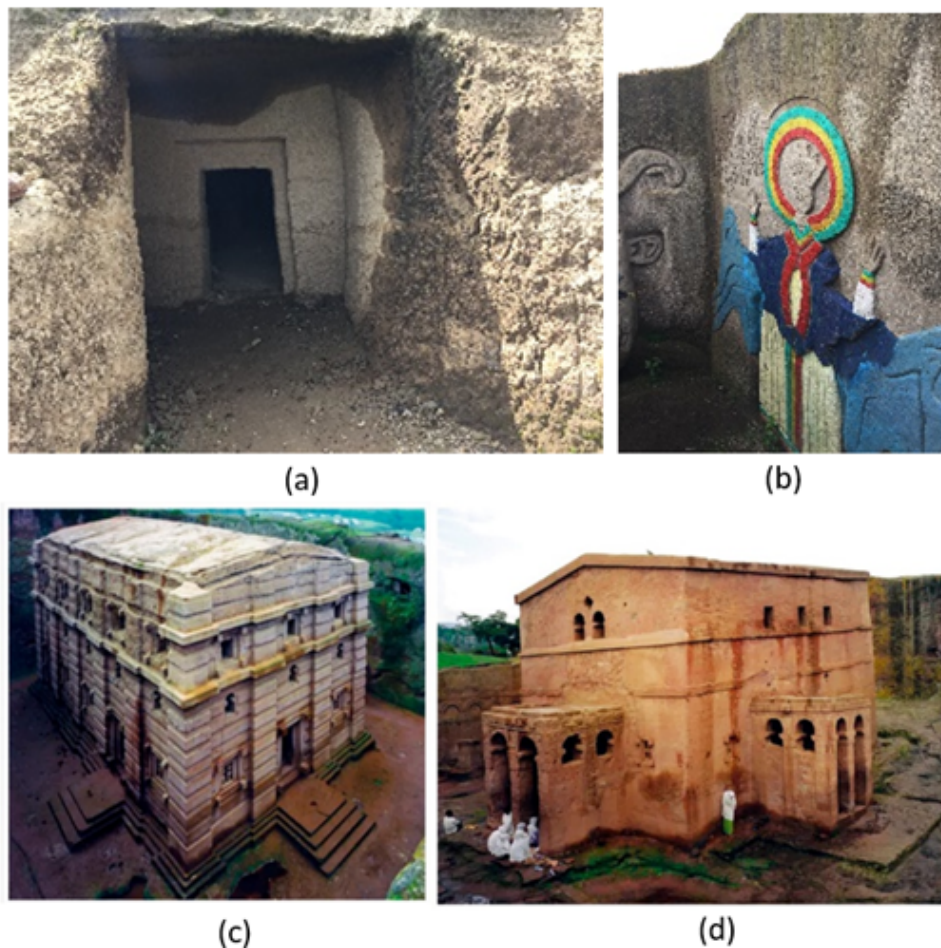
Figure 8.4: Images of newly built rock-cut churches (a) Debre Tsion and (b) Dagmawi Lalibela, and churches at Lalibela (c) Bete Amanuel and (d) Bete Miriam taken during the rainy season. The darker areas on the top and bottom images indicate areas that are wet. *Source of images c and d: Woldeyes, 2019*

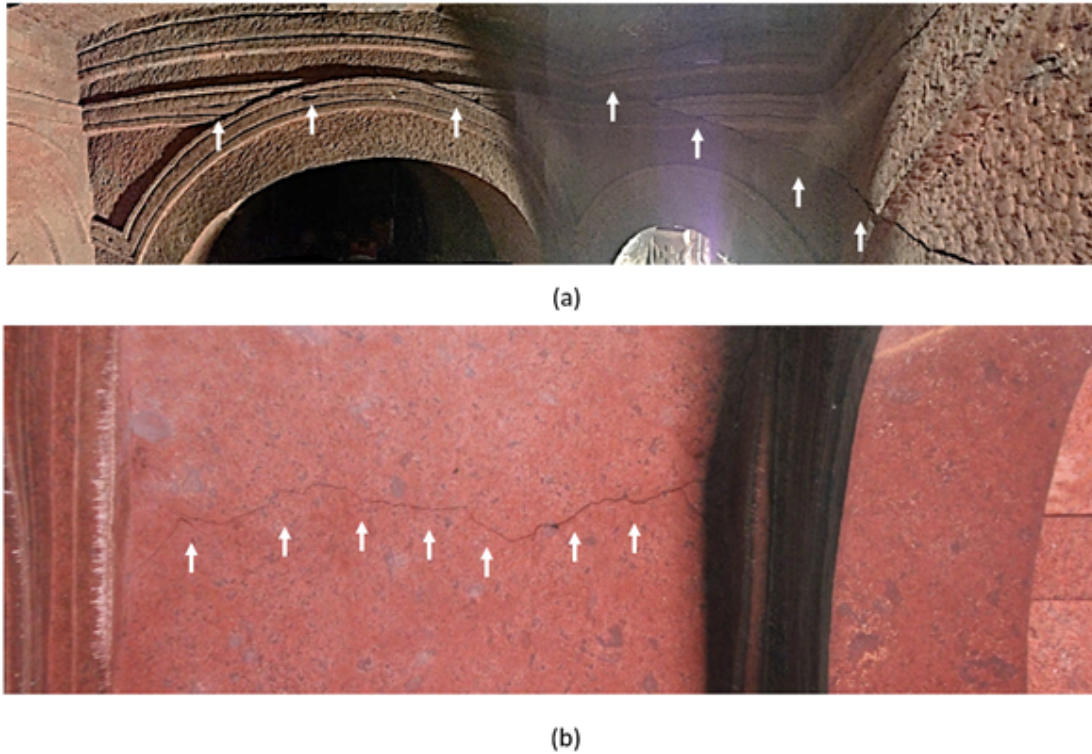
Figure 8.6: Cracks on on the ceiling of (a) Bete Mikael and (b) Bete Giyorgis. White arrows pointing to cracks.

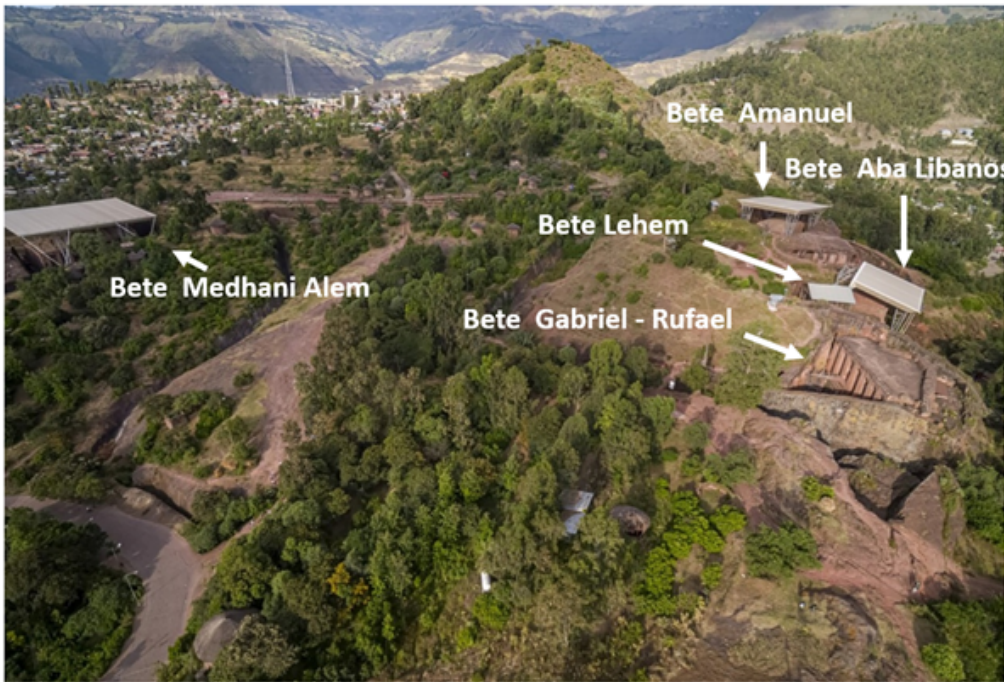
Figure 8.8: Aerial view of the churches showing how the shelters disturb the cultural landscape. *Source: Archeovision 2019*

ohannes, 2014). Another disadvantage of the shelters is that they severely disrupt the cultural landscape of Lalibela (see Fig 8.8). In chapter 7, soft capping (green roofing) was identified as a traditional conservation method that could be improved for future use in Lalibela. There are several advantages to applying soft capping. It is cost-effective and shields the roof from rain infiltration and insolation. It would require maintenance to prevent roots from entering the rock substrate and managing

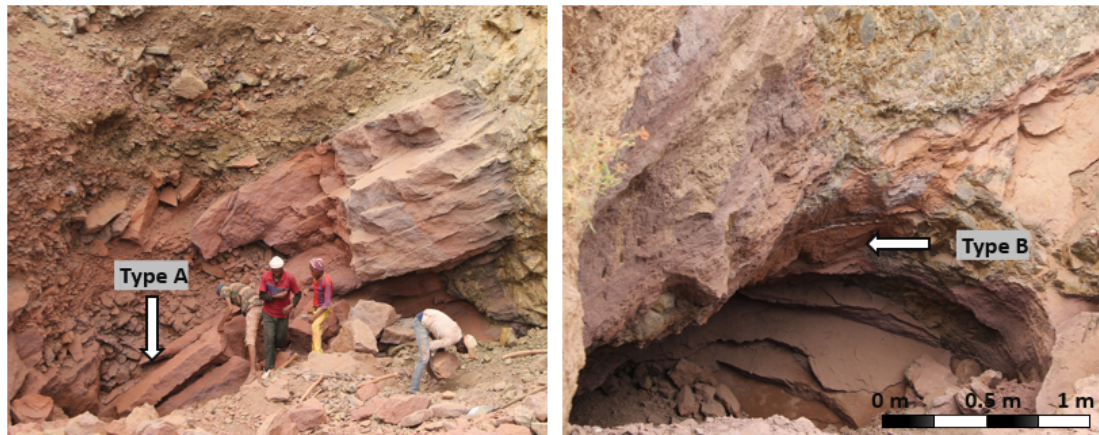
Rock outcrop from which samples Type A and Type B were extracted. Yohannes Amba quarry located near the church complex in Lalibela.
