# TEM crack tip investigations of SCC

Department of Materials Science  
University of Oxford

Thesis submitted for the Degree of Doctor of Philosophy

Michaelmas Term 2002

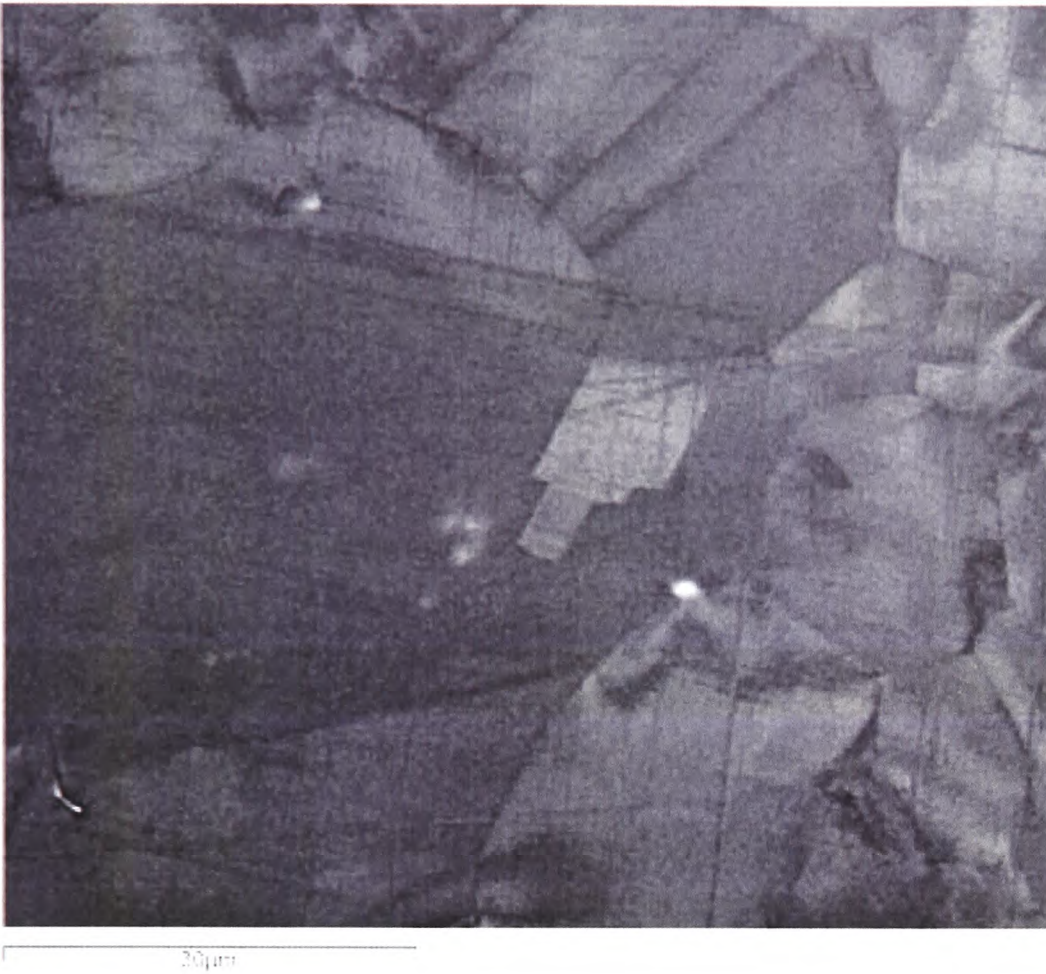
*Fig. 3.5. SEM BS picture of a polished x-section of Alloy 600 (acquired in the JSM 6300 in Topo mode).*

In Fig. 3.5, a typical BSE image acquired from a polished x-sectional surface in Alloy 600 can be observed. This image was acquired to reveal the grain structure of the sample without etching.
