# In-Service Oxidation and Microstructural Evolution of a Nickel Superalloy in a Formula 1 Car Exhaust

**Abstract** The oxidation response and microstructural evolution of an Inconel 625 alloy exhaust manifold exposed to an automobile racing environment has been examined using a range of advanced electron microscopy-based techniques, atom probe tomography and high-sensitivity laser ablation mass spectrometry. The dynamic, corrosive gas conditions result in accelerated oxidation, with the inner exhaust surface also heavily contaminated by multiple species including Zn, P, K and Na. Nb carbides and Ti nitrides identified in stock control samples evolve into mixed (Ti, Nb)N species during exposure, decorated by smaller Mo, Si-rich precipitates. The exposed alloy component therefore reveals unique surface and sub-surface features following in-service use.

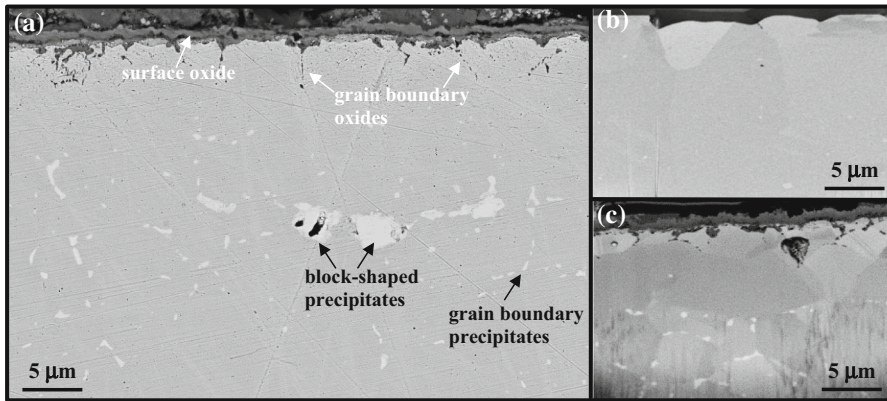
Figure 1a shows a low-magnification backscattered electron (BSE) image of a cross section through the oxidised inner exhaust surface. The surface oxide is visible, penetrating into the alloy, particularly along grain boundaries. Below a featureless precipitate-free zone roughly 7–8  $\mu\text{m}$  deep, a number of other phases can be seen. Most of these are small (<1  $\mu\text{m}$  dia.), along with less common instances of noticeably larger ( $\sim 3$   $\mu\text{m}$ ) block-shaped precipitates. The BSE image of Fig. 1b was taken from an unused section of Inconel 625 for comparison. This cross section was prepared by FIB machining and shows an oxide-free microstructure, with only a few of the larger bulk precipitates. Figure 1c is an equivalent BSE image from a FIB-machined cross section of the oxidised inner exhaust. The clear contrast between grains demonstrates that the smaller precipitates are almost exclusively located at grain boundaries. A large (2–3  $\mu\text{m}$ ) void in the alloy is also located near the surface (see supporting movie).

**Fig. 1** SEM cross-sectional micrographs of Inconel 625 exhaust: **a** BSE image of oxidised inner surface, showing surface oxide scale, grain boundary oxide inclusions and subsurface precipitates, **b** BSE image of FIB-sliced unused exhaust, **c** BSE image of FIB-sliced oxidised inner exhaust surface showing surface oxide, a near-surface void and precipitates located at grain boundaries (FIB-slicing movie available as supporting information)

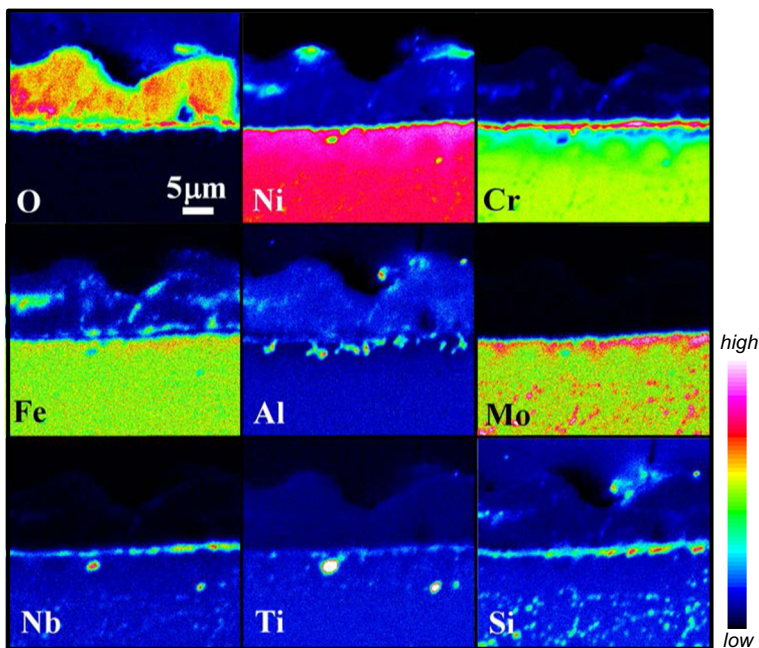
EPMA analysis was conducted on cross sections of both the inner and outer exhaust surfaces to explore elemental distributions. Figure 2 shows EPMA maps from the inner surface.

The oxide layer is approximately 10–15  $\mu\text{m}$  thick, containing regions locally rich in many of the alloying elements. Below the thicker, outermost oxide layer, a thin Cr-enriched layer is present, beneath this a Si-rich layer and then discrete Al-rich regions protrude into the bulk. The latter correlate with the dark imaging regions in Fig. 1. Deeper below the surface, there are isolated Nb, Ti-rich particles, and numerous smaller Mo, Si-rich features which correlate with the lighter-imaging regions in the SEM images at the grain boundaries. The Mo, Si-rich features in particular lie under the precipitate-depleted zone.

**Fig. 2** EPMA elemental maps from exhaust inner surface

An additional fate for Si is to migrate towards the oxide–metal interface, as shown in the EPMA maps (Figs. 2, 3) forming near-continuous layers under the chromia scale. Si has been shown to promote the formation of continuous, stable scales of chromia, alumina or (when present in sufficient quantities) silica. The APT data shown in Fig. 5b confirm that silicon oxides are indeed forming, even if only at levels detectable using sub-nm resolution. All of these scales are more protective than the transient oxides that would otherwise form [39], underlining the benefits to oxidation resistance [36–38] and the need for further dedicated studies on the effect of Si content.

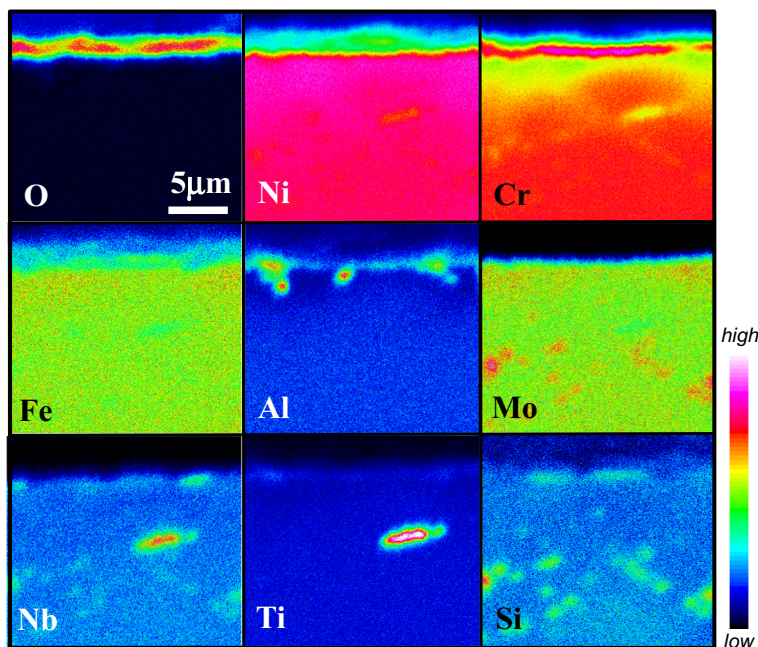
The maps for the exhaust outer surface are shown in Fig. 3. A thinner surface oxide is apparent from the oxygen map, only 2–3  $\mu\text{m}$  thick. At the base of the oxide is a Cr-rich layer; beneath this there are isolated Al- and Nb, Ti-rich features. The microstructure below the oxide is thus very similar to that of the inner surface,

although with only slight Si enrichment beneath the oxide, and Mo, Si-rich precipitates decorating the grain boundaries in multiple locations some  $\sim 5\text{--}6\text{ }\mu\text{m}$  below the surface.

**Fig. 3** EPMA elemental maps from exhaust outer surface

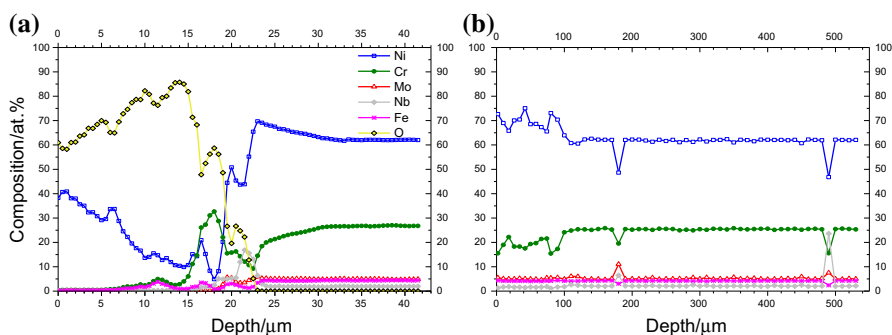
To complement the maps, semiquantitative point profile scans were conducted over the same near-surface region mapped in Fig. 2, and also in a separate scan deeper below the surface. Both of these are shown in Fig. 4.

In the near-surface scan of Fig. 4a, a continuous Cr oxide layer,  $\sim 5 \mu\text{m}$  thick, is clearly identifiable under the main oxide layer. Below it lies a Cr-depleted region, indicative of Cr movement to the surface from the bulk. The levels of Mo and Fe appear constant, but within the Cr-depleted region strong Nb enrichment is seen; the bulk content is only 2 at.% but peaks at  $\sim 30$  at.% here. The deeper scan in Fig. 4b carried out on separate EPMA instrument commences within the Cr-depleted

**Fig. 4** EPMA point profiles **a** through inner exhaust oxide–metal interface, **b** into bulk

region. Importantly, there is good agreement between the alloy compositions determined by both instruments away from the samples surfaces. Of more interest in Fig. 4b is the presence of two isolated points, one where the composition deviates markedly towards strong enrichment of Mo and another Nb; at  $\sim 0.5$  mm below the surface, one spot analysis contains  $\sim 25$  at.% Nb. These again correspond closely with similar features visible in the maps, highlighting that they penetrate to a considerable depth below the alloy surface. A detailed examination of these specific features is presented in the following sections.

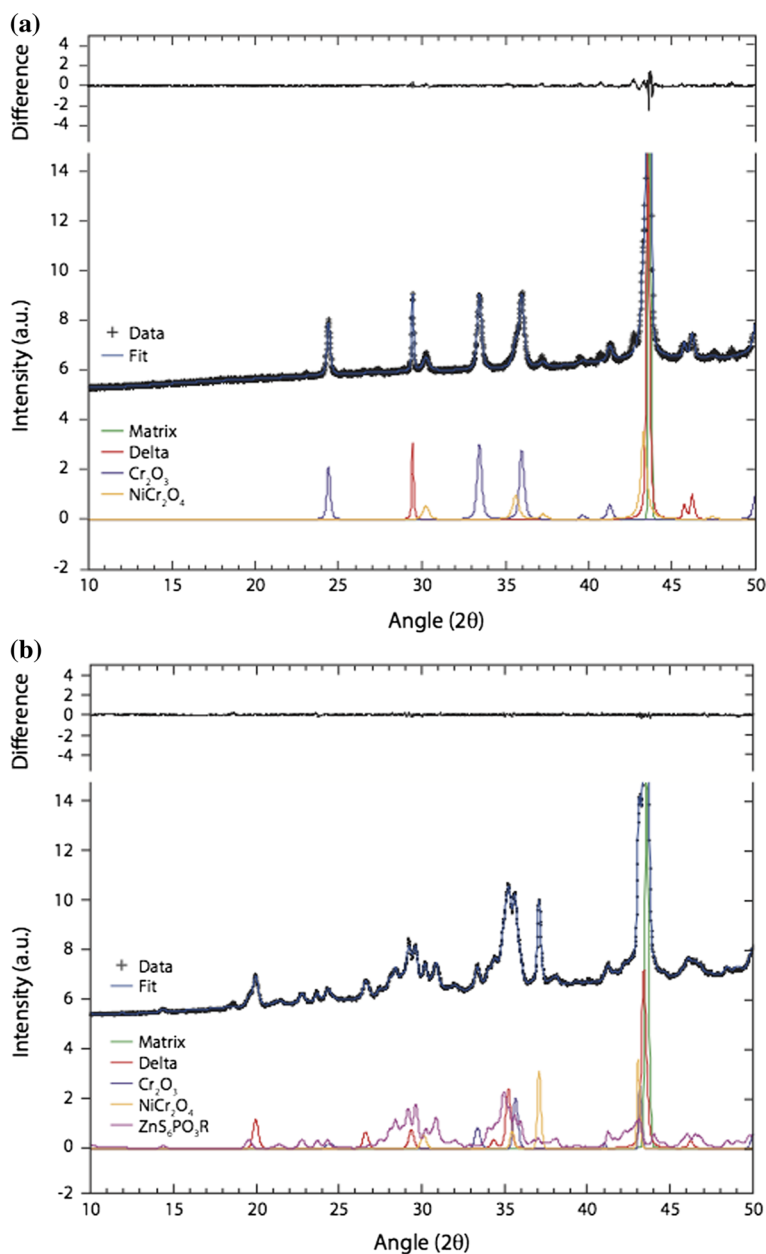
X-ray diffractograms of the inner and outer exhaust surfaces are shown in Fig. 5a, b, respectively. The presence of the bulk  $\alpha$  phase nickel matrix and a small fraction of the orthorhombic  $\delta$  phase were confirmed in both scans, as well as  $\text{Cr}_2\text{O}_3$  oxide and  $\text{NiCr}_2\text{O}_4$  spinel. The inner exhaust surface was, however, shown to contain a phase which was identified as  $\text{ZnS}_6\text{PO}_3\text{R}$ , with R consisting of different alkyl groups, in this instance  $\text{C}_{39}\text{H}_{29}$ . Contamination on the exhaust inner surface will be further discussed in the following section.

**Fig. 5** Experimental X-ray diffractograms and associated fits from **a** the outer exhaust surface and **b** the inner exhaust surface

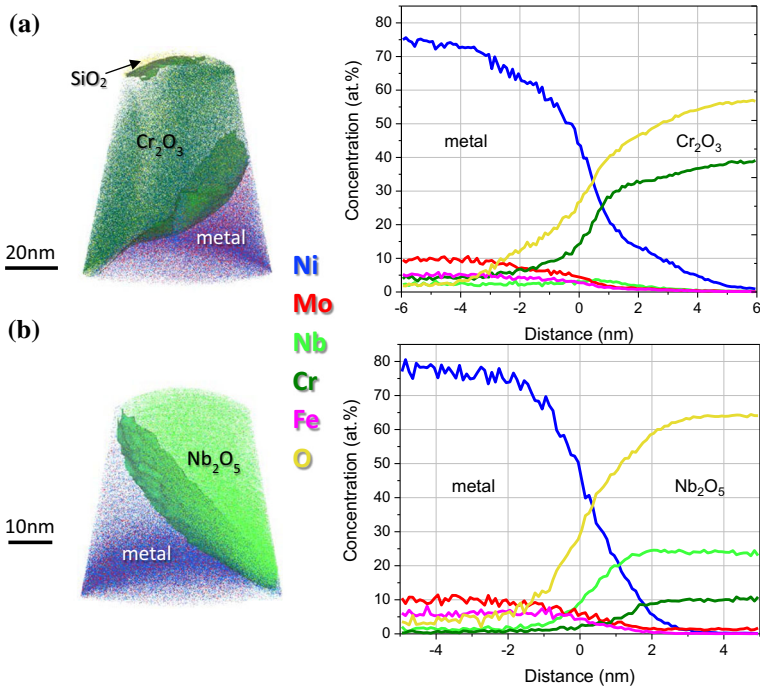
The APT data sets reveal a number of fine-scale features at these interfaces. Firstly, Fig. 6a shows a Cr- and O-rich region directly above the metal; by examination of the proximity histogram, the stoichiometry approaches a 2:3 metal/oxygen ratio, as expected for a protective chromia layer. The interfacial region is approximately 8 nm thick in total. Only trace levels of Al and Ti (1.7 and 1.1%, respectively) are otherwise located in this oxide layer, while there also is a small region consisting solely of Si and O (1:2 ratio) at the top of the atom map.

The EPMA maps of Figs. 2 and 3 suggest that a discontinuous, localised Nb-rich phase is sometimes present beneath the chromia scale. The second APT analysis clearly backs this up, with the atom map in Fig. 6a showing an oxide that contains more Nb than Cr. The Nb/O ratio is close to 2:5, indicating formation of the stable oxide  $\text{Nb}_2\text{O}_5$ . This oxide is not as pure as the chromia layer, however, containing 11.8% Cr along with trace levels of Mo and Ni (0.8 and 0.7%, respectively).

**Fig. 6** APT reconstructions of oxide–metal interfaces showing atom maps and associated proximity histograms through **a** Cr<sub>2</sub>O<sub>3</sub>–metal and **b** Nb<sub>2</sub>O<sub>5</sub>–metal interfaces

**Table 2** APT-derived compositions of Inconel 625, from an unused strip sample, and from the two metal regions identified in the atom maps of Fig. 6

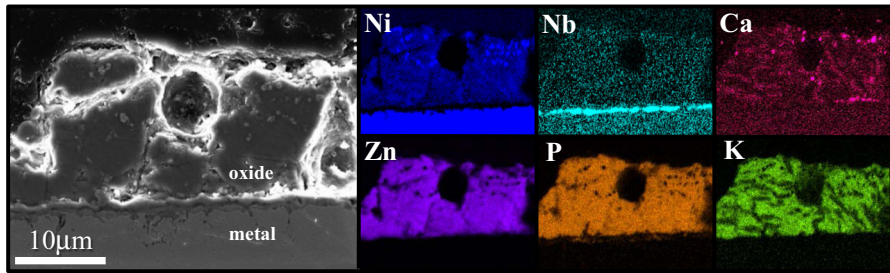
Figure 7 underlines the inhomogeneous nature of the oxide; the brightly imaging features in the SE image are shown as Ni rich in the associated EDX map, while contamination by Zn, P and K is more evenly distributed throughout. Ca, in

**Fig. 7** SE image and EDX elemental maps of contaminant species from exhaust inner surface (Ni, Nb, Zn signals from  $L_{\alpha}$  X-ray emission lines, Ca, P, K from  $K_{\alpha}$  X-ray emission lines)

contrast, is scattered in regions of the oxide. Trace levels of Na, Cu and Mg were also detected by EDX. The Nb-rich layer, which demarcates the oxide–metal interface, shows that all contaminants appear confined to the oxide. Within the oxide itself, EDX line scans confirmed that Zn, P and K were the three main contaminants (comprising around 30 at.% of the oxide). A significant fraction of the inner surface scale is therefore non-alloy species, which confirms the X-ray diffraction results shown in Fig. 5. Within the bulk, all three elements combined make up <1 at.% of the total composition.

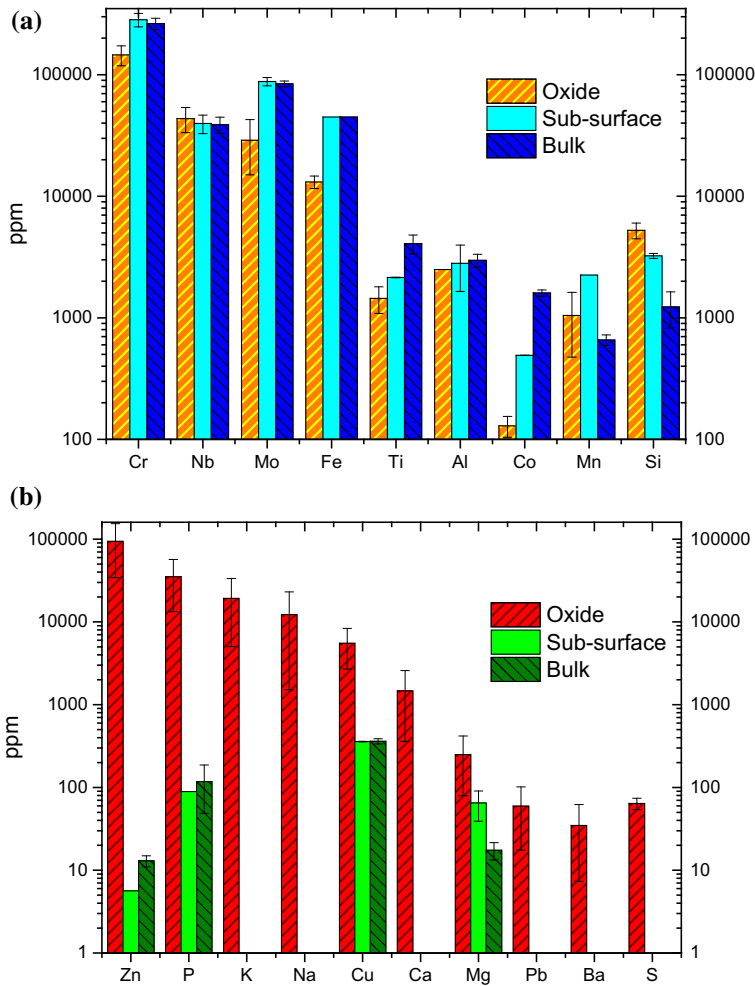
Figure 8a shows that all alloying species are present in the oxide. For major elements, there is approximately half as much Cr and Mo in the oxide compared to the subsurface/bulk. Comparing the subsurface metal region with that of the bulk sample, there is less Ti near the oxide, which may be indicative of this element being caught up in other phases. The minor element, Co, is also depleted leading up to the oxide. It is possible that the relative thermodynamic volatility of Co oxide accounts for its loss [6]. The enrichment of Si near/inside the oxide scale should also be noted, consistent with the EPMA data of Fig. 2 and prior spectroscopic measurements [8].

The contaminants identified in the same three regions are shown in Fig. 8b. Within the oxide, ten contaminants were identified on the inner exhaust surface, underlining the range of species present in the gas stream. The major one found is Zn, over 9 at.% in the oxide, and then in decreasing order (all at.%): P (3.5%), K (2%), Na (1%), Cu (0.5%), Ca (0.1%). Phosphorus was present as a trace element ( $\sim 100$  ppm) in the base alloy, but these results suggest that it has migrated towards the surface deposit. In addition, Zn, P and K seem to be mostly involved in nickel dissolution from the substrate, rather than chromium. There is also approximately 250 ppm Mg, and sub-100 ppm levels of are Pb, Ba and S present. The relative

**Fig. 8** LA-ICPMS analyses of oxide, near-surface and bulk regions from the inner exhaust surface for **a** Inconel 625 elements and **b** detected contaminants. Note log<sub>10</sub> scale on both y-axes

amounts of the main contaminants detected in the oxide are thus in good agreement with those seen by EDX. In the subsurface region and even in the unused bulk control sample, trace levels of Cu (350 ppm), along with sub-100 ppm levels of Zn, P and Mg, were also identified, indicating possible introduction of these species during alloy production.

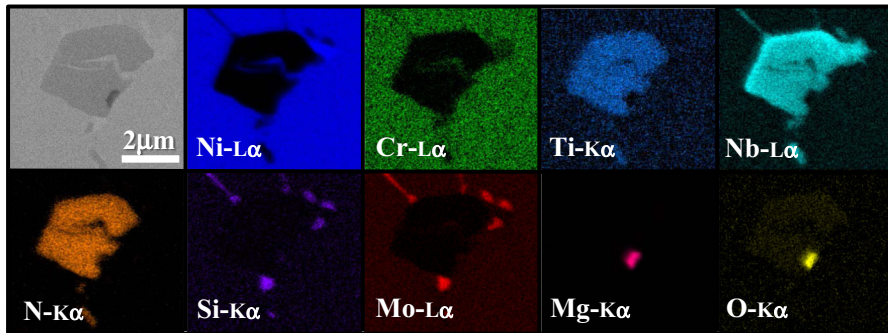
Below the oxide–metal interface, within the bulk, the microstructure contains a number of large blocky precipitates. An SEM–EDX examination of a region containing one such typical precipitate is shown in Fig. 9.

**Fig. 9** EDX elemental maps of a bulk subsurface precipitate in the oxidised alloy

The BSE images show they are partially fragmented, with distinct cracks suggesting they were originally present during alloy sheet processing. They are depleted in Ni and Cr with respect to the matrix and strongly enriched in Ti, N and Nb. These are therefore likely to be (Ti, Nb) nitrides. The perimeters of both the particles shown in Fig. 9 are populated by smaller precipitates of two types: one rich in Mo, Si and containing minor levels of Nb and the other (Nb map in the top right corner of Fig. 9) enriched in Ni and Nb, most likely  $\delta$  phase. A fourth precipitate type is also present, imaging darkest in the BSE images at the interface between the (Ti, Nb) nitrides and the matrix. From the elemental maps, these are nanoscale MgO particles.

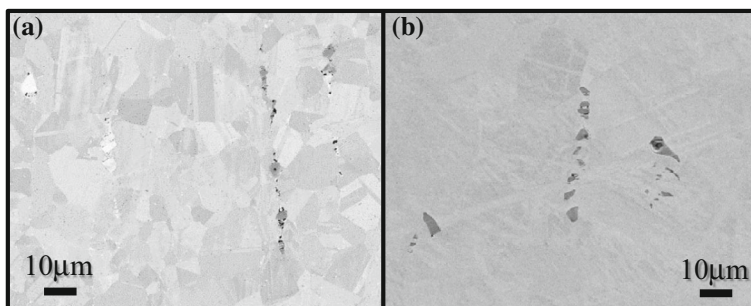
To clarify the origins of the identified phases, unused control sections of Inconel 625 were also examined. Figure 10 compares two low-magnification BSE images from the bulk regions of (a) the oxidised exhaust and (b) unused material. In both, distinct nitride features are apparent, which appear cracked and mainly arranged in bands.

**Fig. 10** BSE images from central regions of **a** oxidised and **b** unused alloy, showing bands of nitrides in both

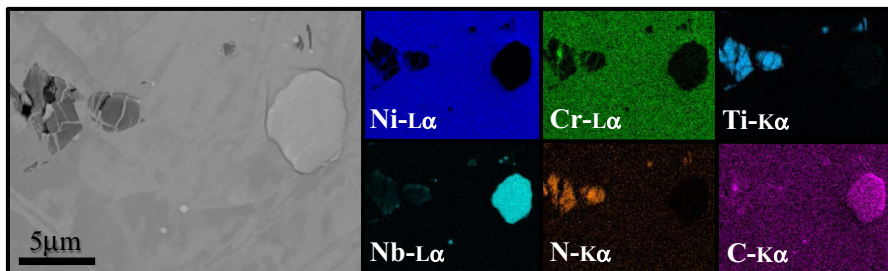
precipitates was seen in the unused material, indicating these are likely to have formed during exposure. The second difference is illustrated in Fig. 11; Nb-based carbides are also routinely observed in the unused material. Semiquantitative EDX analysis indicates an approximate composition of 41Nb–55C–4Ti, consistent with MC-type carbides [21]. Additionally, the nitrides at this stage mainly contain only Ti as metallic species present (Fig. 11), rather than the mixture of Ti, Nb observed in the exposed alloy, indicating the exact nitride composition is variable and dependent on the exposure history.

**Fig. 11** EDX maps of nitride (*left*) and carbide (*right*) particles present in unused alloy

The larger blocky precipitates in the unused alloy are Nb-based MC carbides, which are known to precipitate from the solidification process [21]. While much less work has been done to fully understand the role of nitrogen in superalloys, TiN is a stable nitride [34], and a recent study has shown nitrogen preferentially bonds with Ti and Nb atoms to form nitrides [18]. In the current work, the exposure appears to cause dissolution of the Nb-based MC carbides, which have been previously thought

very difficult to remove by processing [21]. The released Nb appears to be absorbed by preexisting Ti nitrides to form mixed (Ti, Nb)N species. These preexisting nitrides likely form in the liquid alloy during cooling, becoming aligned into bands during sheet rolling of the metal. The generation of brittle, blocky, incoherent precipitate bands during rolling can locally concentrate applied stresses, acting as favourable crack nucleation sites and increasing the effect of thermal stresses (reducing ductility) perpendicular to the loading direction [21]. Controlling the levels of nitrogen introduced during processing, the extent of initial NbC formation or even slightly reducing the amount of Nb may prevent these forming and give better mechanical properties, increasing the short operational lifetime of the exhaust manifolds. Even reductions in Nb of <0.5 wt% have been shown to significantly extend the time before the alloy starts to embrittle at high temperatures [40]. Therefore, small adjustments in the concentration of Nb present in the alloy may prove highly effective in specific applications.
