In-situ observation of compression damage in a 3D braided carbon fiber reinforced carbon and silicon carbide (C/C-SiC) ceramic composite

Short title: In-situ compression damage in a C/C-SiC composite

Abstract

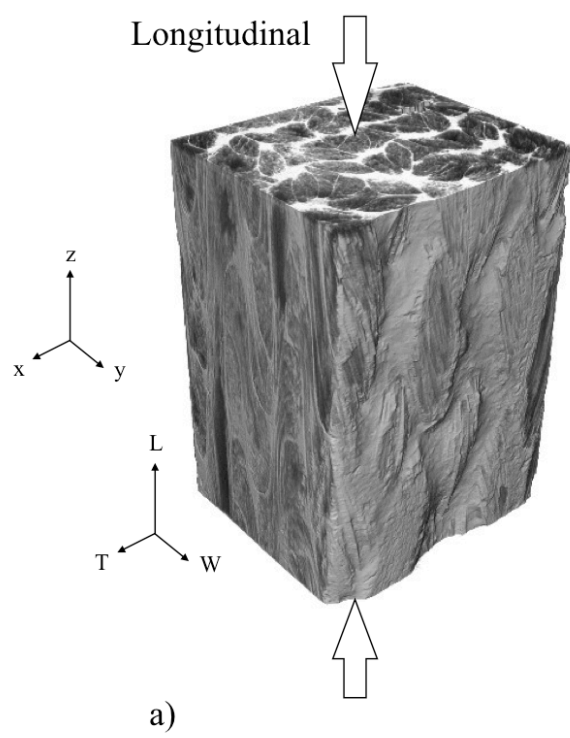
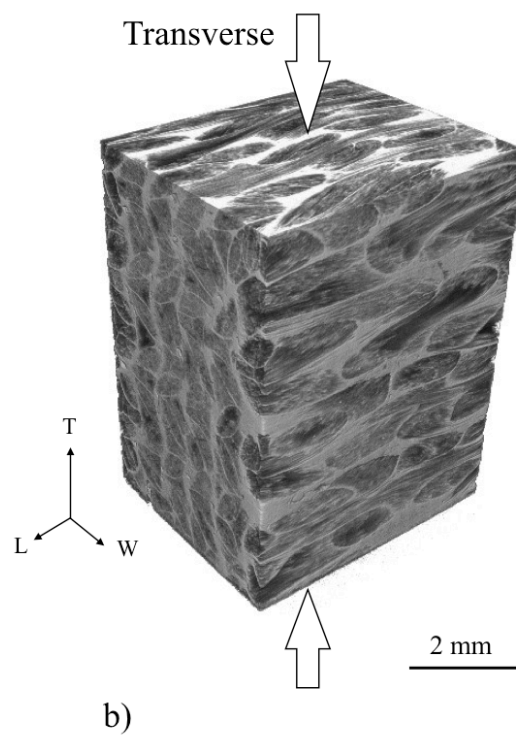
Tomographic reconstructions of the tested specimens are shown in Figure 1. The reconstructed volume is in the central part of each specimen. Due to shadowing from the loading anvils, the observed volume had a height of 7.5 mm and 7.9 mm for the longitudinal and transverse specimens respectively. The microstructure directions (L, longitudinal; W, width; T, transverse) are defined in relation to the loading and tomography coordinate space (x, y, z).

- Figure 1: Microstructures and orientations for a) longitudinal and b) transverse specimens (loaded in compression along z -axis)
- Figure 2: Visualizations of the composite material microstructure: a) tomograph cross-section; b) segmentation to identify pores, matrix and fiber tows; c) 3D pore visualization (porosity 3.5% by volume); d) matrix visualization (matrix 37.8% by volume); area fractions of pores, matrix and fibers in e) TW; f) LW; and g) LT planes with distance in the orthogonal direction.

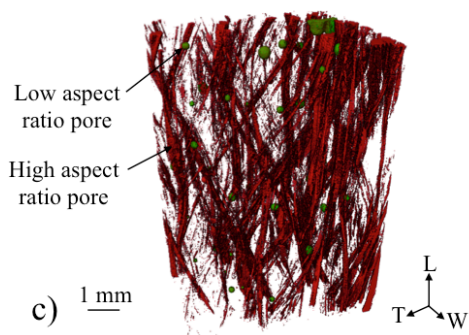
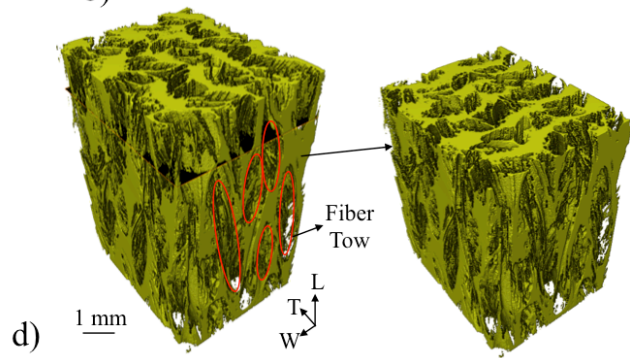
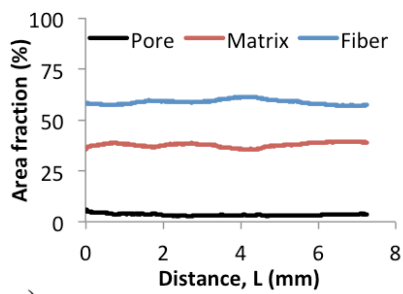
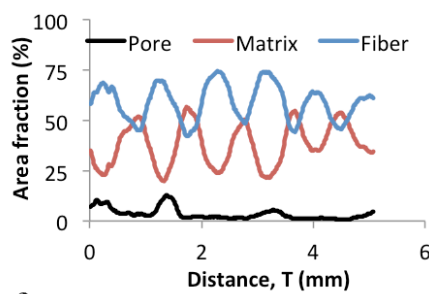
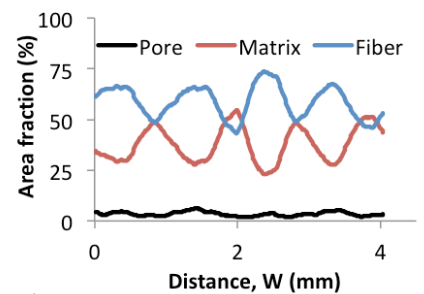
Orthogonal sections of a tomograph of the longitudinal specimen are shown in Figure 2a. Its segmentation into fibers, matrix and pores, using their relative X-ray attenuation (i.e. grey levels), is shown in Figure 2b; green represents fiber, yellow represents matrix, and red represents pores. The regions between the fibers are mostly filled with matrix, and both high aspect ratio and low aspect ratio pores are observed. The high aspect ratio intra-bundle pores are aligned along the fiber bundle length, while the low aspect ratio pores are distributed in the matrix. Volume visualizations of the porosity and matrix (Figure 2c and Figure 2d) show the alignment of the high aspect ratio pores and the continuous structure of the matrix. The area fractions of pores and matrix were measured along the orthogonal directions, in a series of 2D slices of the tomograph, using simple threshold segmentation in the ImageJ software (Schneider et al., 2012). Almost constant fractions of pores,

matrix and fiber are observed in the xy sections (i.e. along the L direction that is parallel to the fiber bundles) (Figure 2e). The weave of the fiber bundles causes large and correlated fluctuations in both the W and T directions for the matrix/fiber fractions in the xz (Figure 2f) and yz sections (Figure 2g), respectively, with a periodicity of 1 mm. The total porosity detected was 3.5%, with a matrix volume fraction of 37.8%. This compares quite well with a component analysis data of the material, following the Archimedes and gravimetric method of Nie (Nie et al., 2010), which measured 4.9% porosity (2.8% open and 2.1% closed), 53% carbon fibers and 42.1% matrix volume fraction.

The anisotropy of the braided microstructure is clearly observed in the tomographs and the quantitative analysis of the fiber/matrix distributions (Figure 2). In the longitudinal direction, the average fiber/matrix ratio is constant (i.e. $2/3$, neglecting the $\sim 5\%$ porosity), and the periodic variation of matrix to fiber ratio in the W and T directions records the same wavelength of ~ 1 mm. This is consistent with the braiding pitch of ~ 2 mm, which is the unit cell dimension of the alternating weave directions (Li et al., 2009). W and T are equivalent directions in the braided architecture, and should have equivalent properties. The non-linear relationship between the load and crosshead displacement at low loads in the longitudinal orientation (Figure 3a) might be attributed to compliance of the load train. However, it is not observed in the transverse direction for similar loads and specimen dimensions (Figure 3b). Measurements of the elastic modulus in this region have not been attempted using the crosshead displacement data, as these cannot be regarded as reliable due to the high stiffness of the specimen compared to the tomography loading rig. Nonetheless, it is interesting to note that similar non-linear behavior has been reported in longitudinal

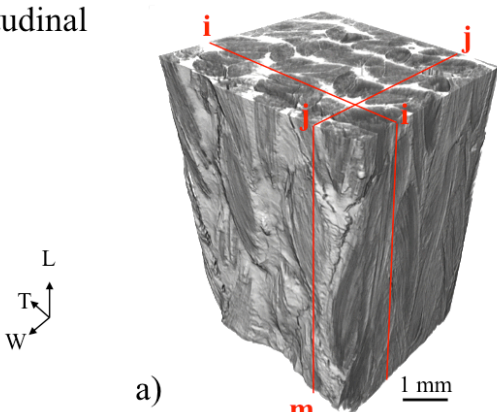
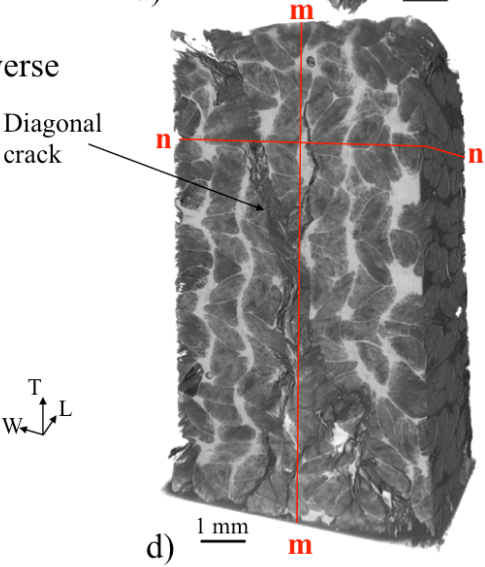
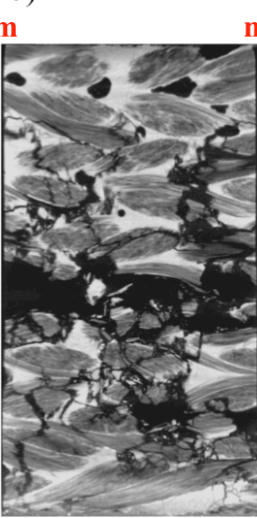
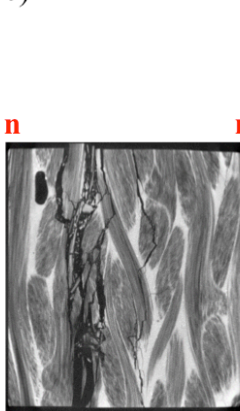
Example tomographs of the damaged specimens are shown in Figure 4. The longitudinal compressed specimen, observed at its maximum load (5000 N), is visualized in Figure 4a, with orthogonal sections presented in the LW (Figure 4b) and LT (Figure 4c) planes. It developed significant damage to one side. The transverse compression specimen developed a significant diagonal crack when it failed. This is shown in Figure 4d, with orthogonal sections (TL and WL planes) in Figure 4e and Figure 4f. The sections of the longitudinal specimen (Figure 4b and Figure 4c) show that cracks propagated mostly along the fiber bundle interfaces. In the transverse specimen

(Figure 4e and Figure 4f), significant damage from multiple fiber breakages and matrix fragmentation is observed only near the main diagonal crack; less damage is visible remote from this.

- Figure 4: Visualization of fracture paths: a) Volume rendering of longitudinal test (compression parallel to L) with b) TL and c) LW cross-sections; d) volume rendering of transverse test (compression parallel to T) with e) TL and f) LW cross-sections.

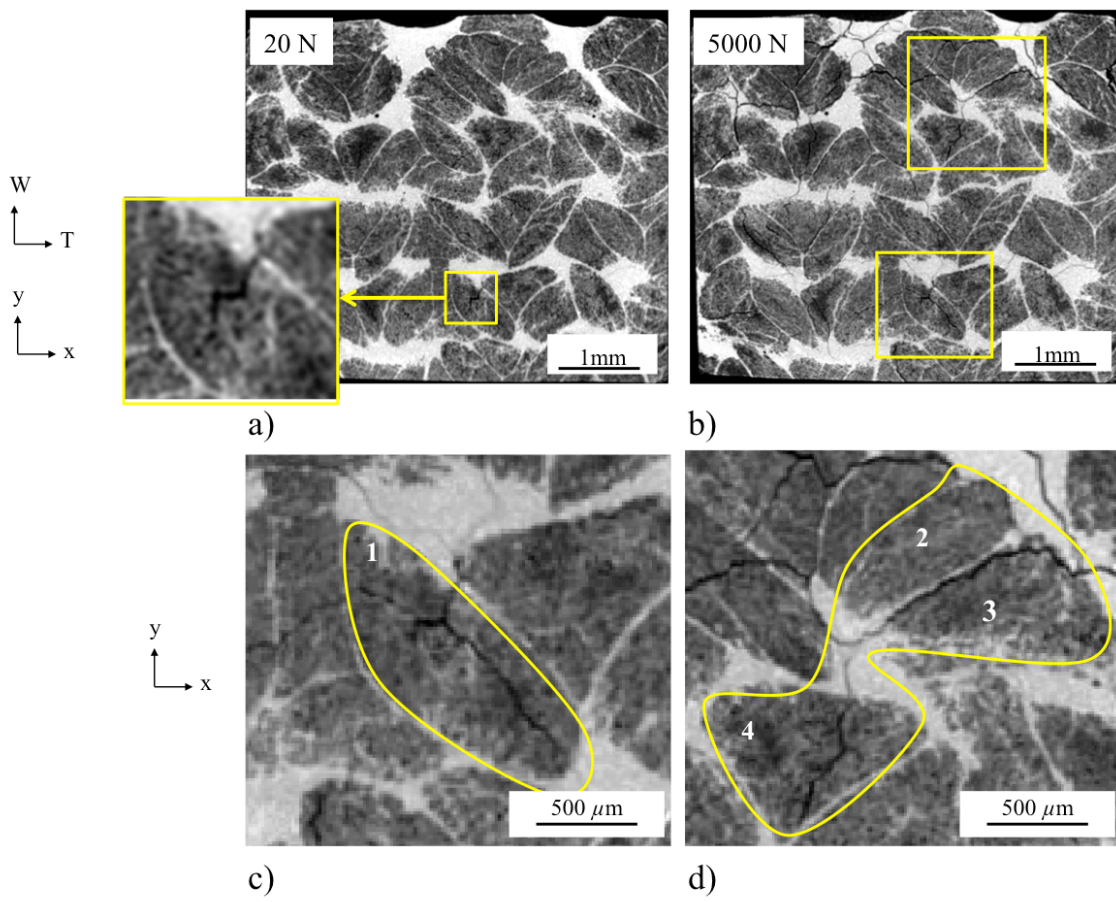
The localized nature of the damage is shown for the longitudinal compressed specimen in Figure 5a and b, which compares the same horizontal xy section (WT plane) of tomographs recorded at 20 N and 5000 N. Cracks clearly existed within the fiber bundles before loading at 20 N (Figure 5a), and by the final loading stage, these had extended beyond the fiber bundles (Figure 5c). This is illustrated by examining the progressive development of cracks in 3D, using the two examples that are identified in Figure 5b. The cracks are visualized as solid features (red), obtained by image segmentation via a greyscale threshold, and the boundaries of the fiber bundles have been manually outlined (in yellow) in the xy plane at intervals separated by $\sim 100\ \mu\text{m}$. The development of cracks at a single fiber bundle is shown in Figure 6: initially the crack existed inside the fiber bundle; but as the load increased this intra-bundle crack extended outside the bundle boundary. The development of damage in three fiber bundles is seen in Figure 7, which shows that the cracks coalesced with increasing load and propagated along the interface between the fiber bundle and matrix.

- Figure 5: Damage development in the longitudinal test, observed in the same TW plane at a) 20 N and b) 5000 N; the highlighted regions at 5000 N are magnified in c) and d). See Figure 6 for numbering.

The observation that pre-existing defects are the origins of cracks that propagate to damage the material (see Figure 6a, Figure 7a, and Figure 5a) is significant. These propagate from within the fiber bundles and coalesce in the brittle matrix. This suggests that the mechanical strength might be improved through control of these pre-existing defects. The clear effect of constraint on damage development also suggests that stitch fibers (Xie et al., 2015; Nie et al., 2008), applied in the transverse directions, might resist cracking and lead to improved strength.

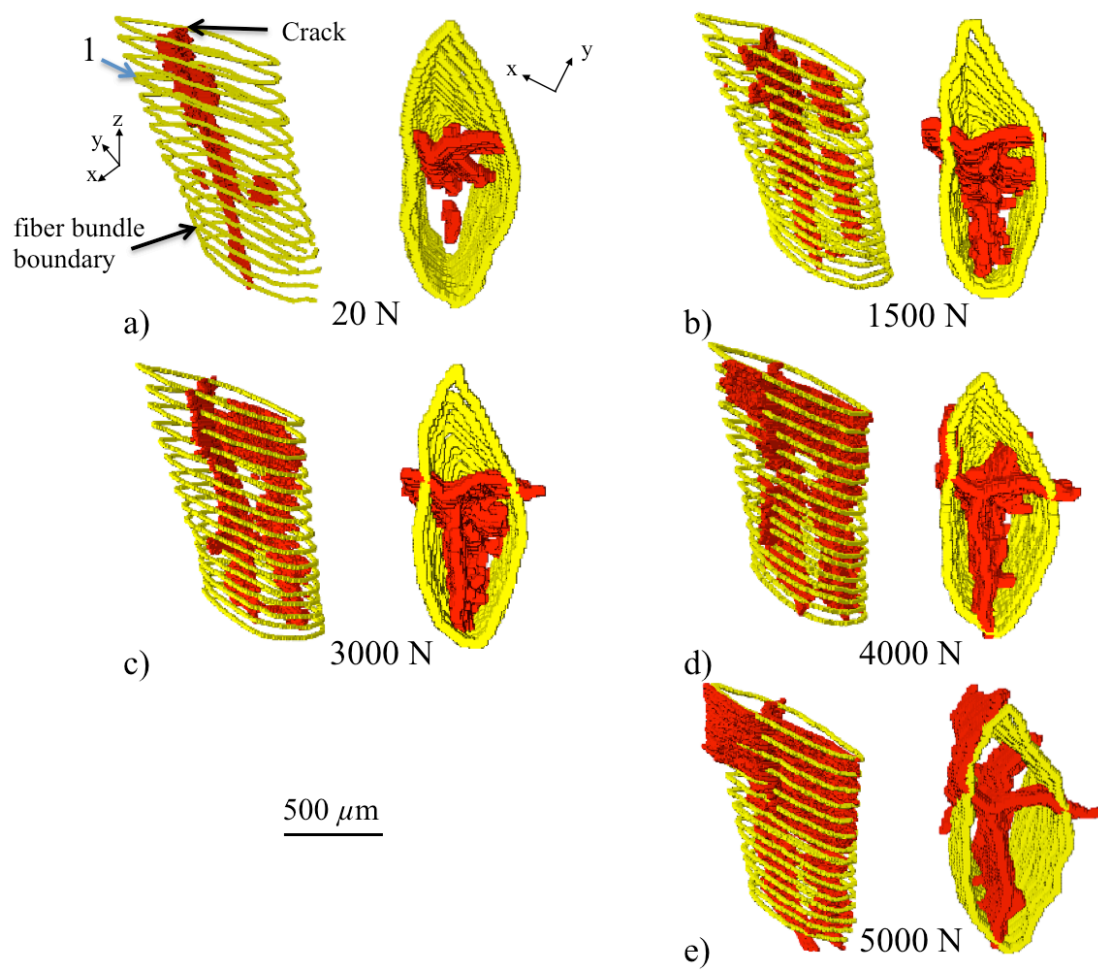
- Figure 6: 3D visualization of crack development in fiber bundle 1 (identified in Figure 5c) with increasing load: a) 20 N to e) 5000 N in the longitudinal compressed specimen.

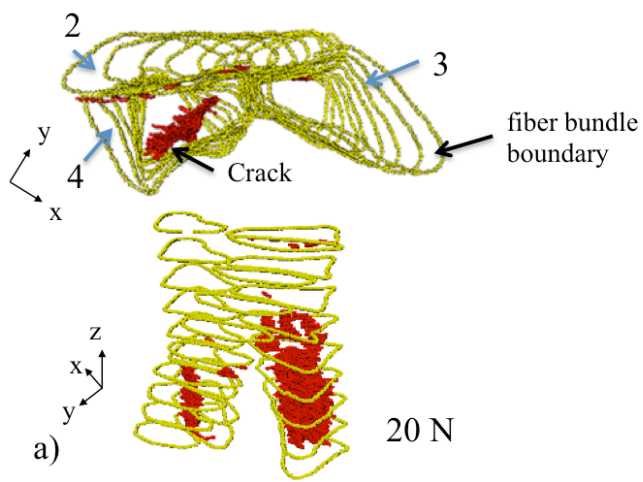
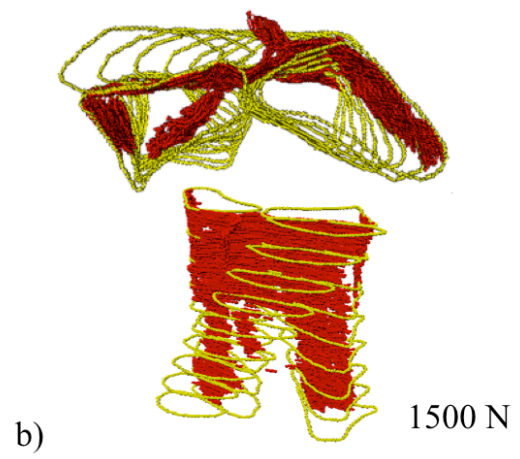
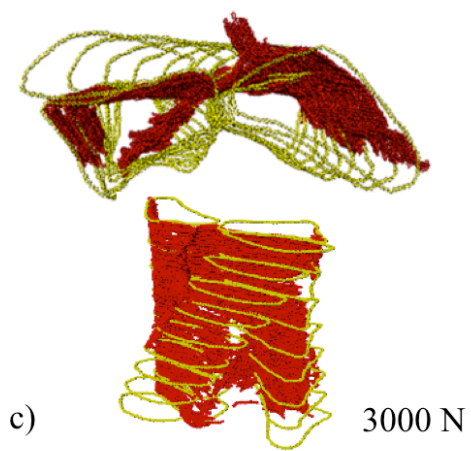
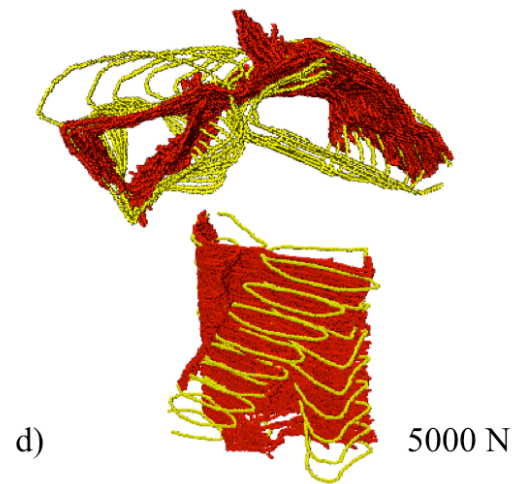
- Figure 7: 3D visualization of crack development in fiber bundles 2 to 4 (identified in Figure 5c) with increasing load: a) 20 N to d) 5000 N in the longitudinal compressed specimen.

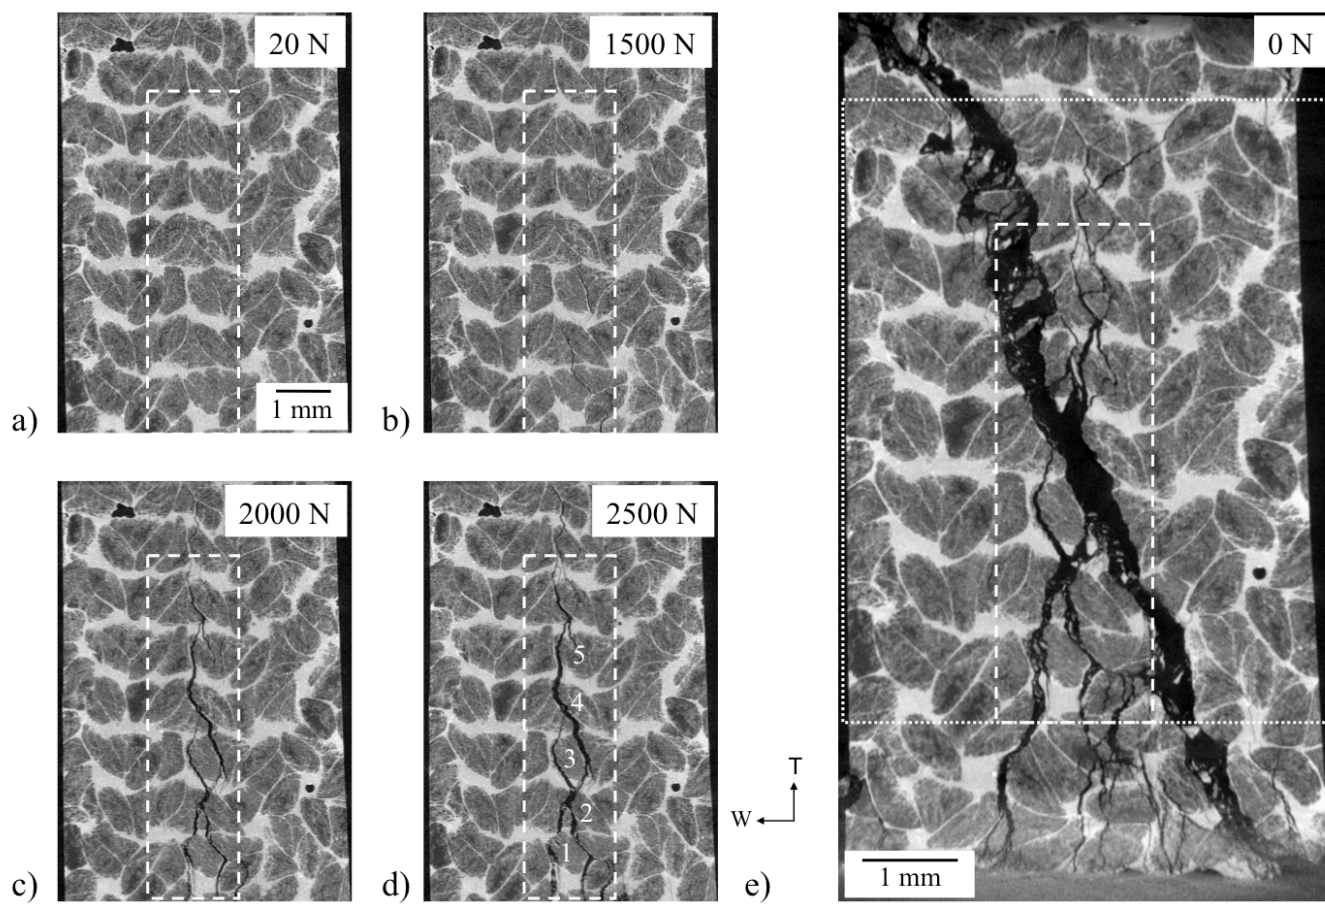
For transverse compression, Figure 8 shows sections in the same vertical yz (TW) plane of successive tomography observations. Vertical cracking, which is identified within the dashed white box in Figure 8a to d, propagated parallel to the TL plane prior to the appearance of the inclined crack (Figure 8e), which occurred at the final failure. The tomograph in Figure 8e was obtained after the specimen had been removed from the loading rig; it shows a vertical section of the whole specimen, and the white dotted box outlines the smaller region that was observed in situ during loading. The development of the vertical cracking (within the dashed box) is visualized in 3D in Figure 9 at 20 N, 1500 N and 2000 N (preload, 50 MPa and 66 MPa); the cracks are threshold segmented (red) and five fiber bundles have been outlined (yellow) in the yz plane at intervals of 100

μm. Cracking developed mainly along the interfaces between the fiber bundles and matrix, similar to the longitudinal specimen.

Figure 8: Damage development in the transverse compressed specimen (TW plane, mid-section). Regions a) to d) are observed under load, and are identified by the dotted box in e), which was observed unloaded, after failure. Five fiber bundles are labeled within a region of interest (dashed box) for reference in Figure 9.

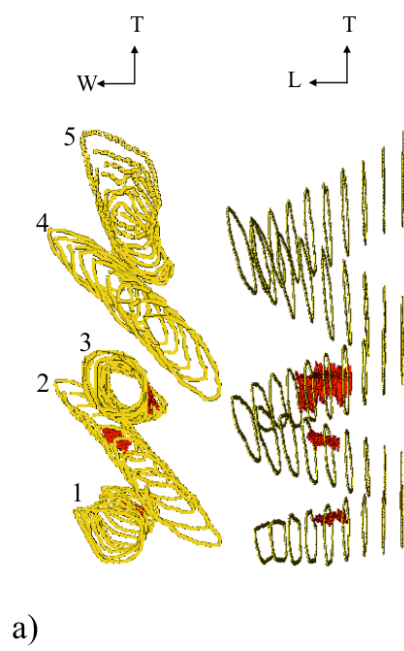
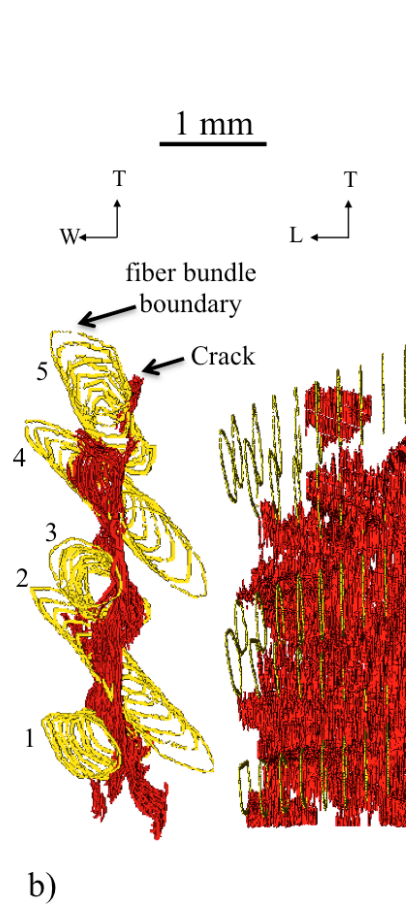
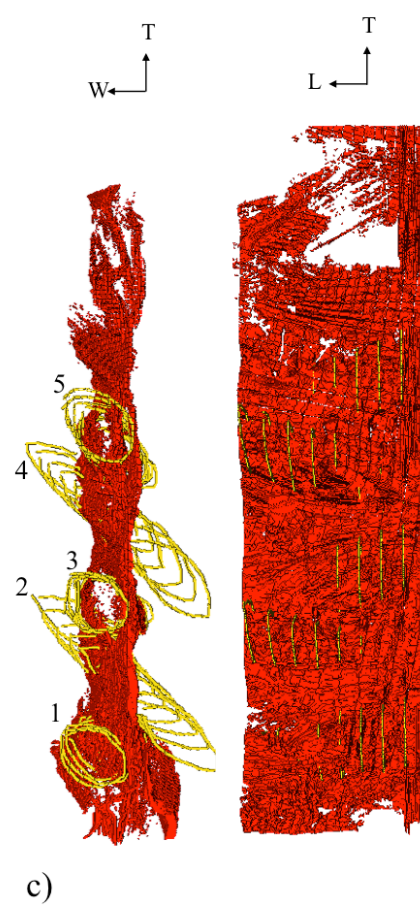
Figure 9: 3D visualization of crack development in fiber bundles 1 to 5 (identified in Figure 8d) with increasing load: a) 20 N; b) 1500 N; and c) 2000 N in the transverse compressed specimen.

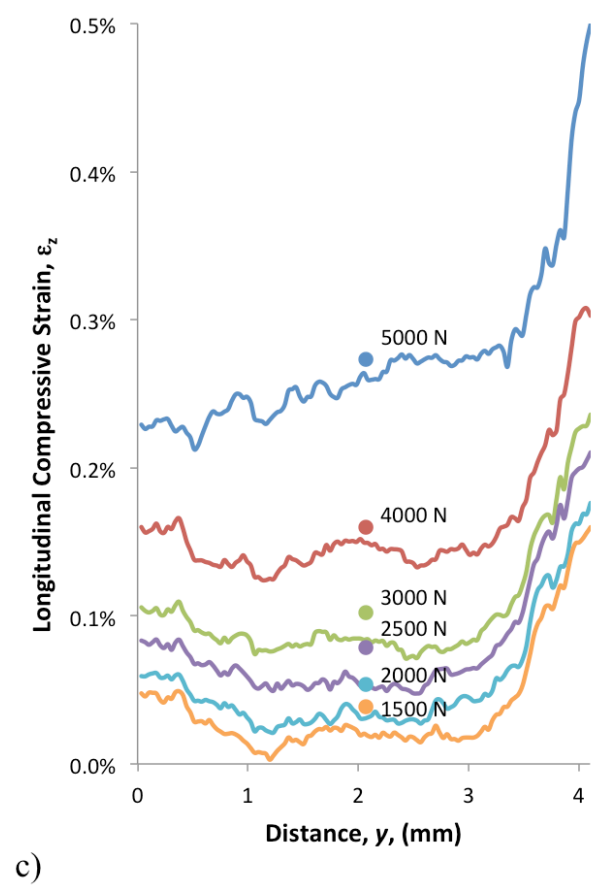
The damage within the microstructure is quite difficult to resolve, as there is little attenuation contrast in tomographs when the crack opening is small compared to the voxel size (Mostafavi et al., 2013). However, DVC analysis can aid crack detection (Yang et al., 2017; Vertyagina et al., 2014; Saucedo-Mora et al., 2016). This is illustrated in Figure 12a and b, which compare a cross-section (TW plane) of the longitudinally loaded specimen (at 5000 N) with the equivalent section of the maximum principal 3D strain field, which is calculated from the local gradients of the displacement field. The variation with load of the longitudinal axial compression strain, across the sample, is summarized in Figure 12c. The strains were averaged along the x -direction, and increase in magnitude with position in the y -direction with a concentration towards one edge. Cracks that are

observed in the tomograph are clearly associated with the largest local strains, and these are concentrated towards the specimen edge that experienced the largest axial compressive strain. Localized strains are also observed within the fiber bundles and at their interfaces where cracks cannot be resolved in the tomograph.

Figure 12: Longitudinally compressed specimen: Comparison of a) a tomograph cross-section (at a height $z=1.27$ mm within the DVC-analysed volume, measured from the lower surface) with b) visualization of the measured maximum principle strain, for a TW section of the longitudinally compressed specimen, observed at 5000 N; c) variation of compressive axial strain across the specimen (average variation with position in y -direction) as a function of applied load. Points mark the average strains.

the value measured at 0.04% strain is expected to under-represent the initial elastic properties, and is also expected to be reduced by the misalignment of loading (i.e. Figure 12c). The periodicity of fiber and matrix (Figure 2) suggests a simple Reuss model for the transverse stiffness may be considered, which is dominated by the most compliant phase. The measured transverse stiffness of 20 GPa, which is unaffected by strain, is then consistent with literature data (Miyagawa et al., 2006) for the transverse Young's moduli of T300 carbon fibers, which is of the order of 5-14 GPa (the manufacturer's value is nominally 8 GPa). This gives confidence in the measurement of elastic deformation by the DVC analysis of tomographs, and future studies with tomographs obtained more frequently could examine the effects of the braided composite structure on the apparent linear/non-linear difference in behavior with orientation that is observed at low loads (i.e. Figure 3).

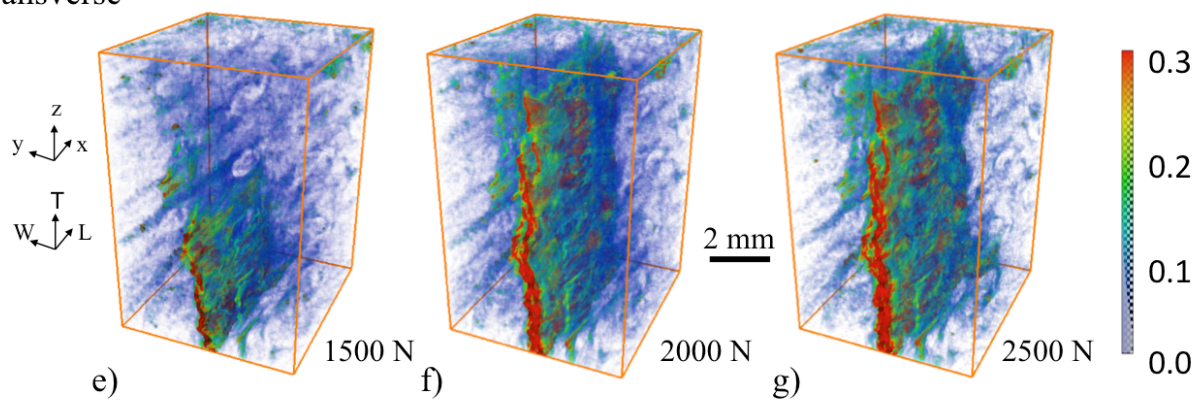
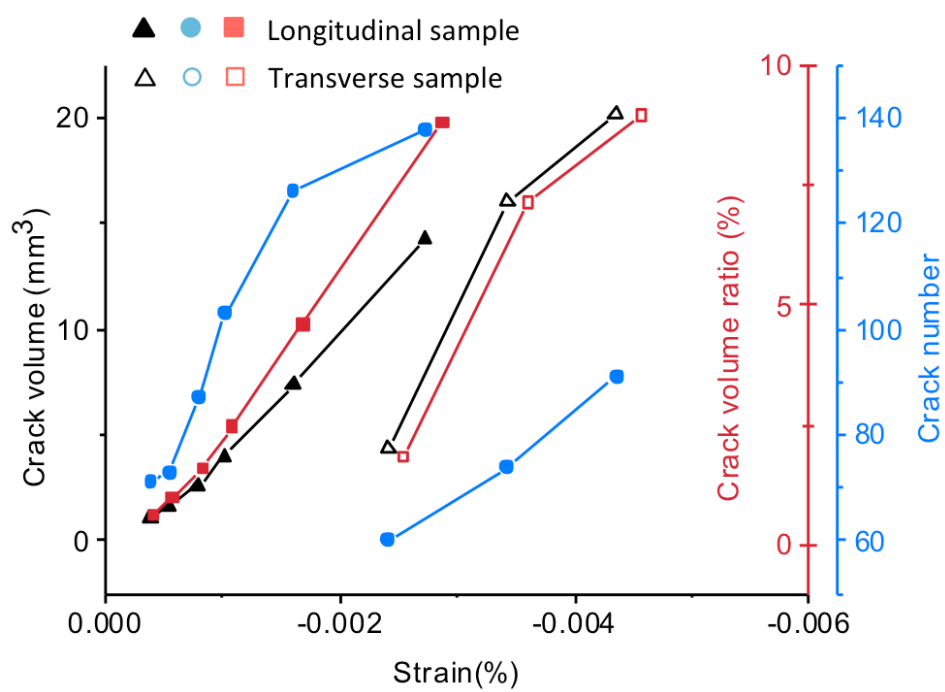
3D visualizations of the development of strain with load are presented in Figure 13 for both the longitudinally and transverse loaded specimens. The damage near to the edge of the longitudinal specimen (Figure 5b), which experienced the largest axial compressive strain (Figure 12c), is clearly visible in Figure 13a to d. The propagation of the vertical crack in the transverse specimen can also be observed (Figure 13e to f).

Figure 13: 3D visualizations of the development of the maximum principle strain field, with compressive load, measured by digital volume correlation for the longitudinal compression (a-d) and transverse compression (e-g) specimens.
