STRUCTURAL APPRAISAL OF A ROMAN CONCRETE VAULTED MONUMENT: THE BASILICA OF MAXENTIUS

A. Albuerne¹ and M.S. Williams²

RUNNING HEAD: Basilica of Maxentius

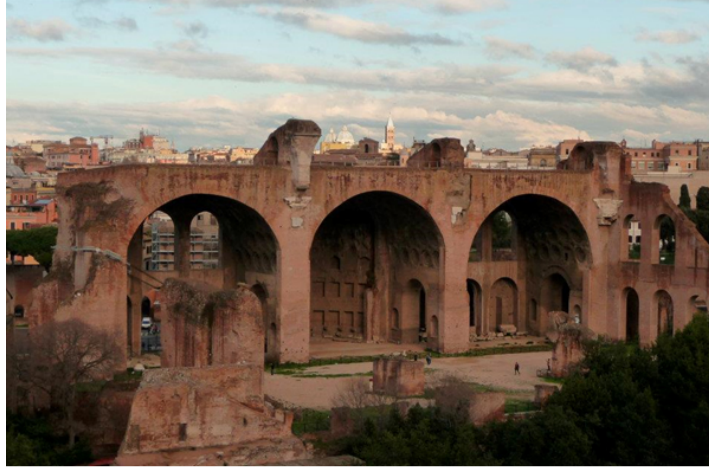
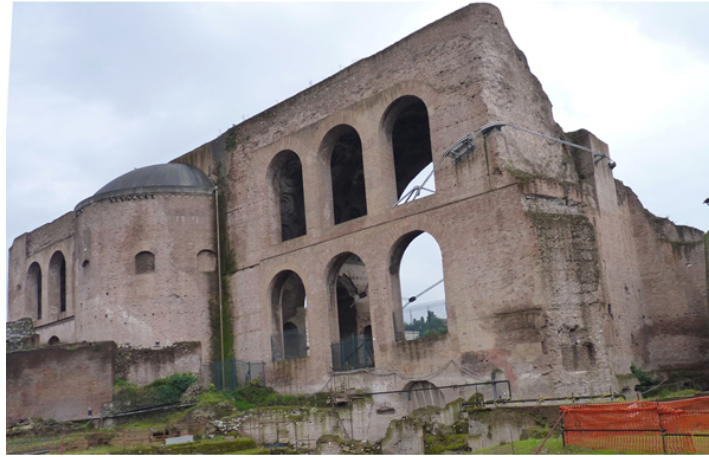
Fig. 3. North nave: a) view of the interior, from the south, and b) exterior, from the north

over the stability of the west façade, a steel cable restraint has been fitted. Two recent views of the north nave barrel vaults are shown in Fig. 3.

The subsequent excavations, first inside the building and more recently outside the west wall, have a clear justification in archaeological terms, enabling us to learn more about the building's history and returning it closer to its original state. However, they have had a negative impact on the safety of the structure, reducing its geometric factor of safety and necessitating the installation of the intrusive steel tie system visible in Fig. 3.

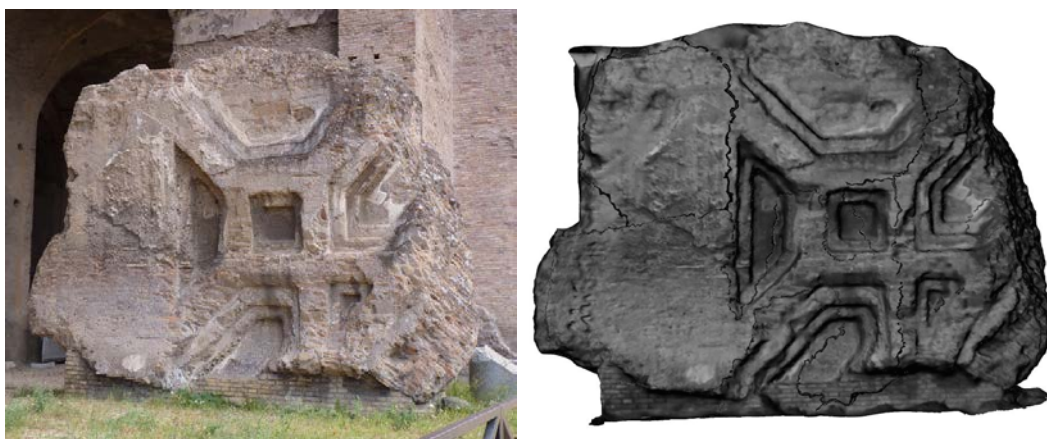
Fig. 6. Photo of vault fragment A, and 3D model created by digital photogrammetry

The software 123D Catch by Autodesk was selected for use. This generates a 3D mesh and surface rendering that can be processed by graphic software such as AutoCad and Rhino. It was applied to particular areas of the Basilica where particularly detailed models were desired, including fragments of the broken vaults and the cross vault springings and buttresses. The 3D models were scaled and oriented using total station measurements as reference; a typical result, for the largest extant segment of cross-vault, known as fragment A, is shown in Fig. 6.

The form of the cross-vault was inferred from the 3D photogrammetric model of fragment A. This was positioned within the reconstructed vault using the surface decoration as a guide. The decoration pattern was projected onto the intrados of a 3D reconstruction of

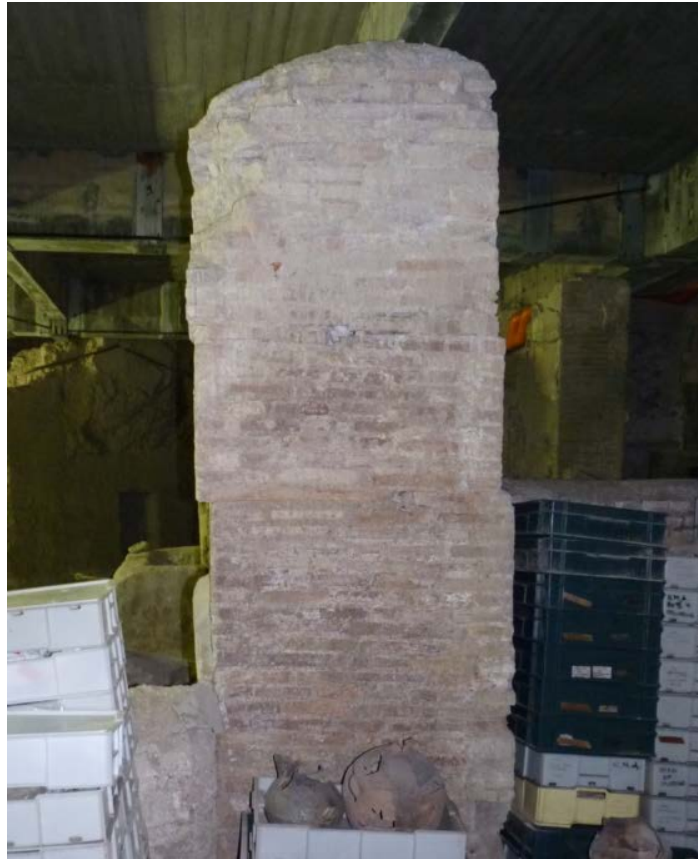
Fig. 7. Remaining wall of the *horrea piperataria* showing lateral slip at *bipedale* layers

Within these underlying structures, evidence was found that the structure had previously experienced large lateral loads. These included diagonal cracking and substantial inclination of some Roman concrete walls. One of the most striking examples is shown in Fig. 7, which shows a wall originally part of the *horrea piperataria* that has undergone lateral deformation at a series of slip planes. It is known that Romans used layers of *bipedales* every 1–1.5m within walls (Choisy 1873), to act as bonding courses connecting together opposite brick facings. These layers gave a very smooth horizontal surface with a much

lower frictional resistance than the concrete core, leading to the observed deformation. From this and other observed foundation damage, it appears likely that the site was subjected to a significant horizontal seismic loading, with its strongest component parallel to the longitudinal axis of the Basilica.
