## Detailed study of interphase degradation in SiC/BN/SiC ceramic matrix composites after elevated temperature tensile testing

<sup>c</sup> Rolls Royce plc., Derby DE24 8BJ, UK

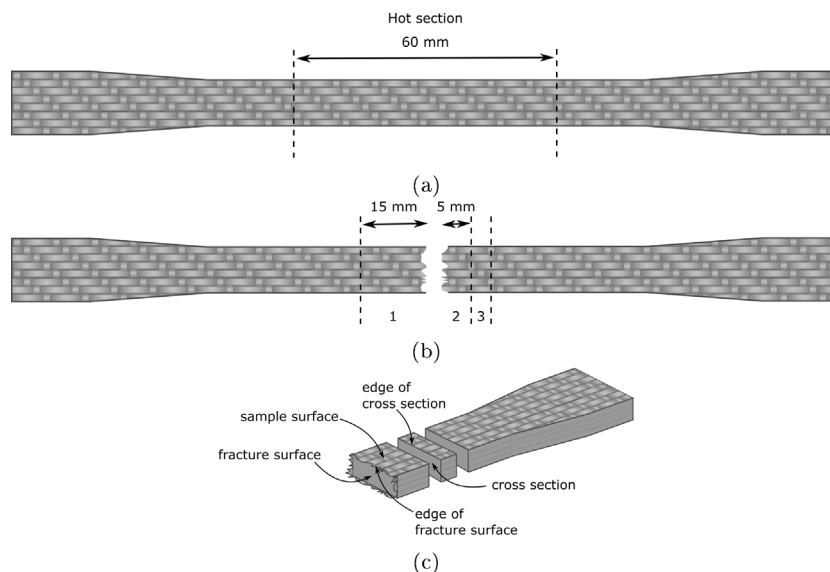
Fig. 1. Dogbone samples used in the tensile creep test. (a) Original sample geometry. (b) Failed sample, showing the sectioning of samples to be viewed from the surface (1) and the sample polished as a cross-section (3). (c) The naming convention for the different areas of the samples described in the text.

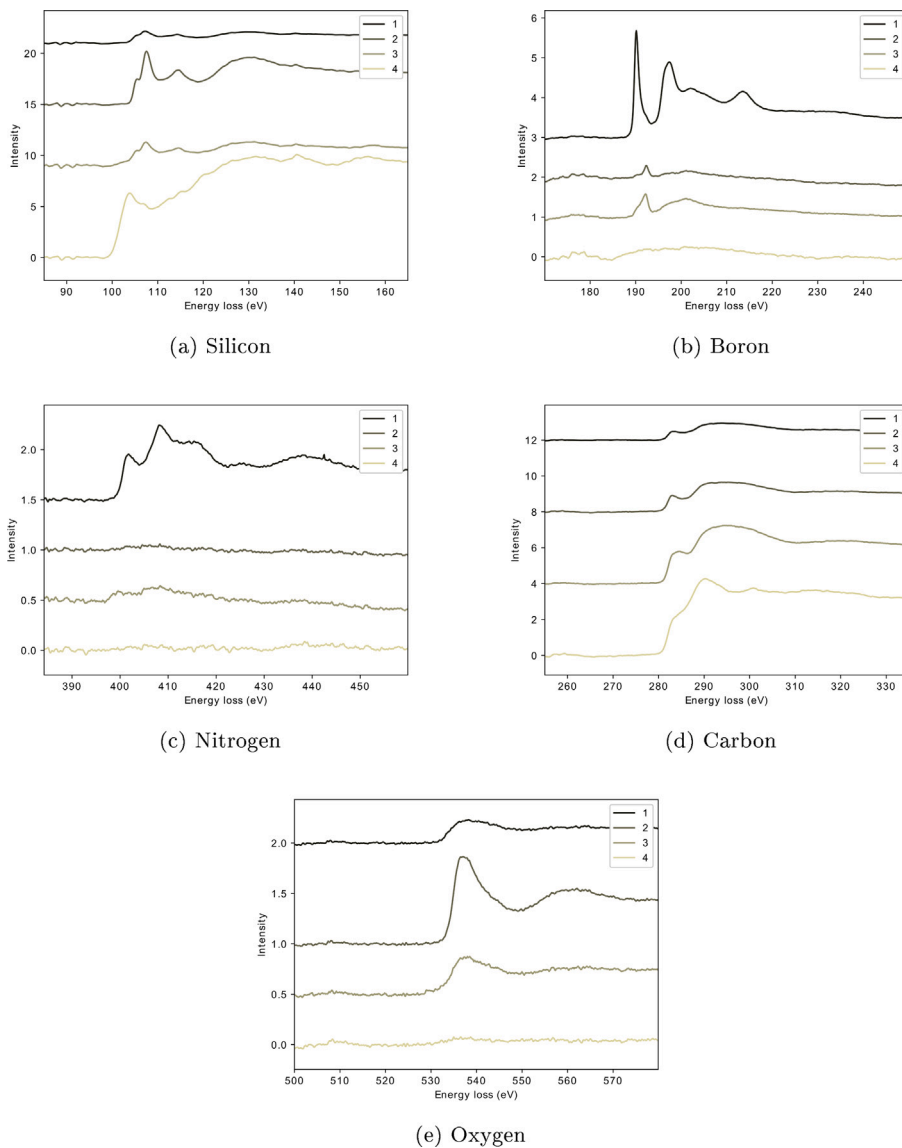
In addition to the oxide layers, the surface sample of CMC1000 has additional layers between fibre/interphase as well as CVI SiC/interphase as can be seen in Fig. 5(a) and in Figure S8 in the Supplementary Information. An HR-TEM image of the fibre/interphase region from square 2 in Fig. 4(a) can be seen in Fig. 7 and corresponding EELS edges for relevant elements can be found in Fig. 8. The layered structure in this area consists of the fibre (4), an unidentified layer (3), an oxide layer (2) and the tBN interphase (1). The turbostratic structure of the interphase is clearly lost in the oxide layer (2) and by inspecting the silicon and boron edges it can be seen that layer (2) is a layer of amorphous borosilicate. Between this layer and the fibre is a layer with slight signs of a turbostratic nature, at least locally, and from the EELS edges this area contain silica, amorphous carbon, boron nitride and boria and can be interpreted as a layer of partially oxidised remaining interphase. A similar layered structure as that along parts of the fibres was found along parts of the CVI, see Figure S8 in the

Fig. 8. Fine structure spectra across the layers in Fig. 7, showing fibre (4), an unknown layer (3), an amorphous oxide layer (2) and interphase (1).

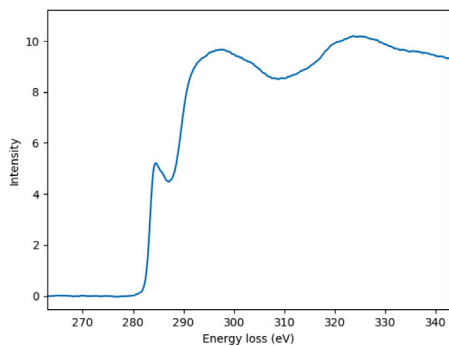
In some areas of sample CMC1000 there is an additional layer of carbon, see Fig. 5(a). This carbon also stretches into layers following parts of the interfaces between interphase and SiC. EELS fine structure analysis confirms that this is amorphous carbon, see Fig. 9. Similar amounts of carbon were not found in any of the other surface samples which indicate that it is not an artifact from sample preparation or surface treatment of the fibres during sample manufacturing. It is likely

All samples had carbon dispersed in the interphase, see Figs. 9, 6(f) and 6(i) and compare with Figure S7c in the Supplementary Information, which has been reported previously for tBN layers deposited by CVI [45]. It is however not possible to tell if the carbon detected in this study was deposited together with the tBN or if it is contamination from sample preparation.

Fig. 9. Carbon edge from the area labelled (3) in Fig. 5(a).

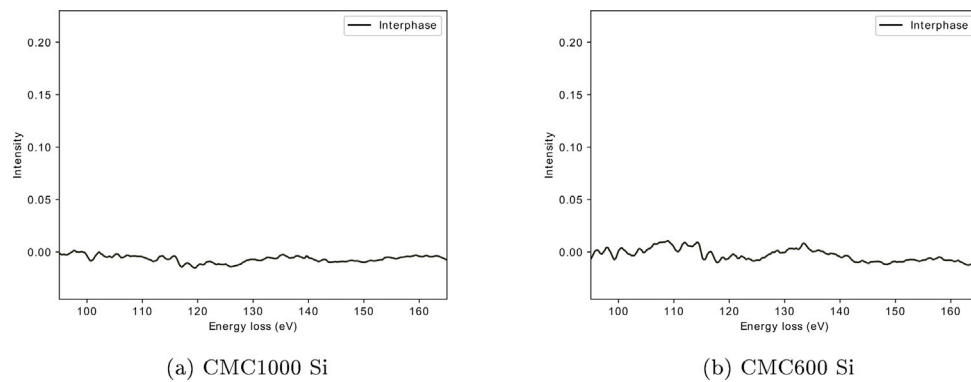
The centre samples reveal how the centre of the dogbone samples have been affected. CMC1000 and CMC600 show no signs of any oxide layers in the centre, see Figs. 10(a) and 10(b). The silicon spectra summed over the interphase show no signs of silicon migration for sample CMC1000 and possibly a weak signal corresponding to silica in sample CMC600, although this signal is below the noise level, see Fig. 11. From the surface samples it was not possible to discern if the silicon for the silica in the tBN interphase had diffused before or after oxidation. The centre samples were subjected to similar temperatures but without the oxidising species and no silicon, or only very little amounts in the form of silica, was found in the interphase, indicating that the oxidation happens prior to or simultaneous with the migration and temperature alone could not cause diffusion of silicon. The increased oxygen signal in the interphase seen in the maps of Figs. 10(a) and 10(b) is likely an artefact caused by differing sample thickness as no elemental edges corresponding to oxide species were identified. Overall no signs of degradation of the interphase were found in the centre sample of CMC1000, and for CMC600 the only indication of degradation was a very weak silica signal in the interphase, this is in line with what was seen in the polished cross sections and fracture surfaces and show that time is more important than temperature in order for the oxidation to reach the centre of the sample.

It has been seen in this work that during a tensile creep test at elevated temperature, a migration of silicon will happen alongside with oxidation. The absence of silicon in the interphase in the centre samples of CMC600 and CMC1000 show that the migration happens during or after oxidation. Silicon migration has also been seen by Opila et al. when testing SiC/BN/SiC CMC's in burner rigs with jet fuel, and they suggested it happened due to the interaction of silicon oxidation products with boria in the interphase [13]. It was also seen by Diaz et al. in low temperature humidity tests, but in that case in the form of SiC migration followed by oxidation once the sample was heated to 800 °C [30]. At 1000 °C this migration appears to be fast enough to prevent formation of a silica layer directly adjacent to the fibre surface and instead a layer forms inside the tBN, as indicated by the presence of tBN between the silica layer and fibre surface. Layered structures were also seen by More et al. after oxygen exposure at 950 and 600 °C in the form of a layer of borosilicate formed after the silica layer had first coated the fibre [48]. Dugne et al. found layered structure along the fibre/interphase interface in the form of a carbon layer coating the fibre, followed by a silica layer before the interphase layer, already

Fig. 11. Silicon spectra from the interphase of the centre samples of CMC1000 and CMC600.
