Cite this article: Mol L, Gomez-Heras M, Brassey C, Green O, Blenkinsop T. 2017 The benefit of a tough skin: bullet holes, weathering and the preservation of heritage. *R. Soc. open sci.* **4**: 160335. <http://dx.doi.org/10.1098/rsos.160335>

The benefit of a tough skin: bullet holes, weathering and the preservation of heritage

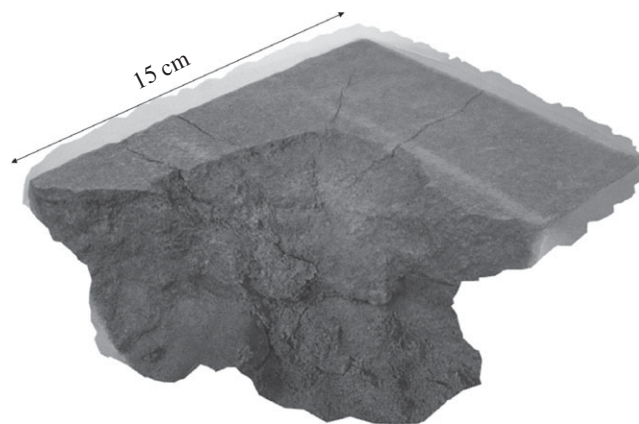
Figure 1. Three-dimensional model of sample block remnant after AK-47 impact.

As illustrated in [figure 1](#), the extent of destruction wrought by the AK-47 impact on our sample blocks ensured the remaining fragments were not suitable for a full examination of the interactions between impact sites, surrounding fracture networks and any unharmed material in the periphery. Impacts were therefore scaled down to ensure a full impact was contained within the test blocks, thus permitting high-resolution imaging of the entire sample (see Methodology section). The low-powered rifle used herein undoubtedly underestimates the potential damage associated with contemporary warfare. It does, however, allow for the full impact structure network, its response to environmental stress and the effect of pre-existing hardening of the surface to be mapped within the constraints of sample size. While this discrepancy in scales must be noted, here we lay the methodological foundations for future investigations of larger impacts, and highlight the pressing need for further research into endangered built heritage.

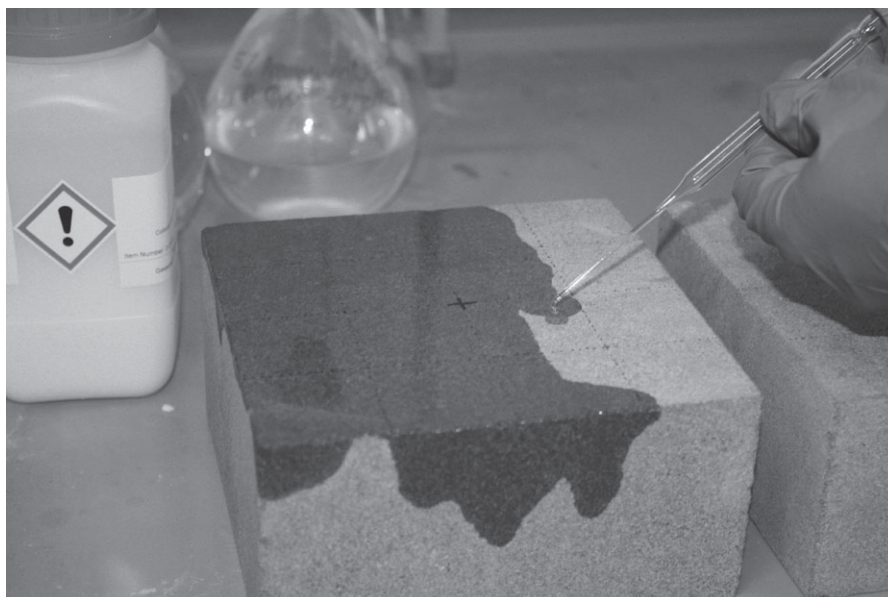
Figure 2. Application of Wacker OH 100 treatment.

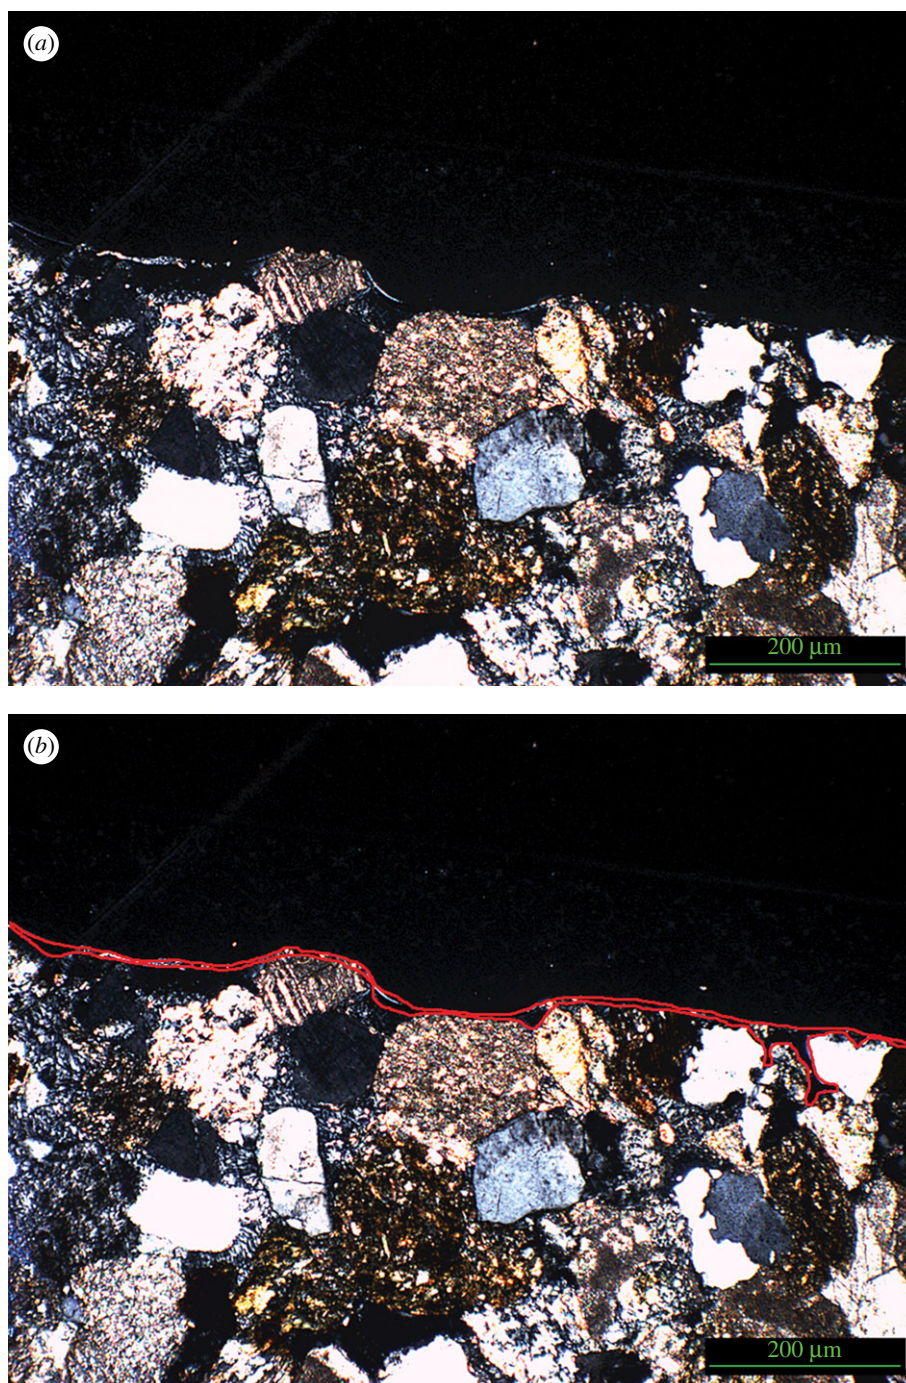
Figure 3. (a) Wacker OH 100 gel layer in original image. (b) Wacker OH 100 gel layer with accentuated observation of gel deposition.

Cementation of the surface, referred to as 'case hardening' and manifested as a surface crust, often develops after freshly cut building stone is exposed to environmental factors such as precipitation and temperature fluctuations [19,20]. This cementation can consist of multiple phases such as carbonate, calcite or iron oxide crusts, and while stabilizing the top surface can also enhance deterioration of the stone matrix owing to subsurface moisture accumulation and subsequent dissolution of the cement matrix as well as increasing pressure on the surface [21–23]. To address this change in surface hardness and porosity, half the samples were treated with Wacker SILRES BS OH 100, an ethyl silicate-based consolidant which forms a silica-based gel upon contact with moisture in the stone pores, and subsequently dries within the pore system [24], by pipetting the substance onto the surface (figure 2). This consolidant is also used in conservation of stone artefacts to increase hydrophobicity and decrease bioinfestation potential [25–27]. One layer was applied to mimic surface consolidation, as it is used here as an analogy for natural case hardening, rather than multiple applications which might have resulted in consolidation of the majority of the sample [28]. After curing, a thin layer of consolidant was observed at the surface of the block but, as anticipated, this layer was mostly restricted to the surface and immediate subsurface (figure 3*a,b*). Case hardening under natural circumstances results in the deposition of a

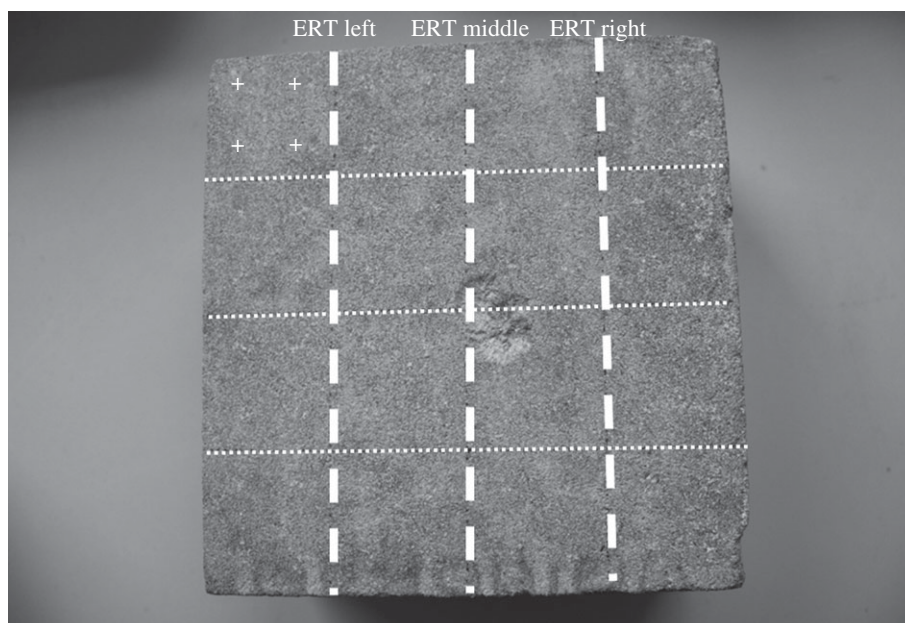
Figure 4. Impact area at sample 6, also showing sampling strategy for the Piccolo and ERT.

Resistivity measurements were taken along three transects across the stone sample (for sampling strategy, see figure 4). The middle transect covers the impact area and it was expected that the most noticeable changes would be seen in this area. Figure 8 shows the distribution of moisture in sample 3 after the environmental cabinet treatment. This sample was not treated with Wacker OH 100. The areas of low resistivity (light greys and whites) are assumed to indicate higher moisture content, whereas the

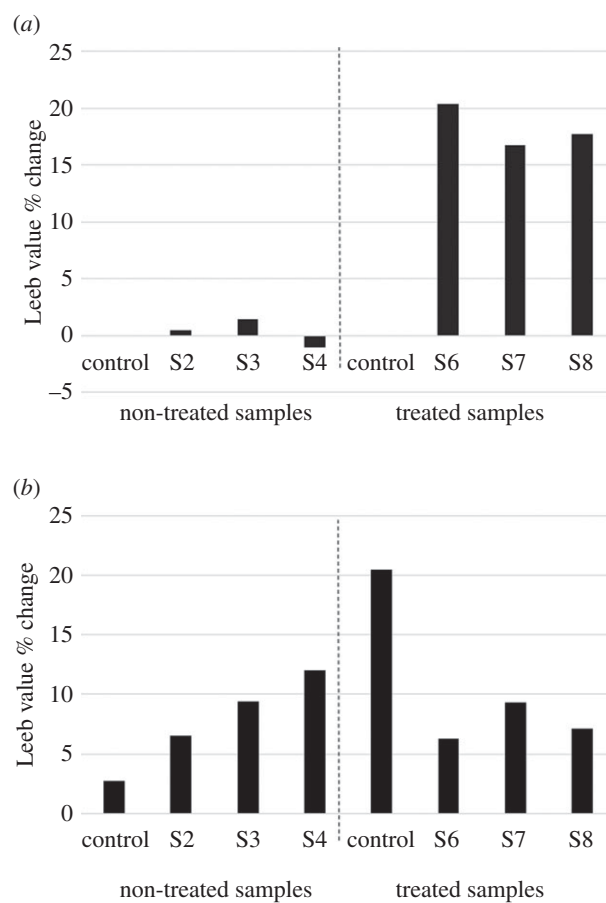
Figure 6. (a) Loss of strength of rock surface as measured after bullet impact and (b) loss of strength of rock surface as measured after environmental stress cycles in cabinet.

The repeated measurements of the sample surfaces are shown in figure 6. The initial Wacker OH 100 treatment shows a significant increase in the measured surface hardness at samples 5–8. This fits the

A further investigation of the overall results on strength loss (figure 6) indicates some unexpected results, while the impact of the initial bullet had a far greater impact on loss of strength on the surface-hardened samples, this trend reversed under the environmental strains placed upon the stone samples in the environmental cabinet, where environmental strain as recorded by surface strength loss had a greater impact on the non-treated samples. The presence of water at the foot of the block (samples 3, 4, 7 and 8) was detrimental irrespective of the presence of case hardening.

As can be seen in figures 6 and 7, all samples were negatively affected by the environmental cabinet treatment. However, the extent to which the samples were affected by the treatment appeared to be strongly related to the nature of fracture network developed at the time of impact, as based on the research set out by Momber [34]: The rigid, Wacker OH 100 treated, fractured surface appears to be more vulnerable to temperature changes overall, whereas the untreated and more plastic surface appears to cope far better with the thermal stresses placed upon the samples in the environmental cabinet but suffered noticeable degradation of the impact area, leaving it vulnerable to potential cavernous weathering. The pre-impact condition of the surface is therefore instrumental in determining the impact of a projectile, such as a bullet, and projecting future deterioration patterns.

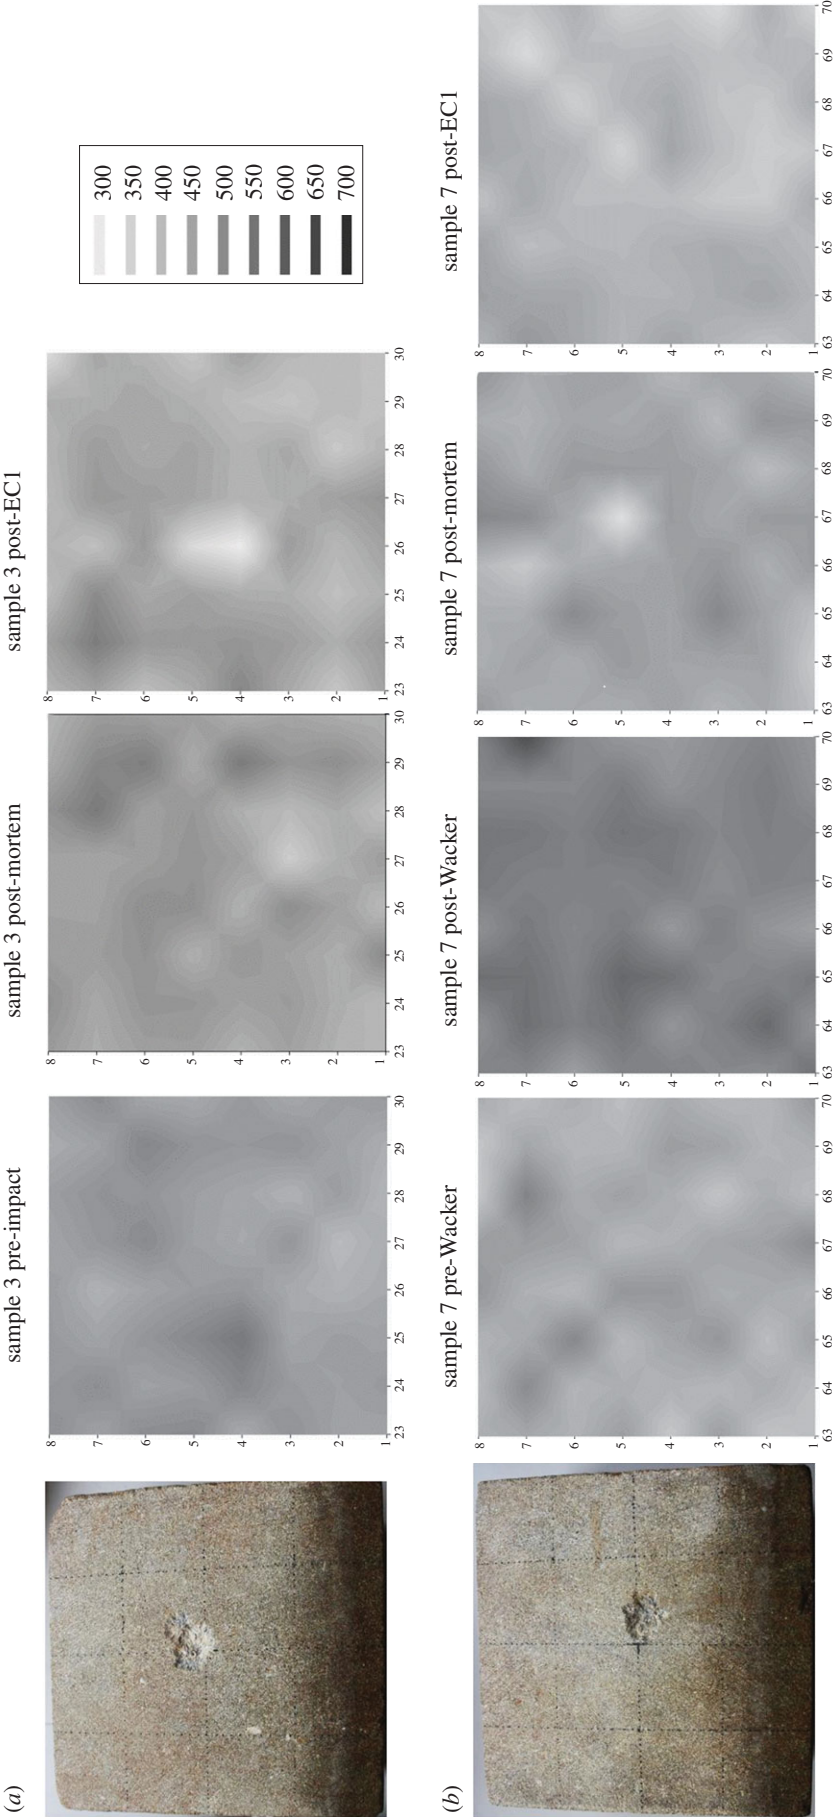
Figure 7. Piccolo data from samples 3 (*a*, sample not treated with Wacker OH 100) and 7 (*b*, sample treated with Wacker OH 100 and shot) in Leeb value. Values were interpolated using SigmaPlot area plot.

However, mean values cannot adequately describe spatial variations in elastic properties. Therefore, the Piccolo data from samples 3 and 7 measured across the surface of the block have been plotted in figure 7 to show change during the various stages of the experiment. Here, two interesting trends emerge. Firstly, sample 3, which was not treated with Wacker OH 100, does not show weakening directly corresponding to the impact area, although damage is apparent elsewhere. This follows the trend of the absorption of the impact by the more elastic nature of the surface (compared with the Wacker OH 100 treated surface). However, after the environmental cabinet treatment there is a clear weakening of the impact area, as represented by the lighter coloured area and relatively stable measurements around the impact area. This trend is reversed in sample 7 where initially the impact area is clearly identifiable post-impact (the very light grey area that corresponds with the location of the impact), accompanied by a general deterioration of the surface strength across the surface of the block. This impact area is much less visible after the environmental cabinet treatment. Instead there appears to be a general but less severe deterioration of the surface.

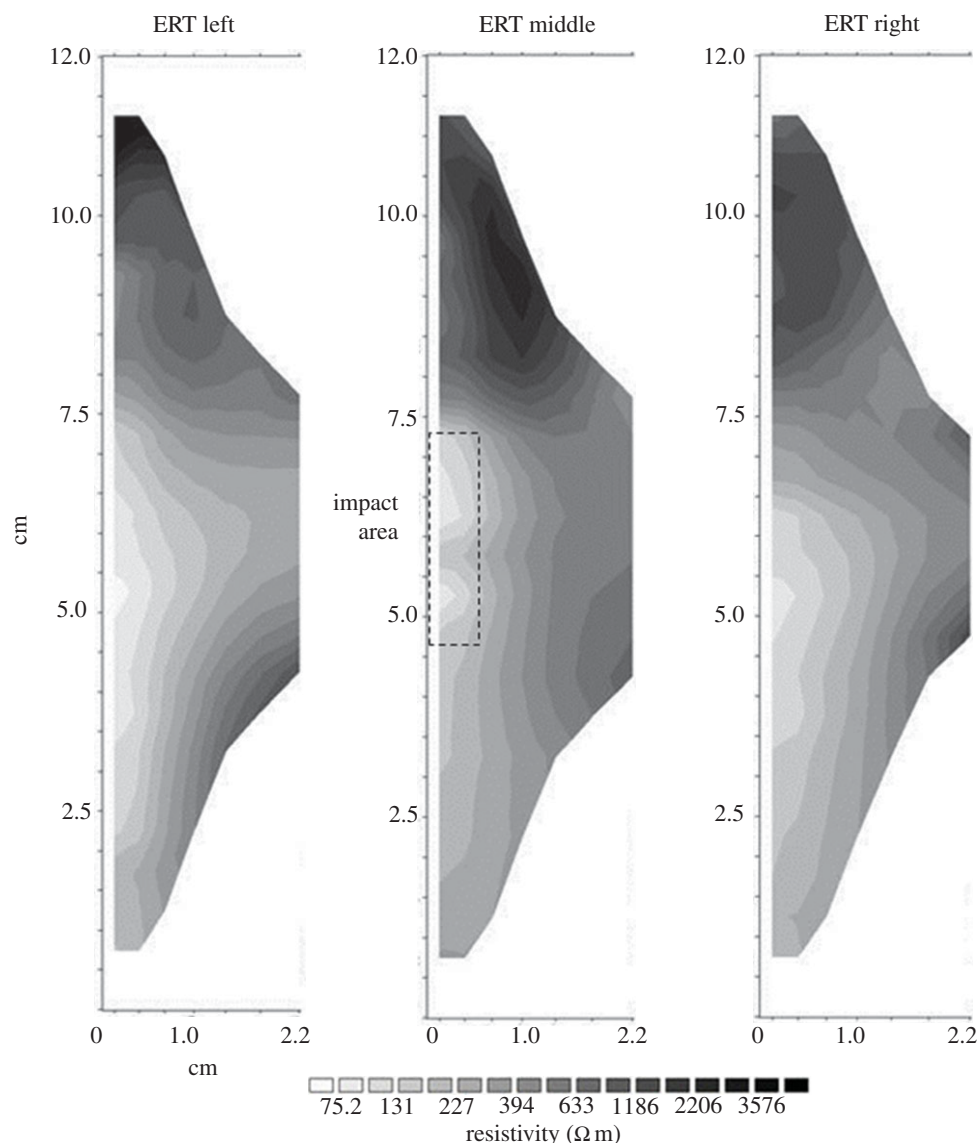
Figure 8. ERT transects of sample 3 (not treated with Wacker OH 100) after the environmental cabinet treatment.

Little is known about the relationship between internal moisture and impact areas resulting from armed warfare, even though internal moisture has been shown to be a driving weathering process [14]. The surface hardness experiment was therefore extended to include the behaviour of internal moisture under the conditions mapped out previously. Both samples 3 and 7 were immersed in water at the foot to simulate groundwater rise, with the impact site vertical and facing outwards as it would probably be situated within a damaged wall (figure 8), to a depth of 2 cm and are used here as examples to illustrate the processes found.

dark grey and black areas indicate high resistivity, are assumed to be lower moisture contents. Capillary rise facilitates the upward movement of moisture until it reaches the impact area where it moves towards the surface and evaporates. An accumulation of moisture within the subsurface impact area can also be distinguished, forming a wedge shape of low resistivity into the stone body and saturating the inter-grain spaces in the fracture network. At the middle transect, the direct impact area shows a higher moisture content than in the surrounding area, suggesting that the evaporation is indeed concentrated in this area, as previously suggested.

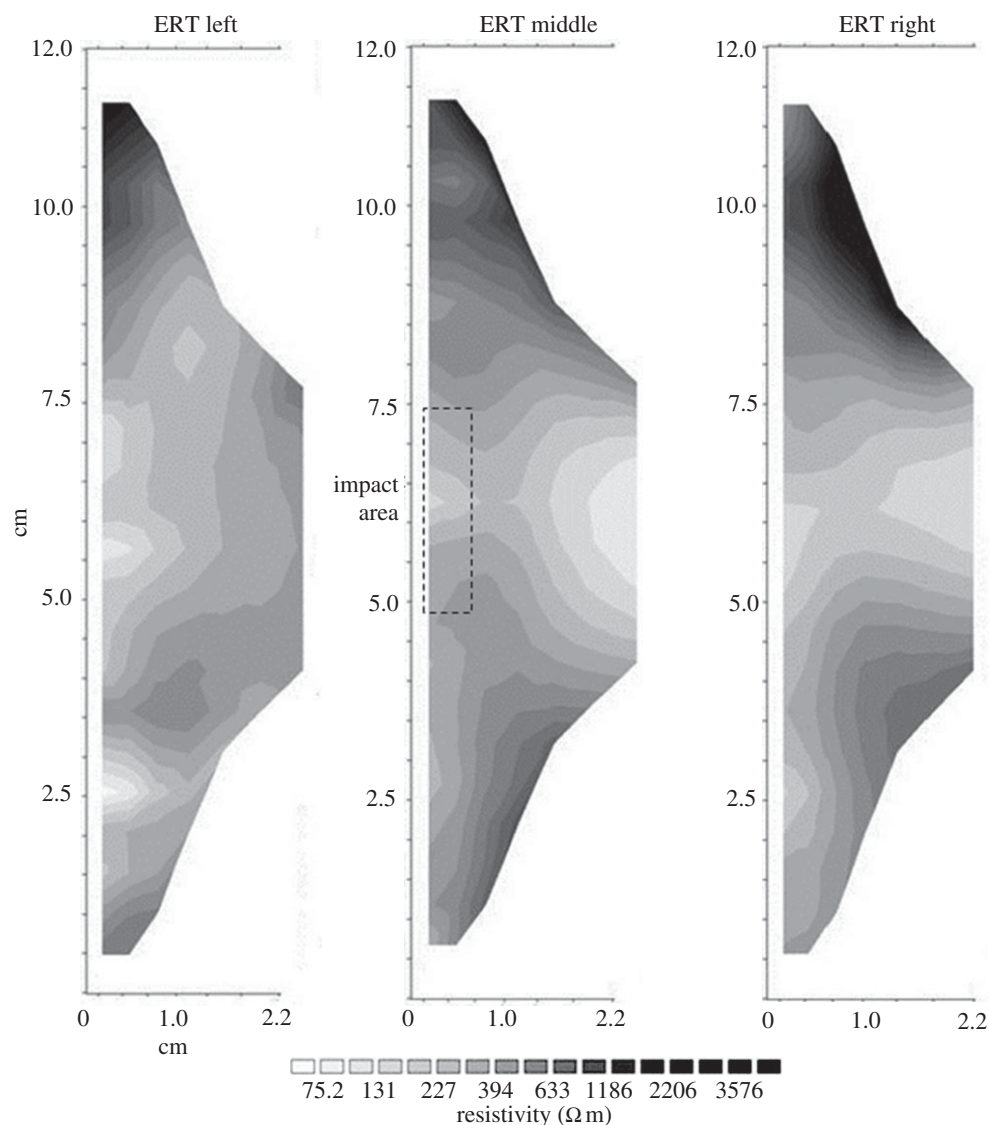
Figure 9. ERT transects of sample 7 (Wacker OH 100 treated) after the environmental cabinet treatment.

Sample 7 (figure 9) shows a very different pattern; moisture is drawn throughout the face of the stone, rather than drawn up towards the impact area. The impact area, while visible, is less clearly defined. However, the area behind the surface impact area clearly draws moisture in to a much greater degree than that seen in sample 3. Towards the foot of the block the moisture appears to be drawn up rather than into the block, as visible in sample 3, indicating more rapid capillary rise along the surface.

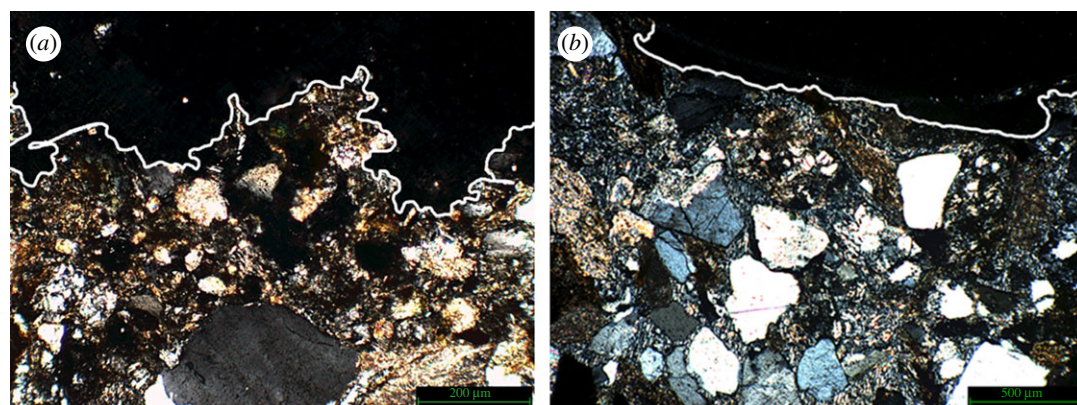
Figure 10. (a) Non-consolidated impact area ($\times 4$) and (b) consolidated impact area ($\times 4$) White line has been added to emphasize shape of impact area.

observed that in the impacts created in non-consolidated stone the impact area was far more ‘jagged’, as illustrated by figure 10*a*, in contrast with the consolidated stone where the impact created a shallower and smooth curve (figure 10*b*).

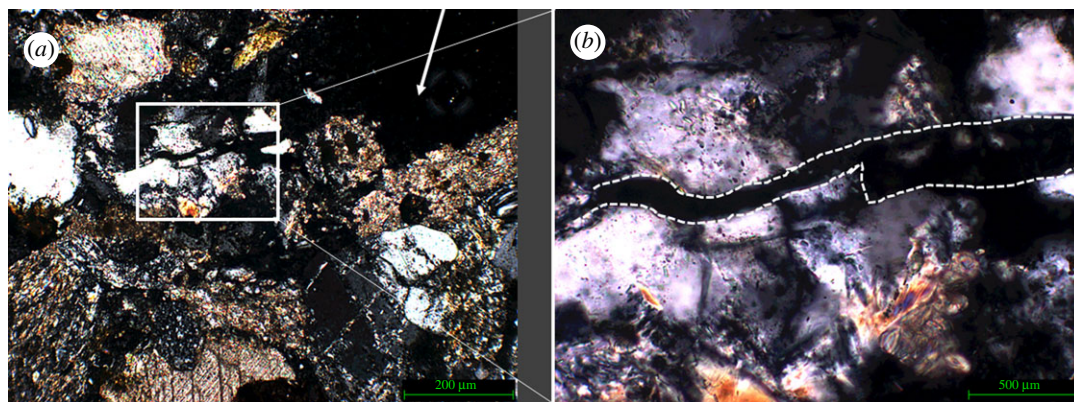
Figure 11. (a) Part of the impact area of sample 2 (not Wacker OH 100 treated); arrow indicates direction of impact. (b) Close-up of the fragmented and separated quartz found in the impact zone of sample 2, and white dashed lines clarify the position of the separation.

Quartz in the direct impact zone showed noticeable fracturing along the impact area. Figure 11*a* illustrates the fractures observed in the impact zone of sample 2 which was not treated with a consolidant. The absence of this surface support has resulted in the separation of the quartz fragment along the fracture line. Figure 11*b* shows a close-up of the area.

The bullet impacted in the area directly to the right of the fractured quartz, therefore, the conclusion could be drawn that the fracture and subsequent separation of the crystal is the result of the shockwaves generated at impact travelling sideways through the near-surface of the stone sample. The absence of a consolidant, and therefore a higher relative elasticity of the surface, facilitates sideways movement of the crystals. This type of separation was not observed in the samples treated with consolidant. This observation supports the notion that the nature of a micro-fracture network created upon impact is as dependent on the state of the material pre-impact as it is on the type of impact. As figure 12*a* illustrates, sample 3 exhibits this type of fracture network in the area directly adjacent to the impact. Figure 12*b,c* illustrates the geometric nature of the fracture network.

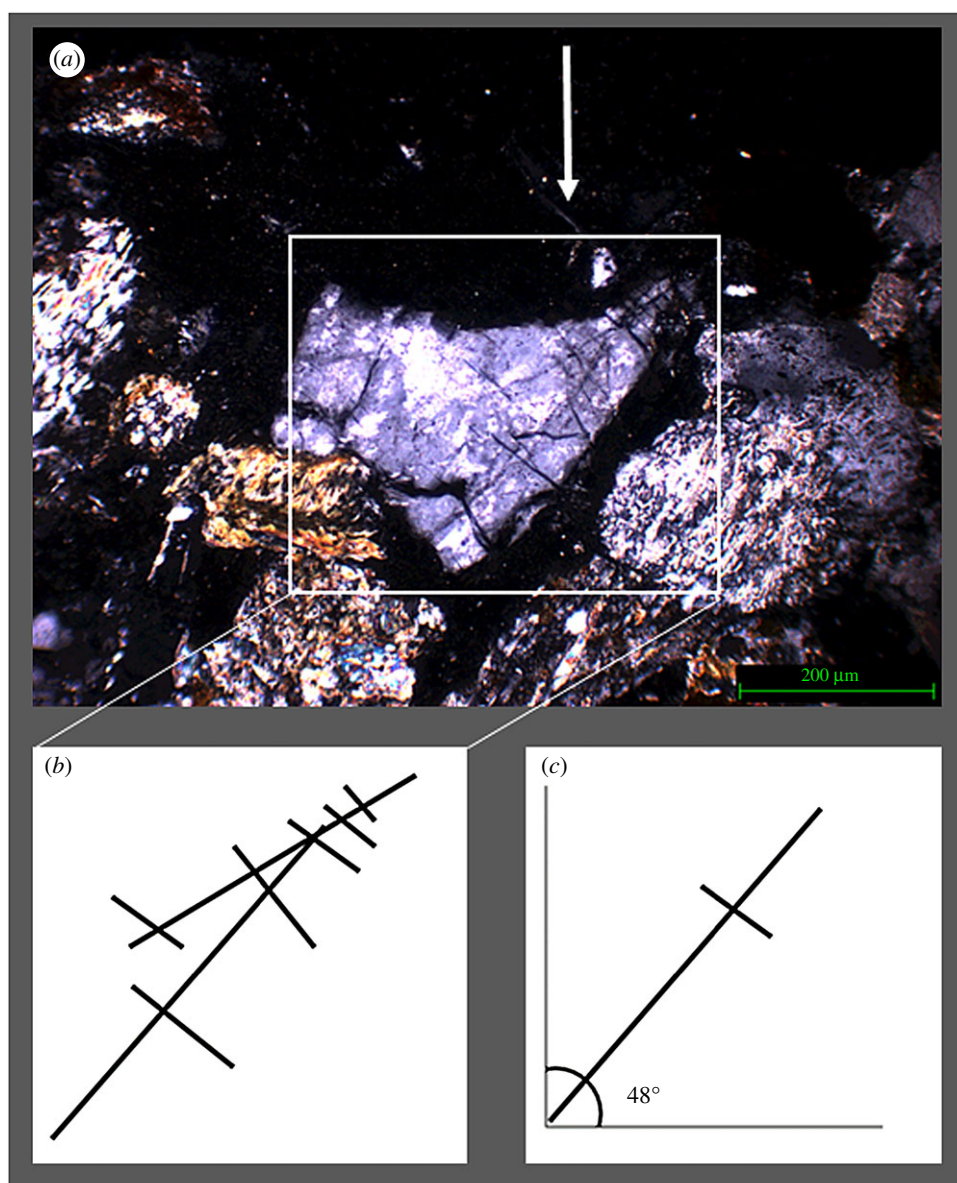
Figure 12. (a) Sample 3 (not treated with Wacker OH 100) impact area, white arrow indicates impact direction, (b) schematic of geometric fracture pattern and (c) schematic of angle of fracture network.

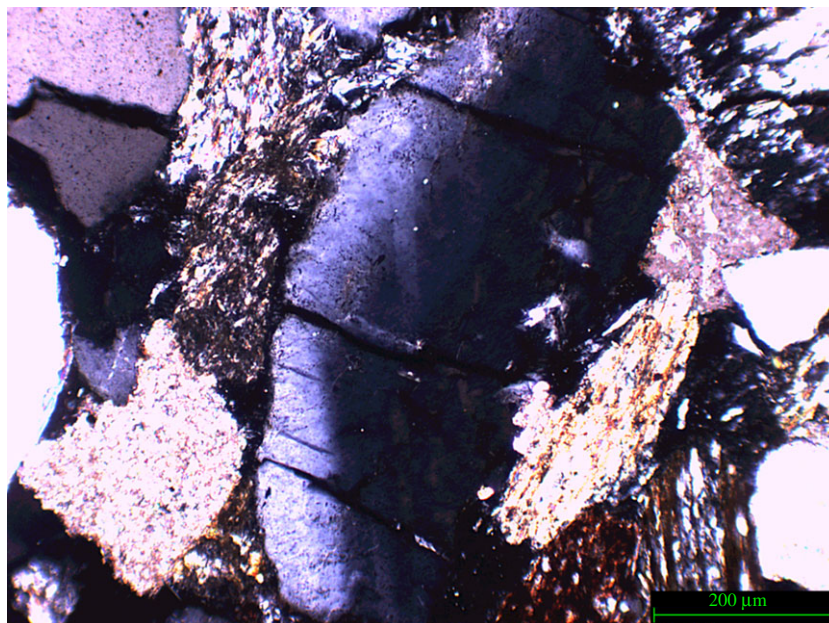
Figure 13. Sample 3, example of grain bruising.

Figure 13 illustrates further the fracture networks which were observed in sample 3 around the zone of impact. This sample also exhibits 'bruising' where part of the grain appears to have been reduced in refractive index (also noted by Fratanduono *et al.* [35] in shocked quartz), resulting in partial extinction as observed using cross-polarized light. This discoloration was not observed in grains outside of the direct impact area, indicating that this 'bruising' is closely connected to the shock generated on impact.

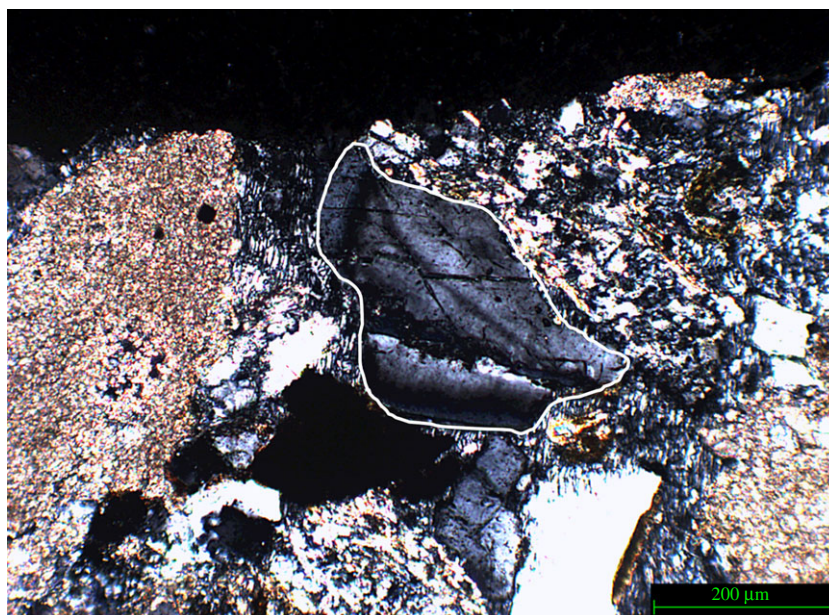
Figure 14. Sample 6 showing fractures, similar to those found in the non-consolidated samples. The mineral specifically referred to is outlined in white.

The above examples are observed in non-consolidated material. In consolidated material (samples 5–8) similar fractures were observed, implying that even though impact area development may differ the effects of the impact on mineral grains immediately surrounding the impact area are very similar. Figure 14 shows fractures found on the edge of the direct impact area in a Wacker OH 100 treated block (sample 6).

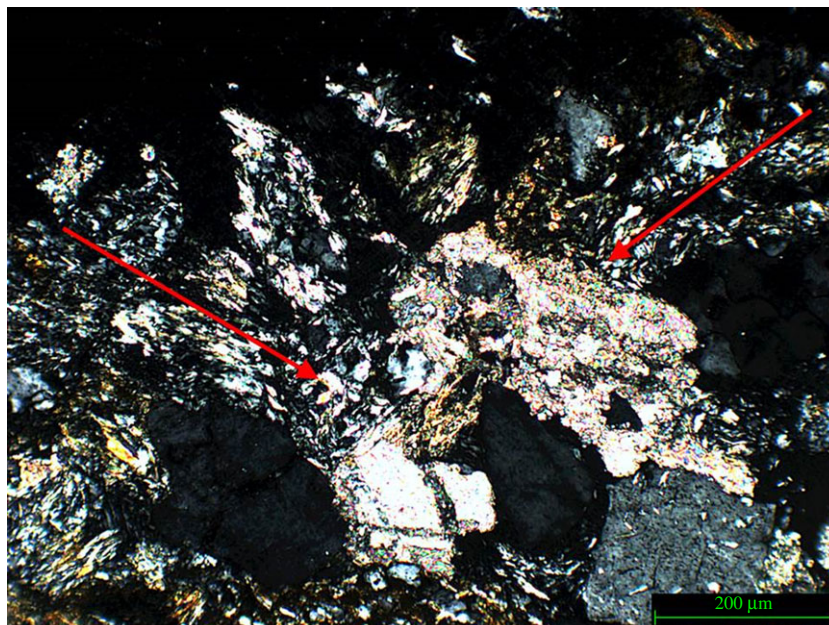
Figure 15. Sample 4, with arrows indicating clay matrix movement. This sample was not treated with Wacker OH 100.

Deformation of the clay (muscovite/kaolinite) cementation indicates a realignment of the general matrix in response to the shock generated on impact. Figure 15 illustrates this realignment in relation to the centre of the bullet impact which is in the area between the two arrows. The arrows indicate the new direction of the clay minerals, an alignment which is not visible in the non-impacted samples

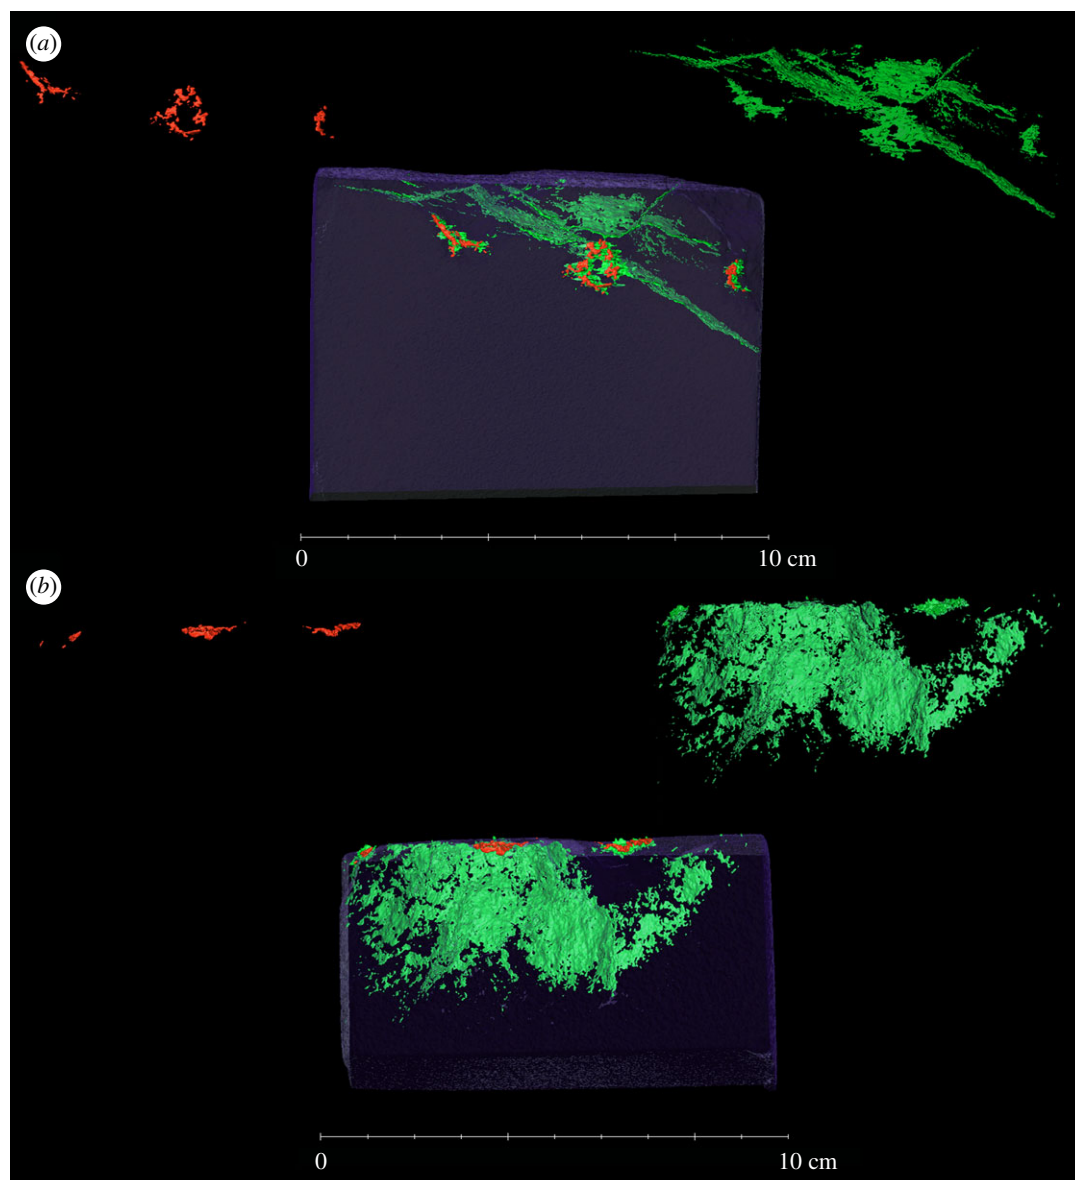
Figure 16. X-ray of impact areas, green demarcates areas of low density (fractured), whereas red indicates areas of higher density, likely to be lead deposits from the bullet encasing. (a) Frontal view (line of sight parallel to travel of bullet) and (b) top-down view. This sample was not treated with Wacker OH 100.

As all previous tests indicated both deformation of minerals around the impact zone as well as consolidation of the clay, a sample was scanned using X-ray tomography to map out compaction and fracture zones. These results are shown in figure 16, where the impacts coincide with compacted areas, whereas the fractured area extends onto the surface, radiating out from underneath the impact zones. The damage appears to have been caused by stress travelling into the block as the bullet hit, towards the

edges of the block while following a bedding plane within the stone sample. This exploitation of a pre-existing weakness is a commonly observed mechanism in stone under environmental stress [36]. These results also confirm the creation of compaction areas at the site of impact, which in turn affects impact site response to environmental stress and potential for long-term deterioration.

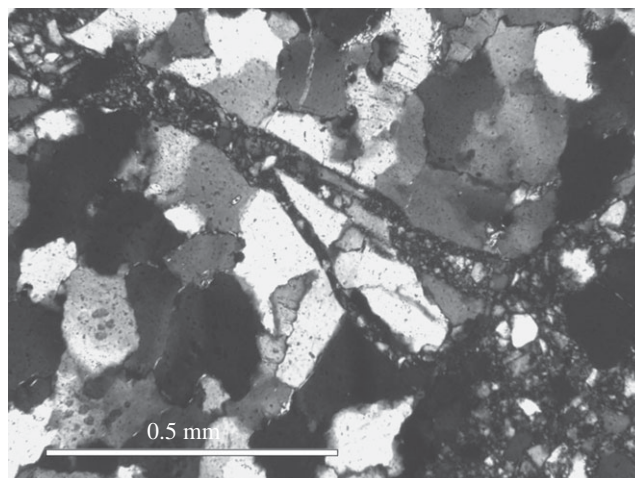
Figure 17. Fractures in a quartz-rich metasedimentary rock from the Ries Impact structure, Germany. Compare fractures with figures 10–14. Crossed polars. Sample from Alte Bürg quarry, 12 km from impact centre.
