Observation and quantification of the diffusion-induced grain boundary migration ahead of SCC crack tips

Zhao Shen^{a,*}, Phani Karamched^a, Koji Arioka^b, Sergio Lozano-Perez^a^a Department of Materials, University of Oxford, Parks Road, OX1 3PH, Oxford, UK^b Institute of Nuclear Safety Systems, Inc. (INSS), 64 Sata, Mihama-cho, Mikata-gun, Fuku, Mihama, 919-1205, Japan

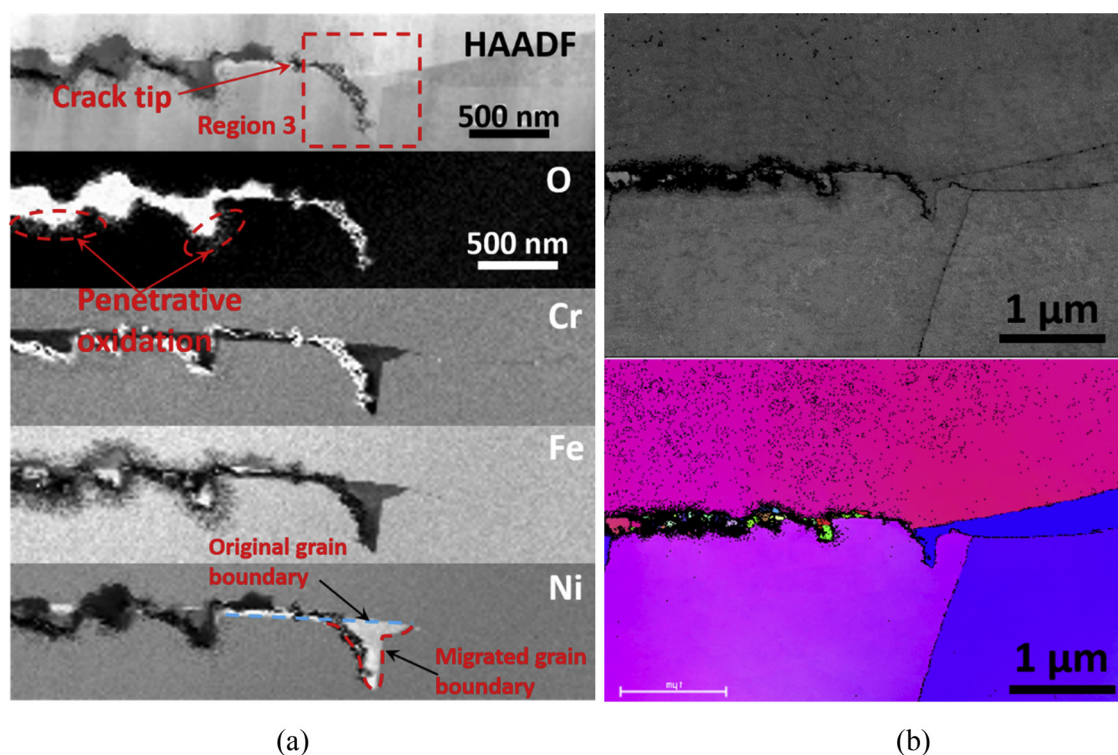
Fig. 3. a) HAADF and elemental images of crack tip 3; b) TKD maps containing the crack tip 3 (Top: pattern quality map; Bottom: IPFZ map).

Fig. 3a shows a crack tip prepared from region 2 (see Fig. 1b). DIGM at this GB seemed to be more intensive than that observed in region 1 (Fig. 2a). Penetrative oxidation in the crack flanks was also observed and stopped at a specific point. This point was identified as the crack tip of this crack (see Fig. 3b). An IOZ with a length of around 1.8 μm was observed ahead of the crack tip, which was much longer than what was

observed in Fig. 2b. Further observation reveals that the crack propagation was not along the original GB but the migrated GB because the intergranular oxidation occurred along the migrated GB instead of the original GB. This is consistent to what was reported by Bertali et al. [13–15] and Kuang et al. [12]. In addition, the authors considered that the DIGM could enhance the intergranular oxidation, which then increased the SCC susceptibility. According to this conclusion, the crack tip 2 should exhibit higher SCC susceptibility than the crack tip 1 since the DIGM at the crack path 2 seemed to be more intensive than the crack path 1. However, from our current observations of crack propagation, crack 1 advanced further than crack 2, which contradicts the above theory meaning there should be additional factors contributing to the lower CGR along the crack path 2.

To further confirm our hypothesis that the DIGM could lead to the retardation of SCC propagation, a TEM sample was prepared from a potential inactive crack tip at region 3 (see Fig. 1b). The HAADF image reveals that the crack propagation diverged from the original GB plane (see Fig. 3a). The EELS maps show that the divergence of crack propagation was the result of DIGM. As shown in the Ni-map (see Fig. 3a), the sudden DIGM protrusion diverged the crack propagation from the original crack path to a very sharp corner, which could have led to its arrest. TKD analysis around the crack tip region is shown in the Fig. 3b. Comparing the DIGM in the regions 1 and 2 to that in region 3, the latter seemed to be more intense. The inverse pole figure (z-axis) (IPFZ) map in the Fig. 3b revealed that accelerated DIGM occurred in the region 3 might be because it is located close to a GB triple point. According to the results reported in literature [6,8,12–16], the DIGM is the result of elemental diffusion. At a triple point, diffusion of solute elements (Cr and Fe) was more available, resulting in the formation of a more intense DIGM, as shown in Fig. 3.
