Micromechanical testing of oxidized grain boundaries in Nickel alloys from nuclear reactors

Sergio Lozano-Perez¹, Helen Dugdale¹, David E J Armstrong¹, Takumi Terachi², Takuyo Yamada², Edmund Tarleton¹ and Steve G Roberts¹

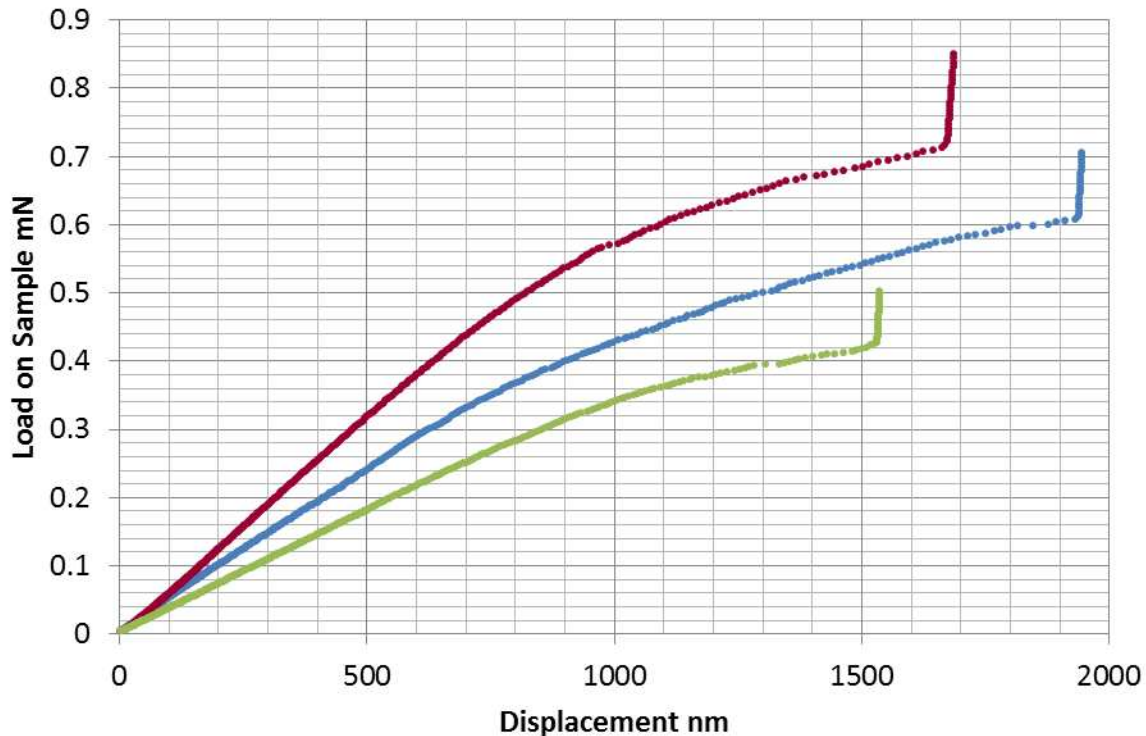
Figure 2: Load displacement curve for some of the type 'b' cantilevers tested which exhibited plastic deformation and no fracture.

Many of the cantilevers tested simply deformed plastically during testing and no fracture events could be seen on the load/displacement curves, as shown in Figure 2. They were all type 'b' (larger cross-section). Evidence of slip was observed on the surface and the cantilevers were plastically deformed and depressed into the trench.

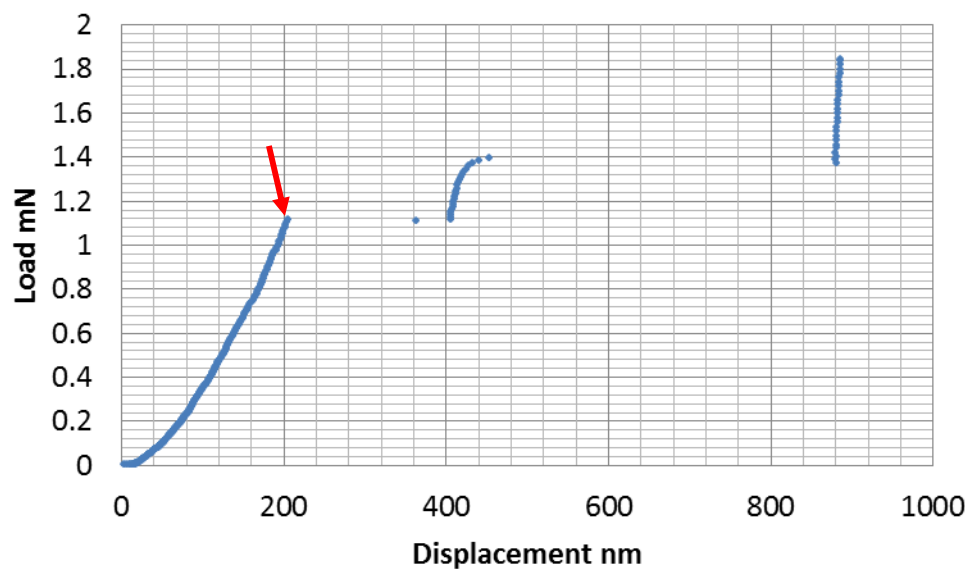
Figure 3: Load displacement curve for the cantilever shown in Figure 4, which exhibited complete fracture. The point where fracture occurred has been arrowed.

Most of the type 'a' cantilevers tested (smaller cross-section) exhibited complete fracture. Fracture occurred along the oxidized grain boundary, which covered the full cross-section. Although the recorded load-displacement data clearly shows the point where fracture occurred (arrowed in Figure 3), this data was not considered reliable since we believe that the nanoindenter tip contacted the trench edges during testing. This issue has been subsequently fixed and accurate data will be provided in our next publication. In Figure 4, a type a cantilever which exhibited full fracture during testing is shown.

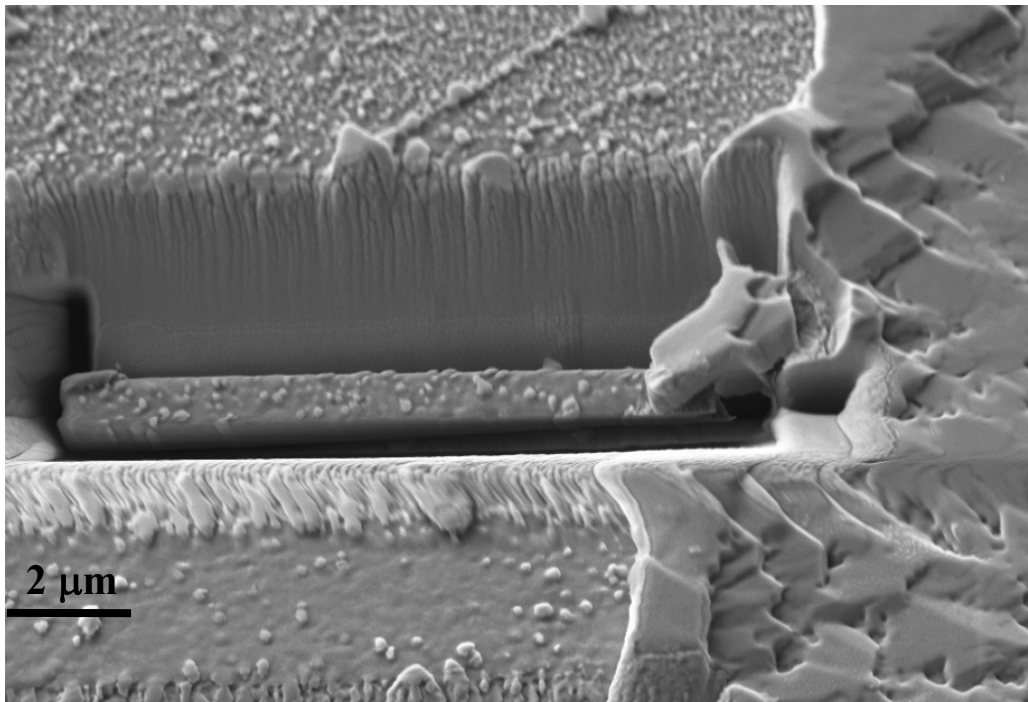
Figure 4: SEM SE image showing a type ‘a’ cantilever which exhibited complete fracture. The cantilever appears fully detached and is resting at the bottom of the trench.

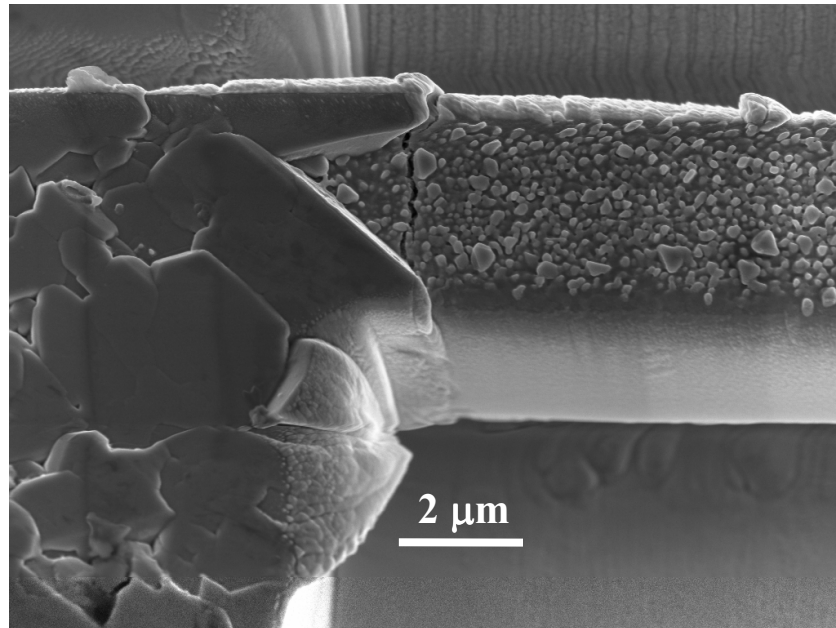
Figure 5: SEM SE image showing a type 'b' cantilever after testing. An intergranular crack has developed, but did not reach the bottom of the sample.

Type 'b' cantilevers, with a depth of over 4 μm , were usually found to fracture partially, as can be seen in Figure 5. A crack developed during testing but didn't reach the bottom of the sample. A detailed characterization by FIB 3D slicing revealed all the details of the fracture.

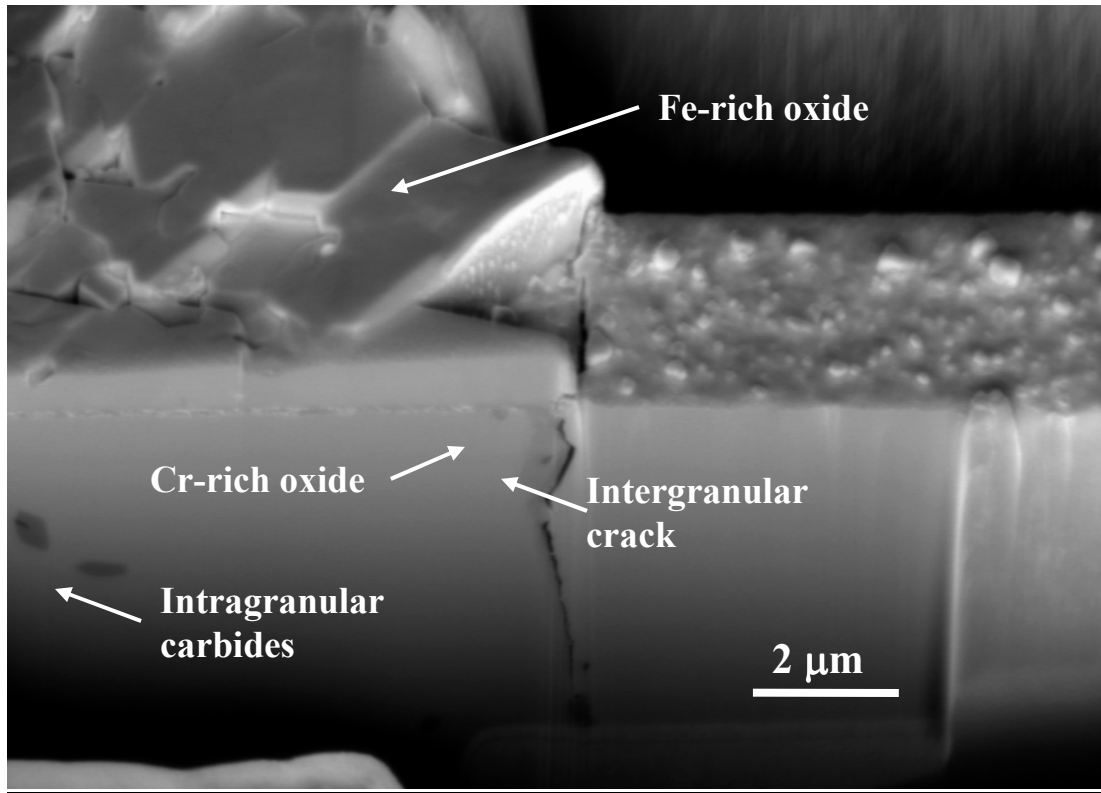
Figure 6: SEM in-lens image showing the same cantilever as in Figure 5 after the first slices have been milled to reveal the internal microstructure. The crack can be seen to propagate following the oxide-metal interface.

As can be seen in Figure 6, a cross-sectional view of the cantilever reveals that the crack has followed the oxide-metal interface. A detailed examination of the subsequent slices reveals that the Cr-depleted region around the intergranular Cr-rich carbide was oxidized preferentially (see 3D reconstruction in Figure 7). This, however, did not cause the crack to proceed in a straight manner across the oxide and, instead, it circumvented the wider oxide area, always following the oxide-metal interface.

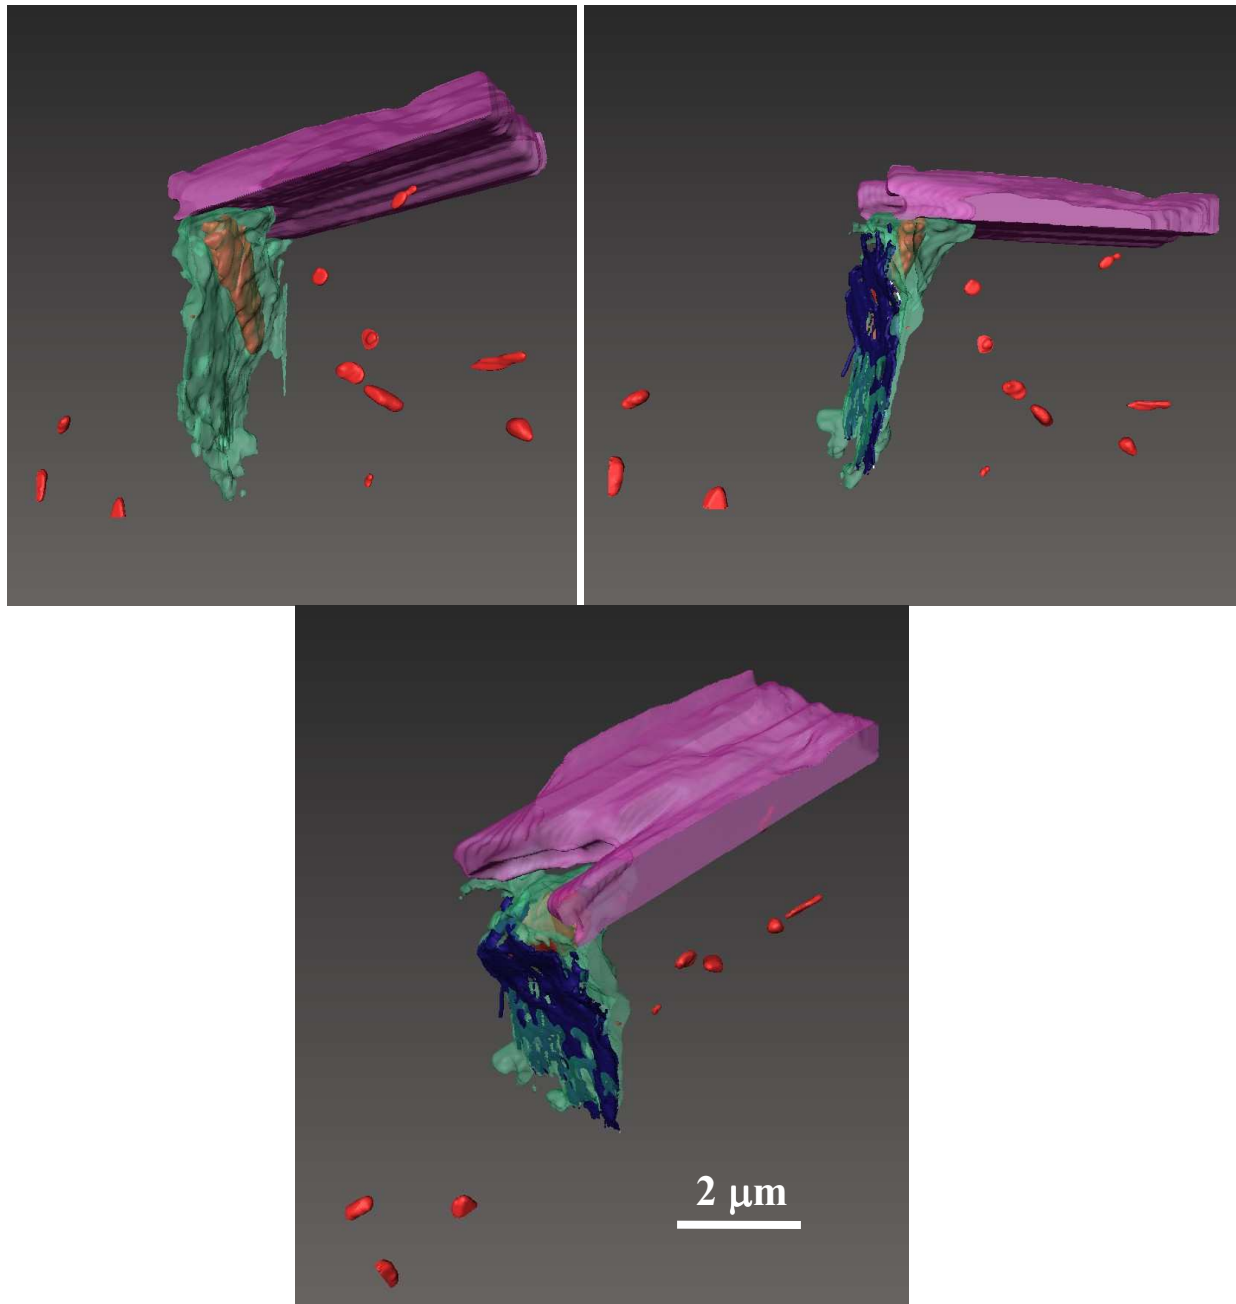
Figure 7: 3D reconstruction of the cantilever shown in Figure 5. 3 different perspectives are shown. Fe-rich oxide is shown in purple, Cr-rich oxide in green, Cr-rich carbides in red and the open crack in blue.

The 3D reconstruction also reveals that the depth of the crack is not homogeneous along the width of the cantilever, explaining why the sample did not fracture completely: there was not a fully oxidized grain boundary plane across the cantilever.

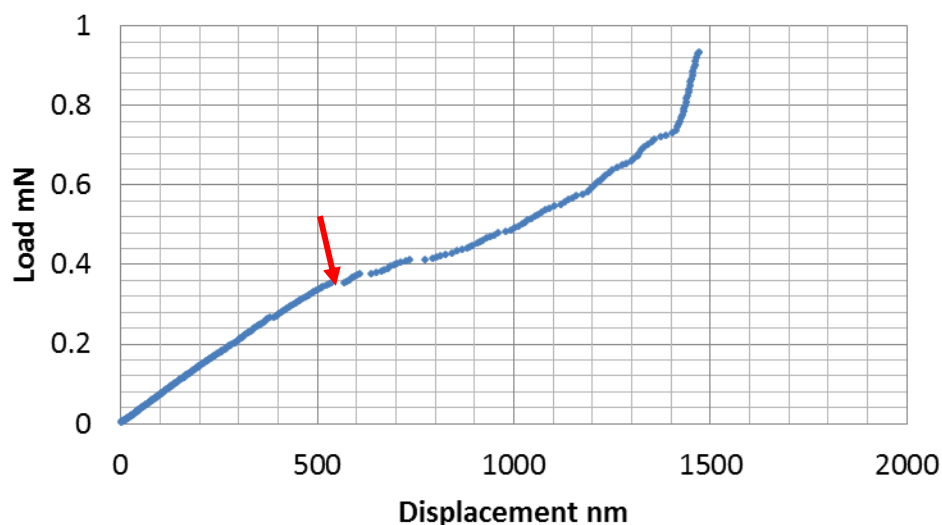
Figure 8: Load displacement curve for the cantilevers shown in Figure 5, which exhibited partial fracture. The point where fracture is believed to initiate has been arrowed.

The load-displacement curve recorded while testing the cantilever shown in Figure 5 is shown in Figure 8. The point where the crack first appeared is revealed in the plot by the small jumps in the data in the arrowed region. Further analysis is necessary to fully understand this data. At present, finite element modeling of a cantilever with the reconstructed geometry is being performed. A comparison between the experimental and the simulated load-displacement curves will help understanding the fracture behavior and the calculation of the real stress required to fracture the oxide.
