Effectiveness of commercial anti-graffiti treatments in two granites of different texture and mineralogy.

This paper presents a study of the efficiency of two chemically different anti-graffiti coatings (sacrificial and permanent anti-graffiti products) on two different compositional and textural granitic stones, Rosa Porriño and Albero.

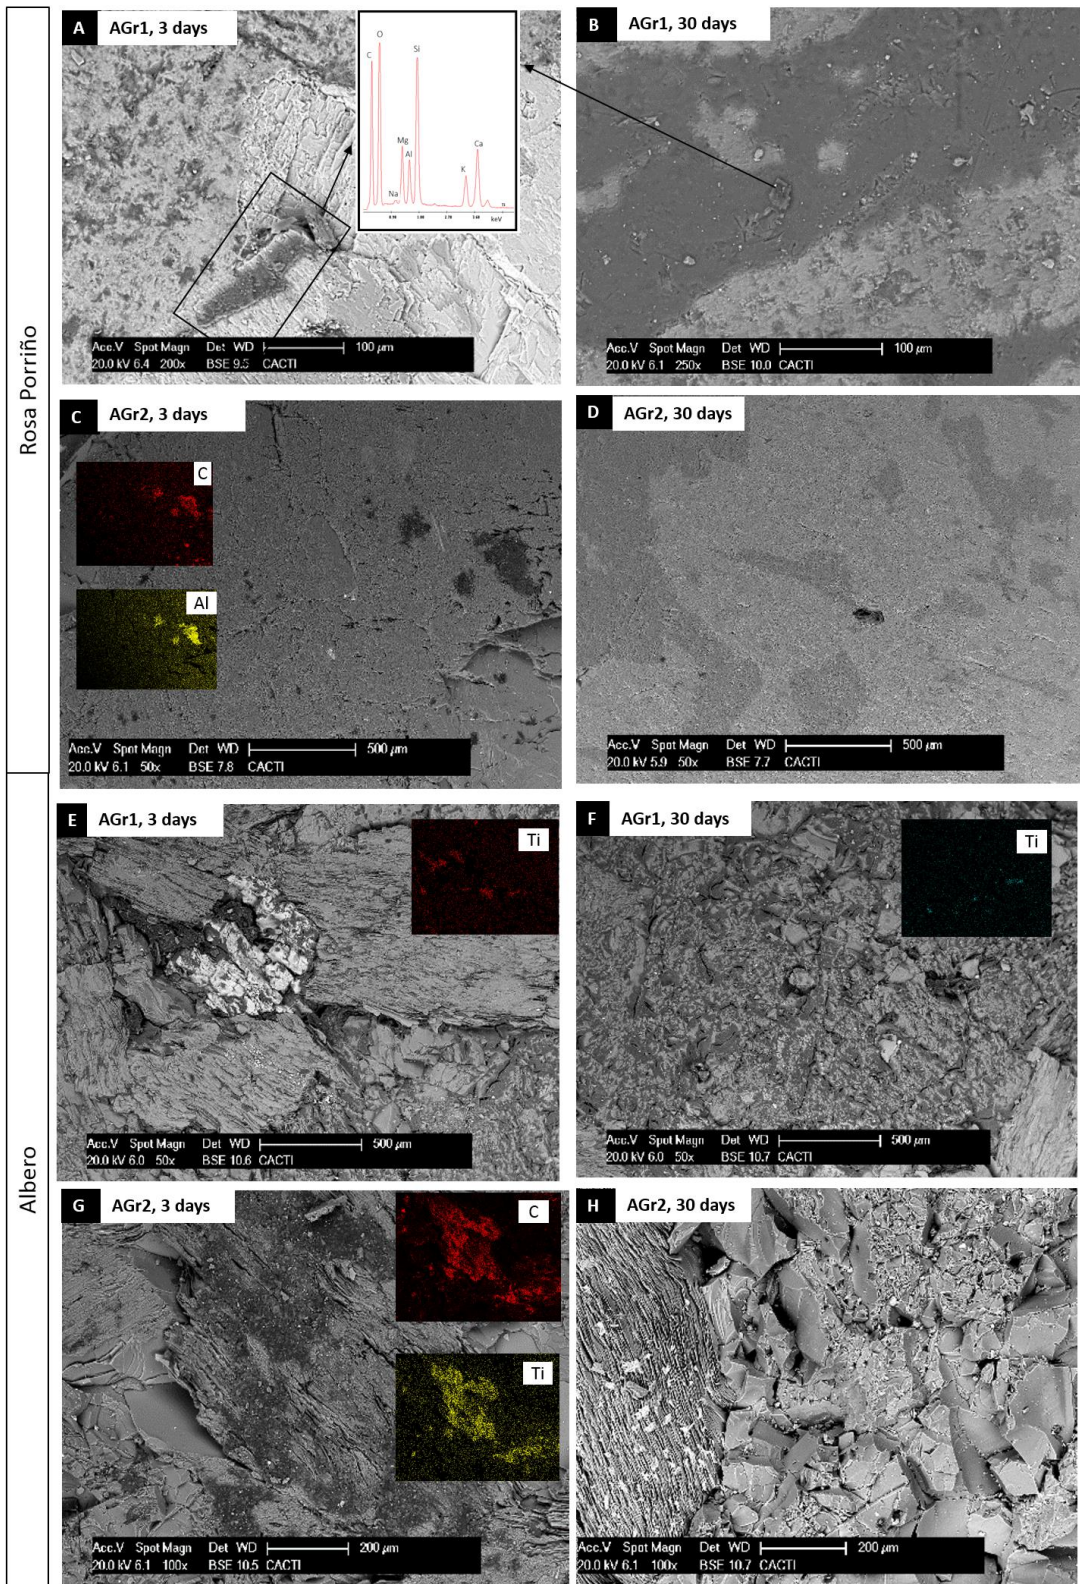
Fig. 5: SEM micrographs and EDS spectra of the surfaces of Rosa Porriño and Albero granites with anti-graffiti products AGr1 and AGr2 after the extraction of silver graffiti.

spectrum from the fissures were absent (Fig. 6C). Therefore, the fact that the rest of the cleaned Albero surfaces coated with AGr2 showed higher θ° than the reference surface suggests the presence of graffiti remains filling the fractures and fissures on the surfaces as was detected via SEM through voluminous C-rich volumes with Al, Mg, Ca and Ti for the blue graffiti and with Al-rich particle for the silver graffiti.

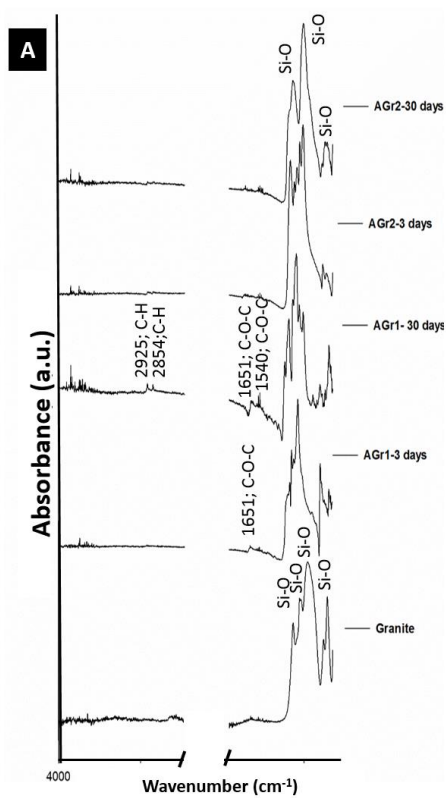
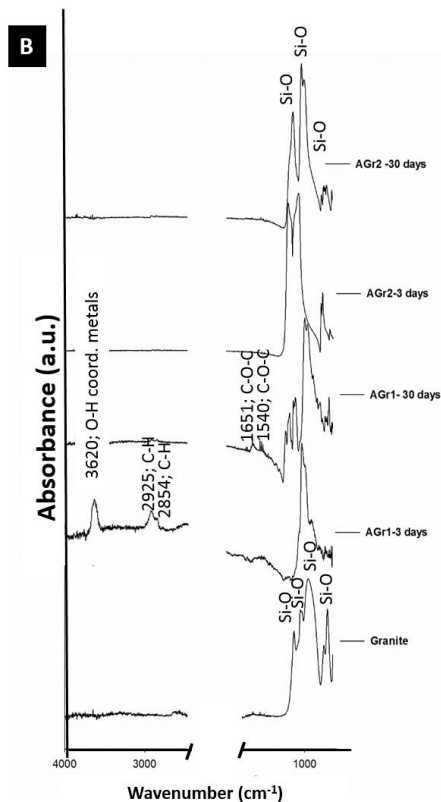
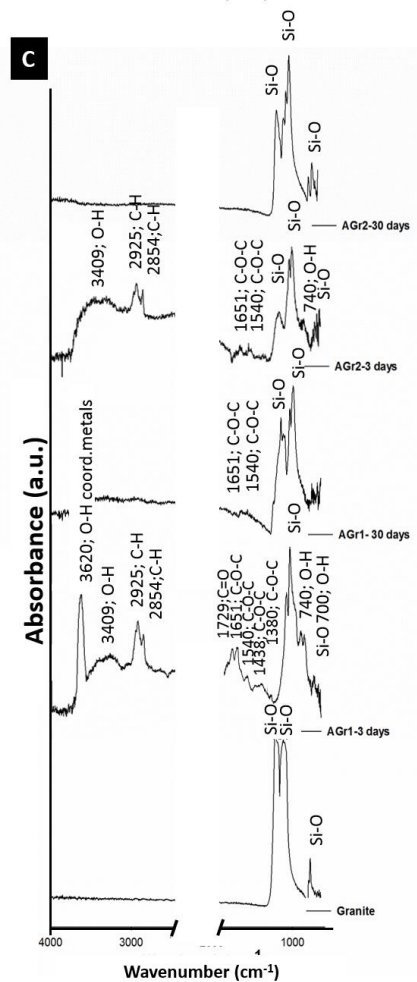
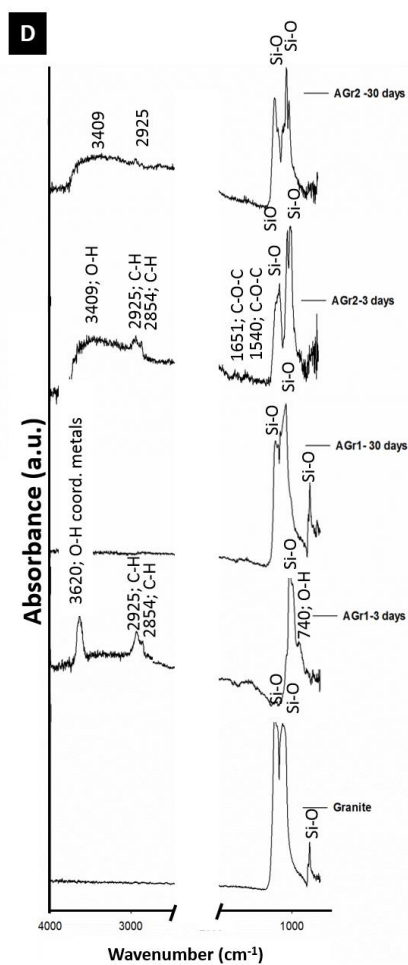
Fig. 6. Fourier transform infrared (FTIR) spectra (absorbance) obtained for the evaluation of the cleaning effectiveness of blue (A and C) and silver graffiti (B and D) on uncoated samples of Rosa Porriño (A and B) and Albero (C and D) and coated with AGr1 and AGr2 anti-graffitis. Spectra obtained at 3 days and at 30 days after the graffiti application are depicted.

Fig. 6 depicts the most representative FTIR (absorbance) spectra for Rosa Porriño (A and B) and Albero (C and D) granites coated with AGr1 and AGr2 after cleaning of both graffiti colours (3 and

Regarding cleaning results and corroborating SEM observations, in general terms, the surfaces of Rosa Porriño exhibited lesser graffiti residues than the surfaces of Albero because less bands and/or less intense bands assigned to graffiti were identified in the FTIR spectra of cleaned Rosa Porriño surfaces. Speaking about Rosa Porriño covered with both anti-graffiti products, considering FTIR results (blue graffiti cleaned surfaces: Fig 6A; silver graffiti cleaned surfaces: Fig 6B), different behaviours were identified depending on the anti-graffiti nature: 1) in the surface coated with AGr1, bands assigned to graffiti (both colours) were identified in the FTIR spectra of the surfaces cleaned after both times (3 and 30 days after graffiti application) and 2) for samples coated with AGr2, FTIR spectra without any bands assigned to graffiti remains were obtained. In the case of surfaces coated with AGr1, SEM also allowed to find graffiti remains on the surfaces after the cleaning at both different times, but less graffiti remains 30 days after graffiti application comparatively to the surfaces cleaned 3 days after graffiti application. For surfaces coated with

In the case of Albero surfaces coated with AGr1 and AGr2 (blue graffiti cleaned surfaces: Fig. 6C; silver graffiti cleaned surfaces: Fig. 6D), blue and silver graffiti remains were still detected by their intense absorption bands in the FTIR spectra taken on the surfaces cleaned 3 days after graffiti application corroborating the results by SEM. It was observed that on Albero surfaces cleaned 30 days after graffiti application, in their FTIR spectra the bands assigned to graffiti were less intense or inexistent comparatively to these bands in the spectra registered on the surfaces cleaned 3 days after graffiti application.
