Hydrogen-enhanced oxidation of ferrite phase in stainless steel cladding and the contribution to stress corrosion cracking in deaerated high temperature water

Abstract

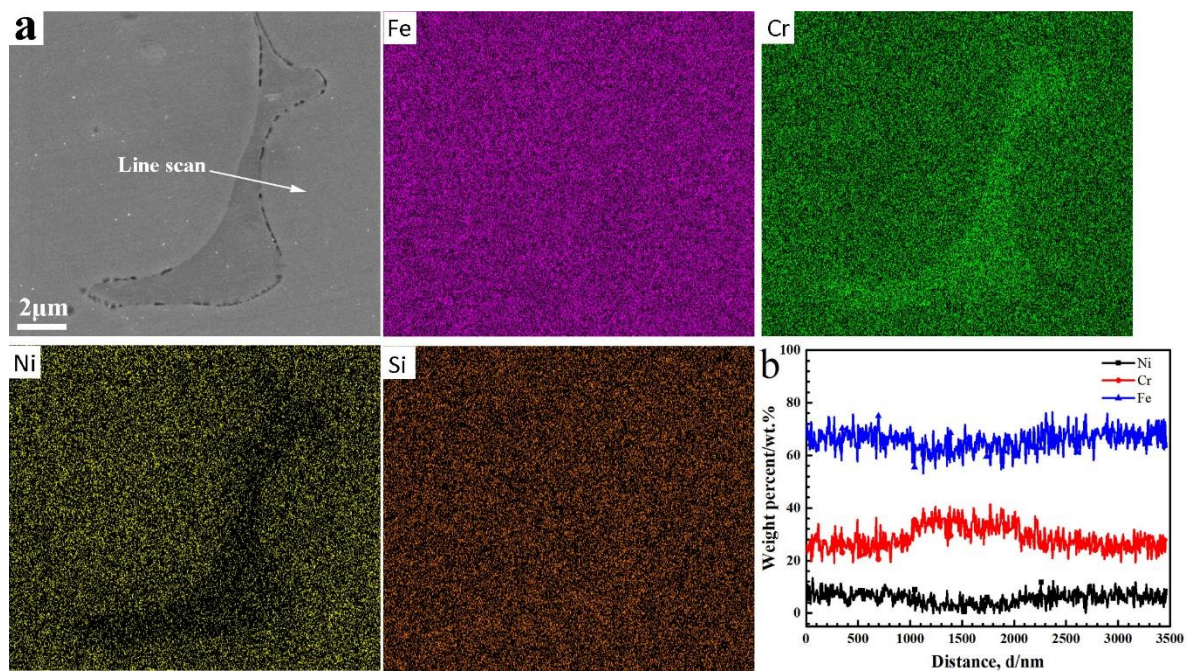
Fig. 2. The SEM-EDS area maps and the element profile of the ferrite in 308L SS.

Fig. 2. The SEM-EDS area maps and the element profile of the ferrite in 308L SS.

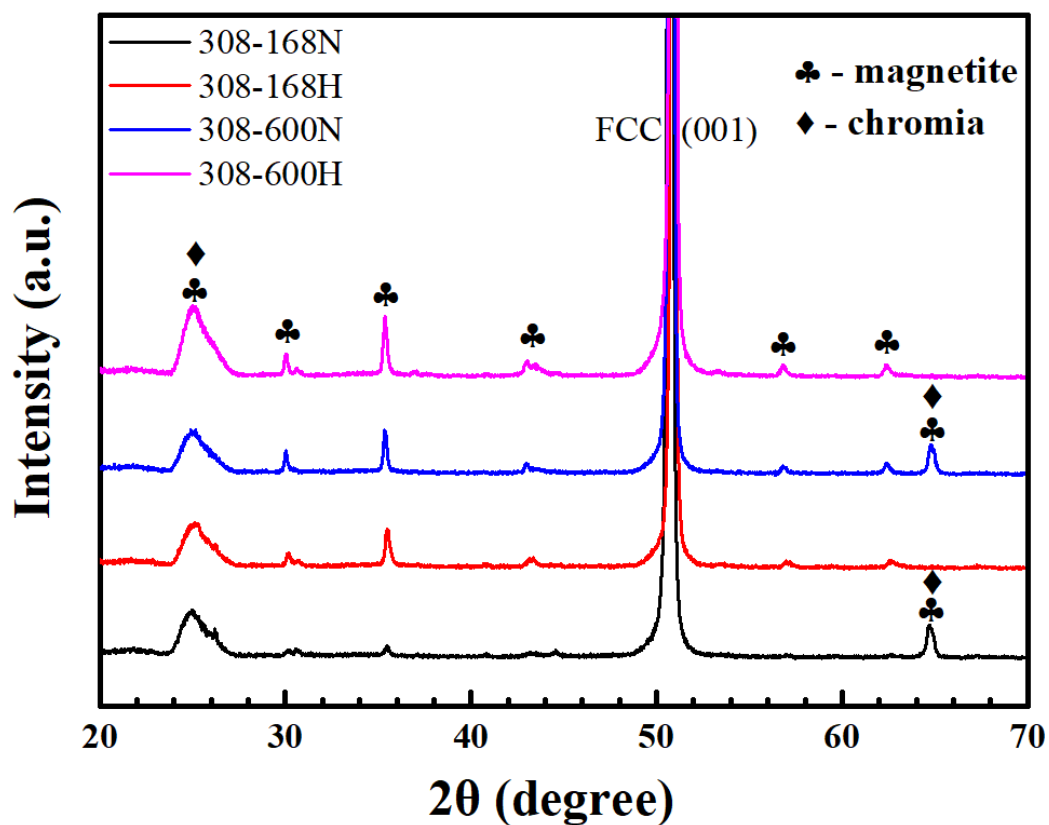
Fig. 3. XRD patterns of the oxide film formed on 308L SS with and without charged-hydrogen after being exposed to deaerated high temperature water at 290 °C for 168 h and 600 h.

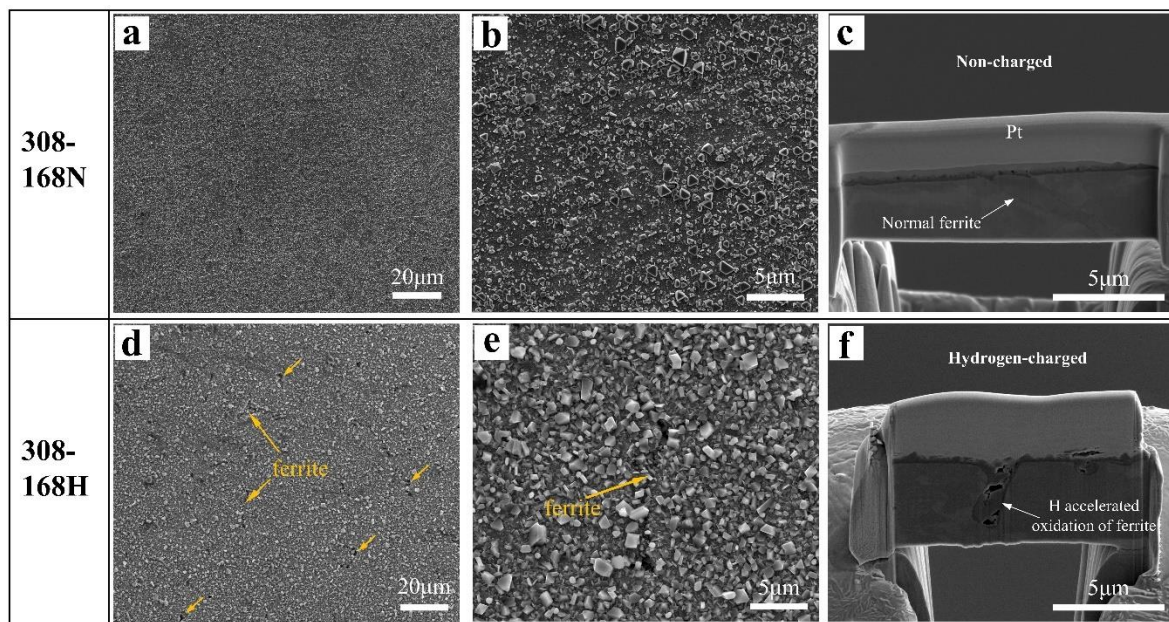
Fig. 4. SEM images showing the morphologies of oxide films and ferrites after being exposed to deaerated high temperature water at 290 °C for 168 h: (a) (b) (c) 308-168N, (d) (e) (f) 308-168H.

Fig. 4. SEM images showing the morphologies of oxide films and ferrites after being exposed to deaerated high temperature water at 290 °C for 168 h: (a) (b) (c) 308-168N, (d) (e) (f) 308-168H.

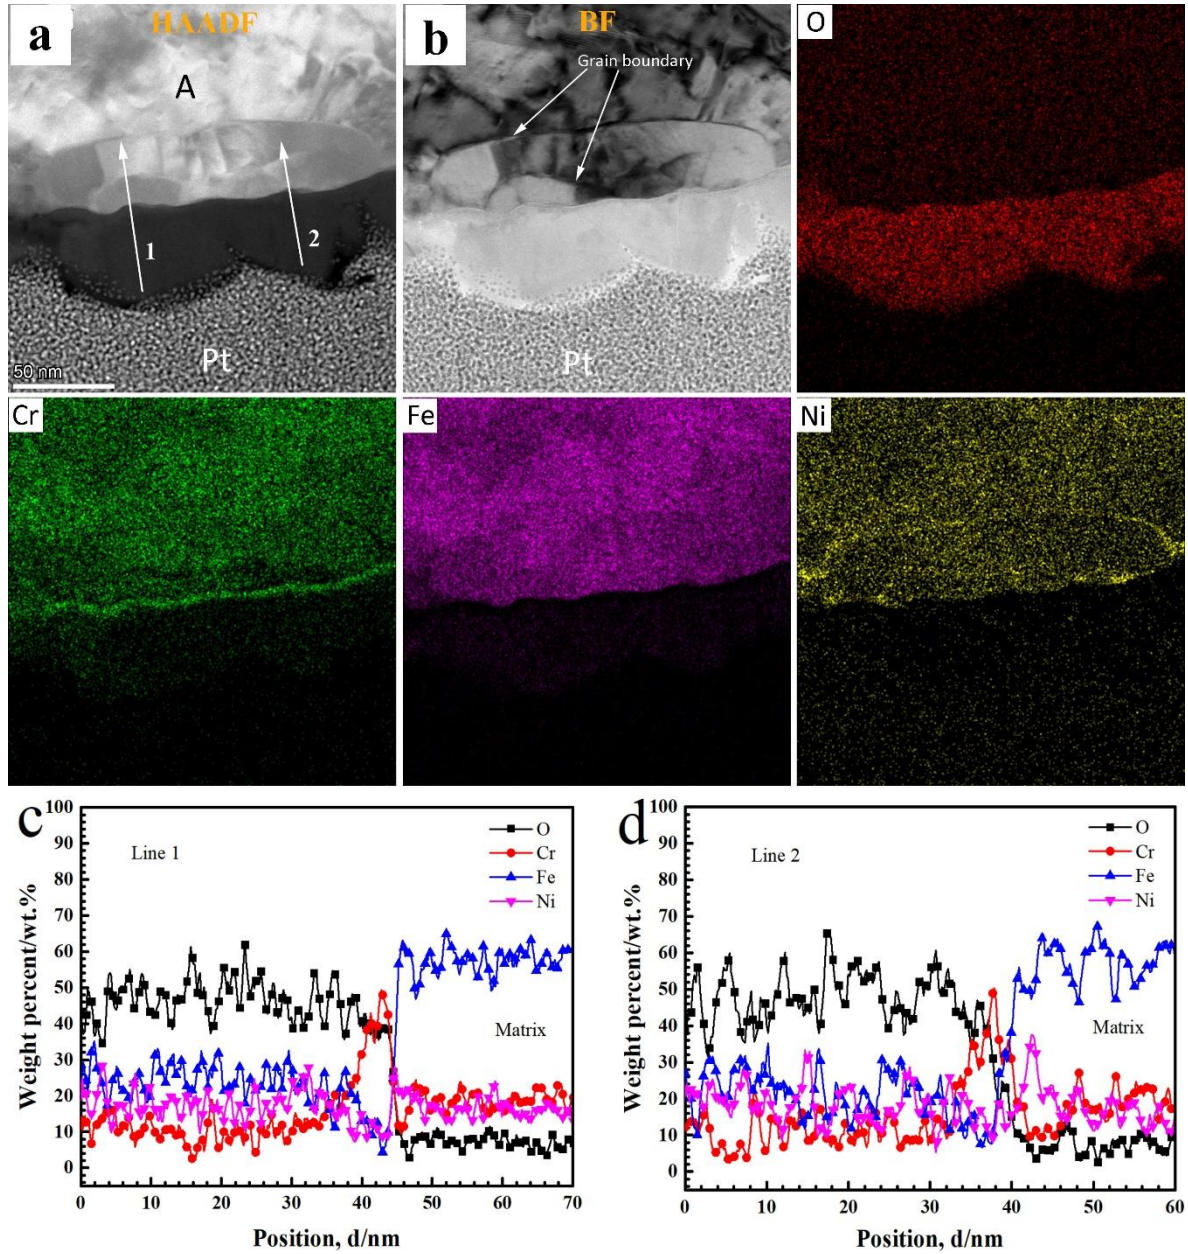
Fig. 5. TEM-EDS results of the oxide film formed on austenite of 308-168N after being exposed to deaerated high temperature water at 290 °C for 168 h: (a) (b) STEM-HAADF and STEM-BF images of the oxide film formed on austenite and the corresponding EDS area maps, (c) EDS line scan profile shown in (a) as line 1, (d) EDS line scan shown in (a) as line 2.

Fig. 5. TEM-EDS results of the oxide film formed on austenite of 308-168N after being exposed to deaerated high temperature water at 290 °C for 168 h: (a) (b) STEM-HAADF and STEM-BF images of the oxide film formed on austenite and the corresponding EDS area maps, (c) EDS line scan profile shown in (a) as line 1, (d) EDS line scan shown in (a) as line 2.

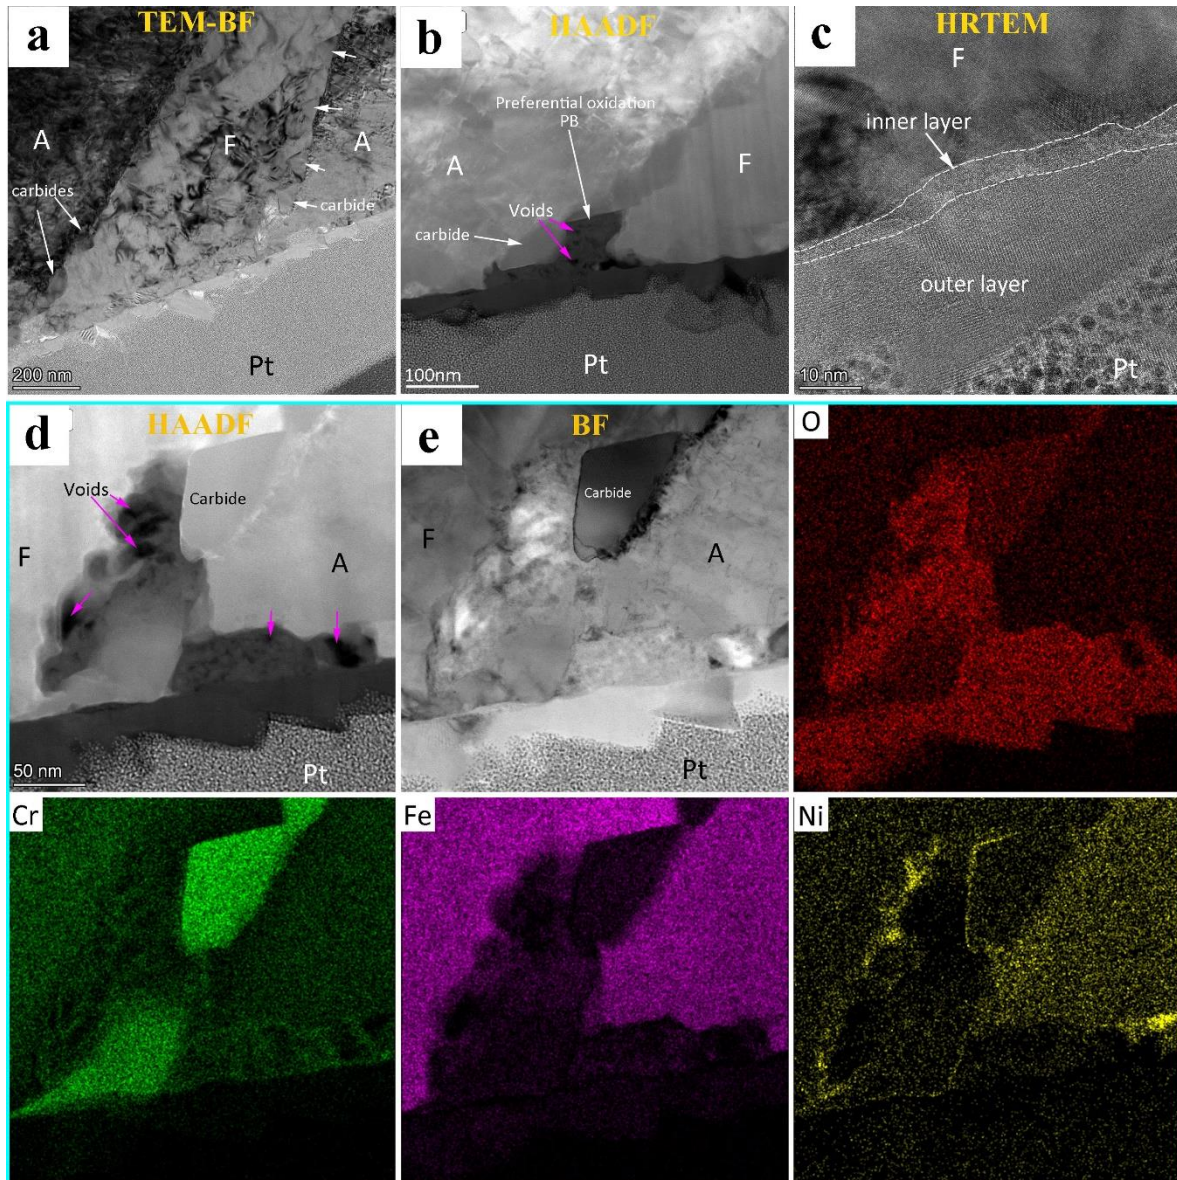
Fig. 6. TEM results of the sampling location of the phase boundary and the oxide film formed on 308-168N after being exposed to deaerated high temperature water at 290 °C for 168 h: (a) TEM-BF image of the oxide films and phase boundary, (b) STEM-HAADF image of the oxide film formed near the left side phase boundary shown in (a), (c) HRTEM image of the oxide film on ferrite, (d) (e) STEM-HAADF and STEM-BF images of the oxide film formed near the right side phase boundary shown in (a), and the corresponding EDS area maps.

Fig. 6. TEM results of the sampling location of the phase boundary and the oxide film formed on 308-168N after being exposed to deaerated high temperature water at 290 °C for 168 h: (a) TEM-BF image of the oxide films and phase boundary, (b) STEM-HAADF image of the oxide film formed near the left side phase boundary shown in (a), (c) HRTEM image of the oxide film on ferrite, (d) (e) STEM-HAADF and STEM-BF images of the oxide film formed near the right side phase boundary shown in (a), and the corresponding EDS area maps.

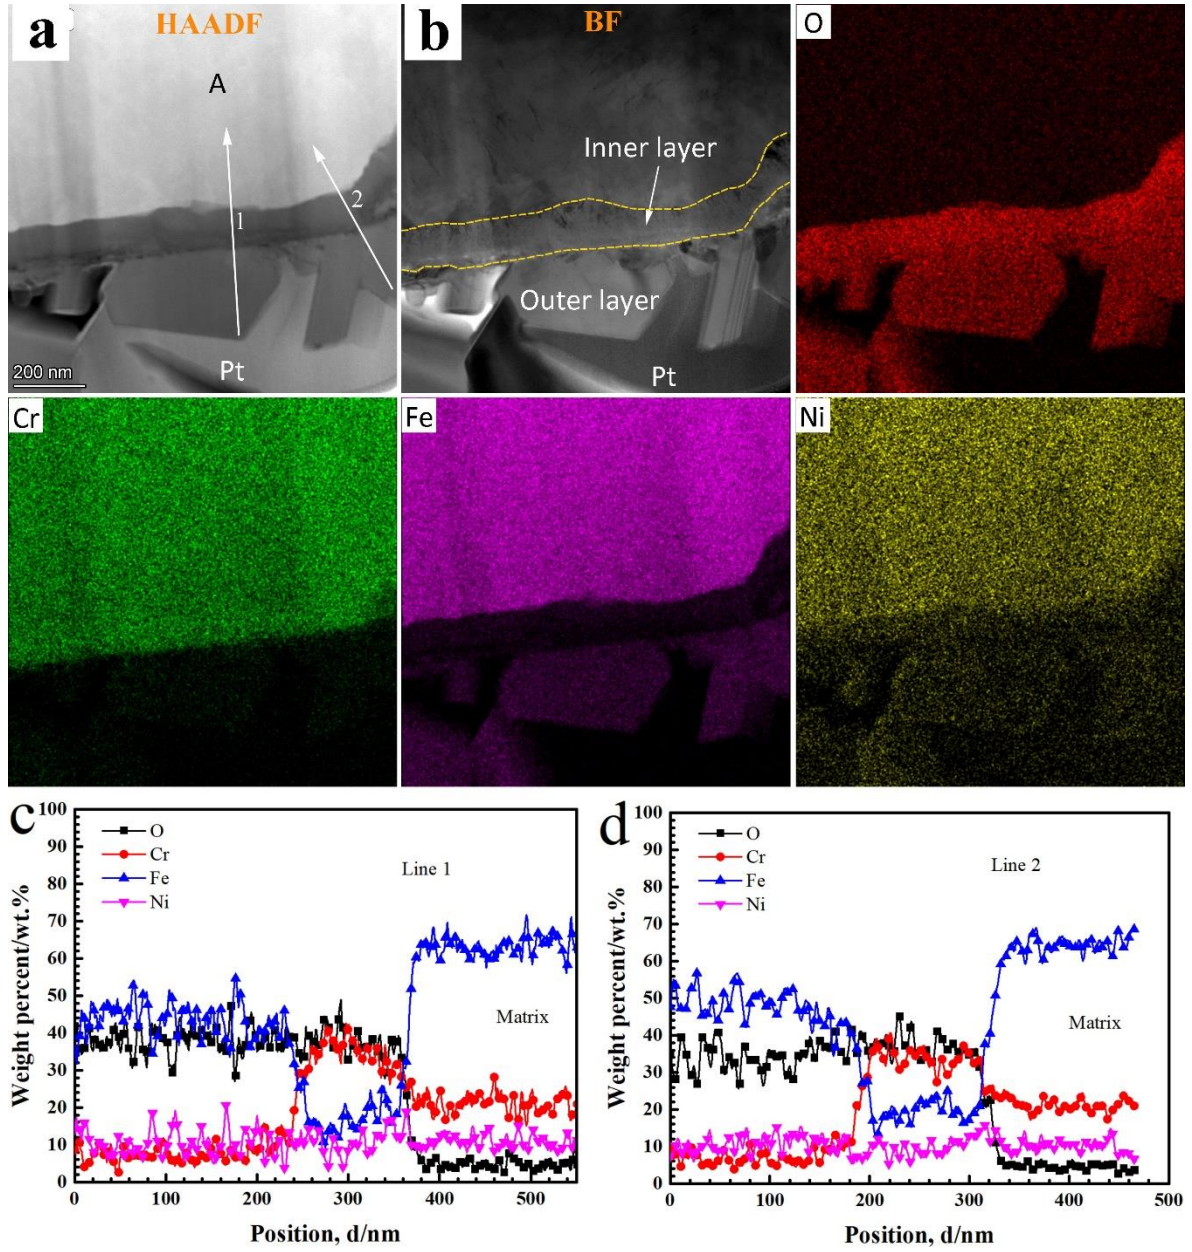
Fig. 7. TEM-EDS results of the oxide film formed on austenite of 308-168H after being exposed to deaerated high temperature water at 290 °C for 168 h: (a) STEM-HAADF image of the oxide films on austenite and the corresponding EDS area maps, (b) STEM-BF image of the oxide films on austenite, (c) EDS line scan profile shown in (a) as line 1, (d) EDS line scan shown in (a) as line 2.

Fig. 7. TEM-EDS results of the oxide film formed on austenite of 308-168H after being exposed to deaerated high temperature water at 290 °C for 168 h: (a) STEM-HAADF image of the oxide films on austenite and the corresponding EDS area maps, (b) STEM-BF image of the oxide films on austenite, (c) EDS line scan profile shown in (a) as line 1, (d) EDS line scan shown in (a) as line 2.

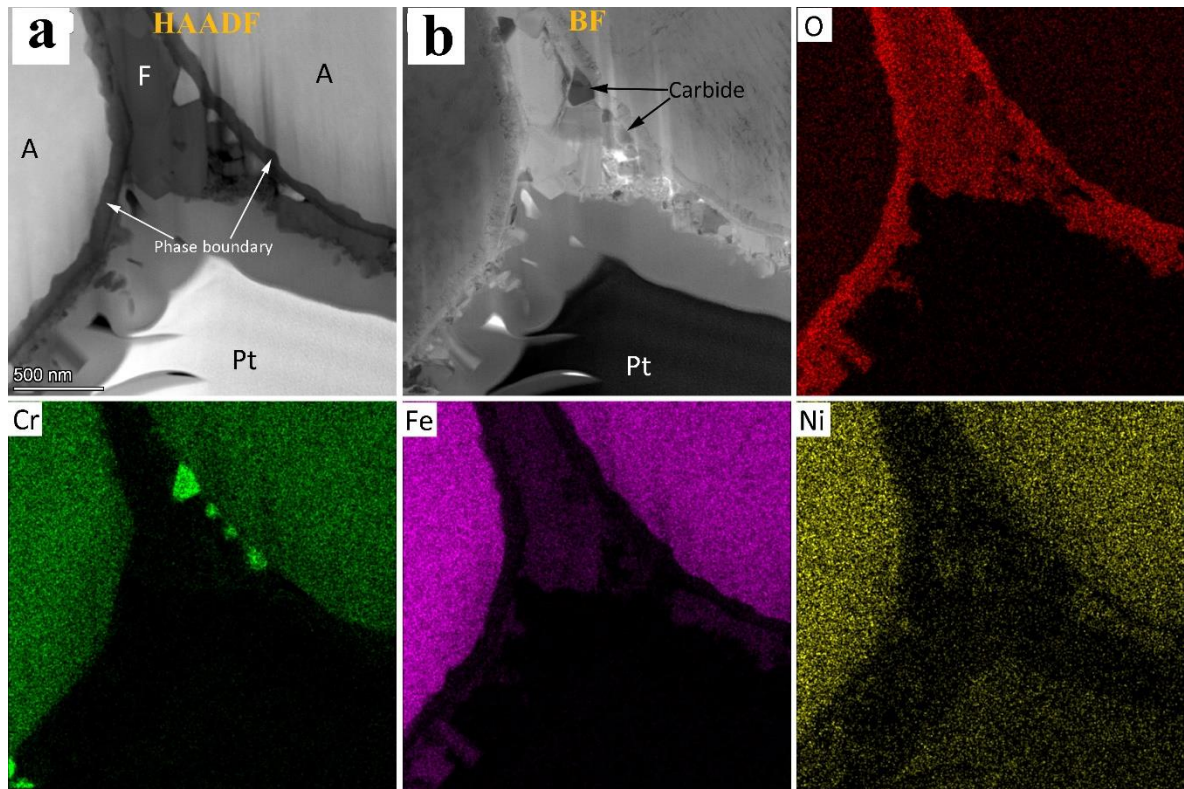
Fig. 8. TEM-EDS results of the sampling location of the phase boundary and the oxide film formed on 308-168H after being exposed to deaerated high temperature water at 290 °C for 168 h: (a) STEM-HAADF image of the oxide films formed near phase boundary and the corresponding EDS area maps, (b) STEM-BF image of the oxide films formed near phase boundary.

Fig. 8. TEM-EDS results of the sampling location of the phase boundary and the oxide film formed on 308-168H after being exposed to deaerated high temperature water at 290 °C for 168 h: (a) STEM-HAADF image of the oxide films formed near phase boundary and the corresponding EDS area maps, (b) STEM-BF image of the oxide films formed near phase

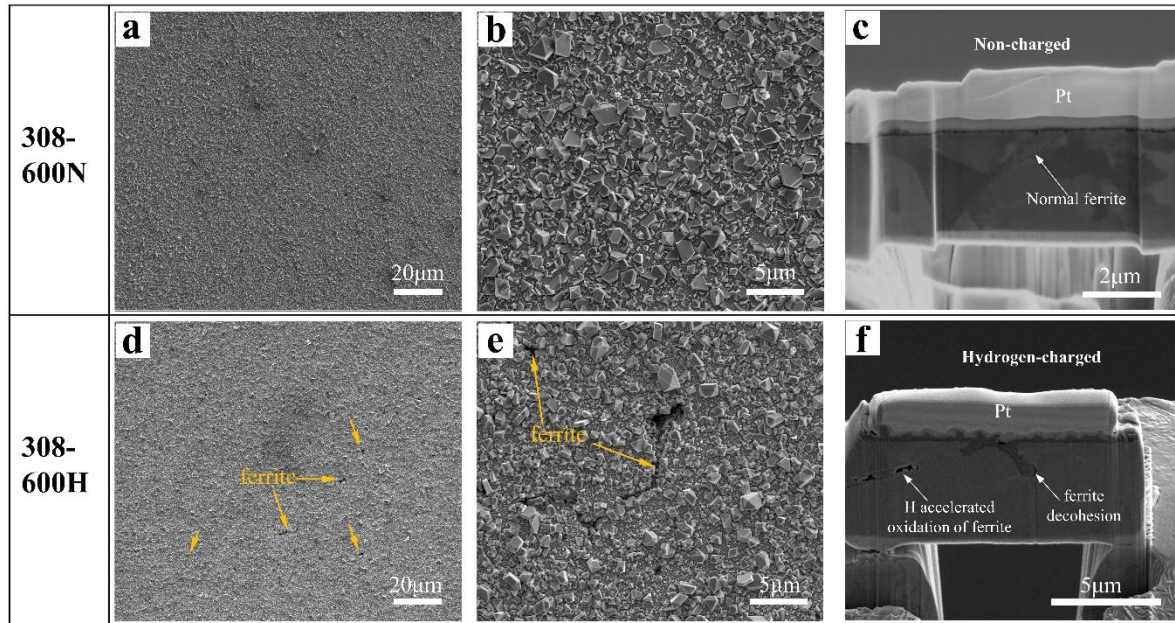
Fig. 9. SEM images showing the morphologies of oxide films and ferrites after being exposed to deaerated high temperature water at 290 °C for 600 h: (a) (b) (c) 308-600N, (d) (e) (f) 308-600H.

Fig. 9. SEM images showing the morphologies of oxide films and ferrites after being exposed to deaerated high temperature water at 290 °C for 600 h: (a) (b) (c) 308-600N, (d) (e) (f) 308-600H.

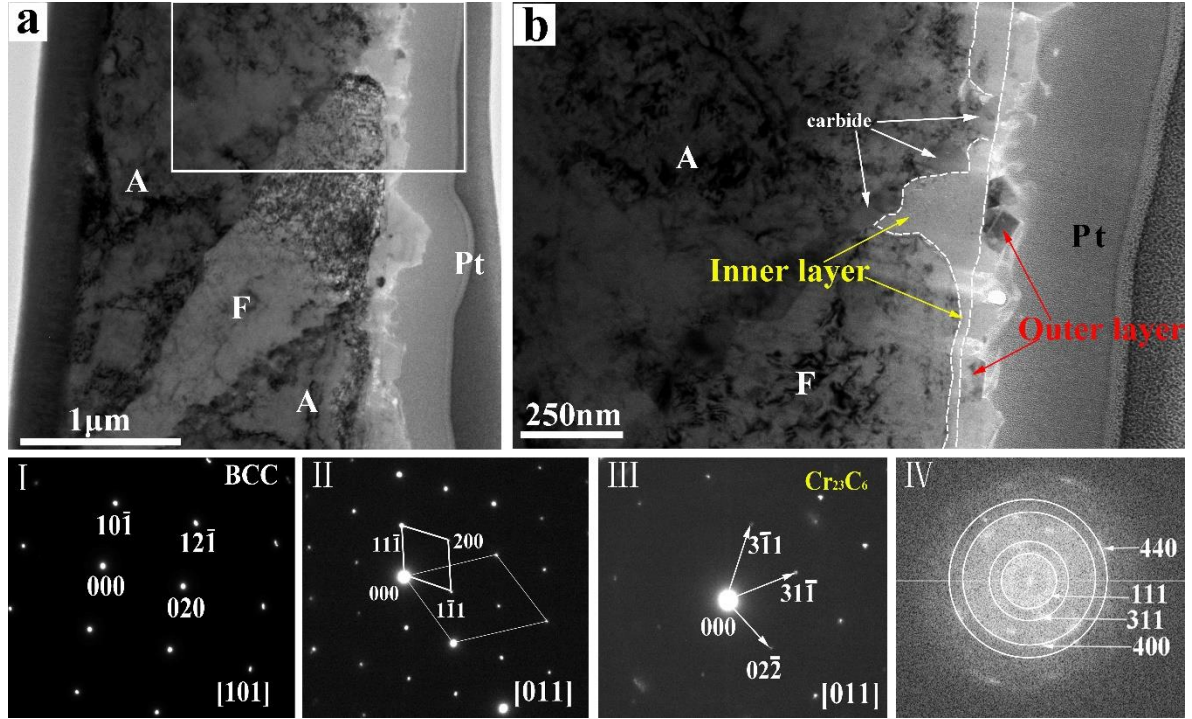
Fig. 11. TEM results of the sampling location of the phase boundary and the oxide film formed on 308-600N after being exposed to deaerated high temperature water at 290 °C for 600 h: (a) TEM-BF image of the austenite/ferrite phases and oxide film, (b) High magnification TEM-BF image of the phase boundary and oxide film, as located in (a) rectangular area. SAED image of the ferrite is shown in (b) as pattern I, SAED image of the outer oxide is shown in (b) as pattern II, SAED image of the carbide is shown in (b) as pattern III, and the diffractions from FFT of the inner oxide is shown in (b) as pattern IV. [36]

Fig. 11. TEM results of the sampling location of the phase boundary and the oxide film formed on 308-600N after being exposed to deaerated high temperature water at 290 °C for 600 h: (a) TEM-BF image of the austenite/ferrite phases and oxide film, (b) High magnification TEM-BF image of the phase boundary and oxide film, as located in (a) rectangular area. SAED image of the ferrite is shown in (b) as pattern I, SAED image of the outer oxide is shown in (b) as pattern II, SAED image of the carbide is shown in (b) as pattern III, and the diffractions from FFT of the inner oxide is shown in (b) as pattern IV. [36]

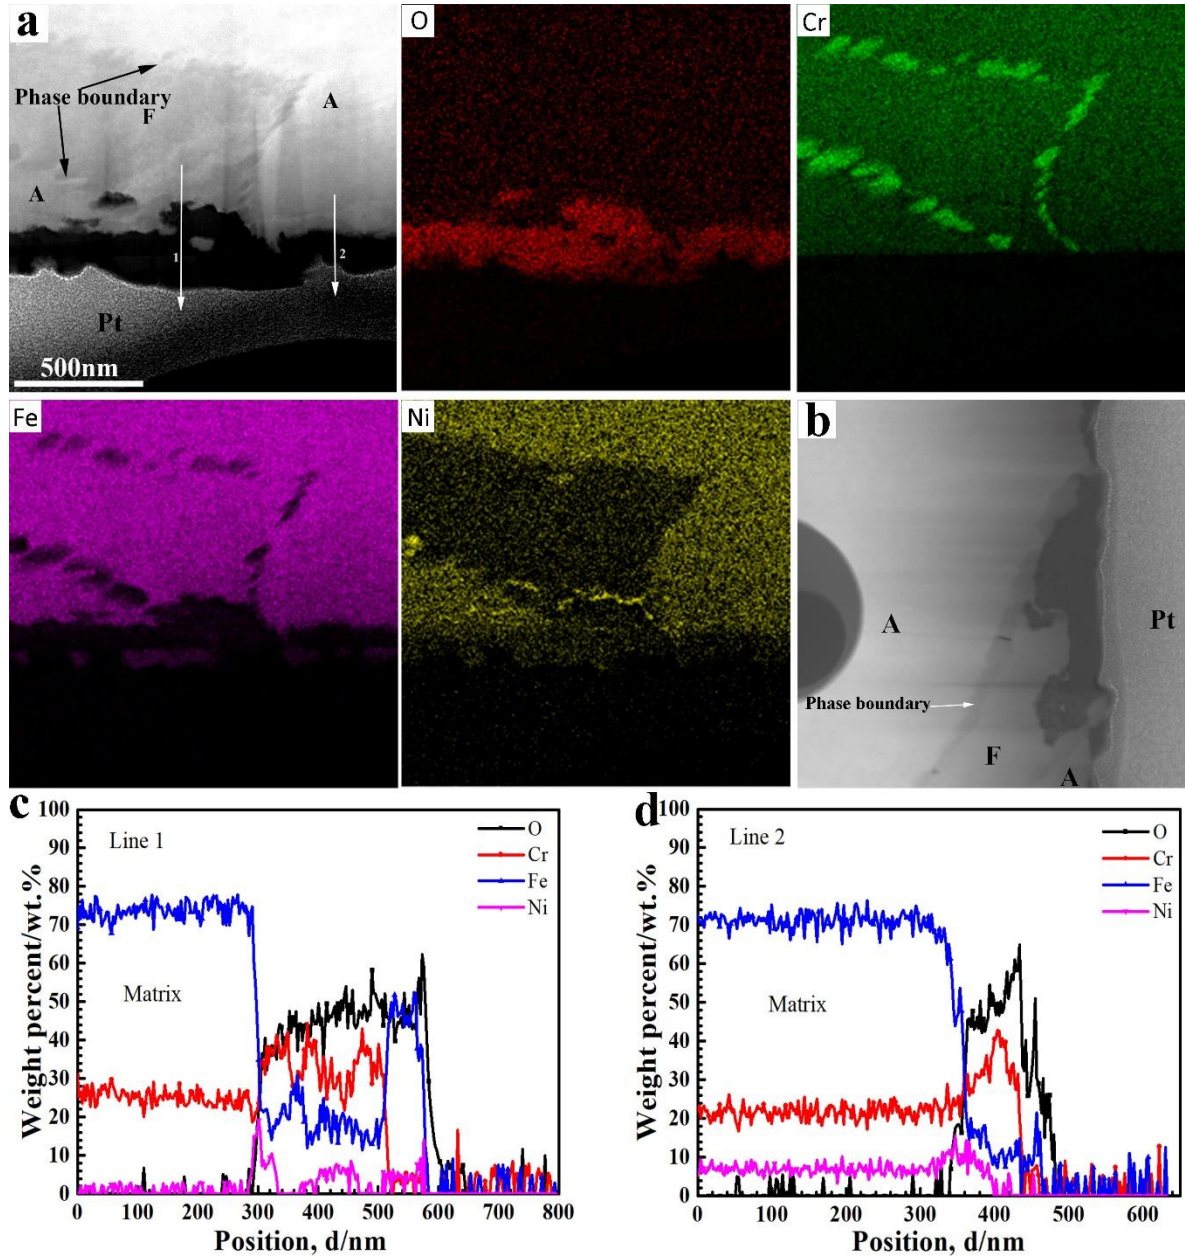
Fig. 13. TEM-EDS results of the sampling location of the phase boundary and the oxide film formed on 308-600H after being exposed to deaerated high temperature water at 290 °C for 600 h: (a) STEM-HAADF image of the sampling location 1 of the phase boundary and the oxide film, and the corresponding EDS area maps, (b) STEM-HAADF image of the sampling location 2 of the phase boundary and the oxide film, (c) EDS line scan profile shown in (a) as line 1, (d) EDS line scan profile shown in (a) as line 2. [36]

Fig. 13. TEM-EDS results of the sampling location of the phase boundary and the oxide film formed on 308-600H after being exposed to deaerated high temperature water at 290 °C for 600 h: (a) STEM-HAADF image of the sampling location 1 of the phase boundary and the oxide film, and the corresponding EDS area maps, (b) STEM-HAADF image of the sampling location 2 of the phase boundary and the oxide film, (c) EDS line scan profile shown in (a)

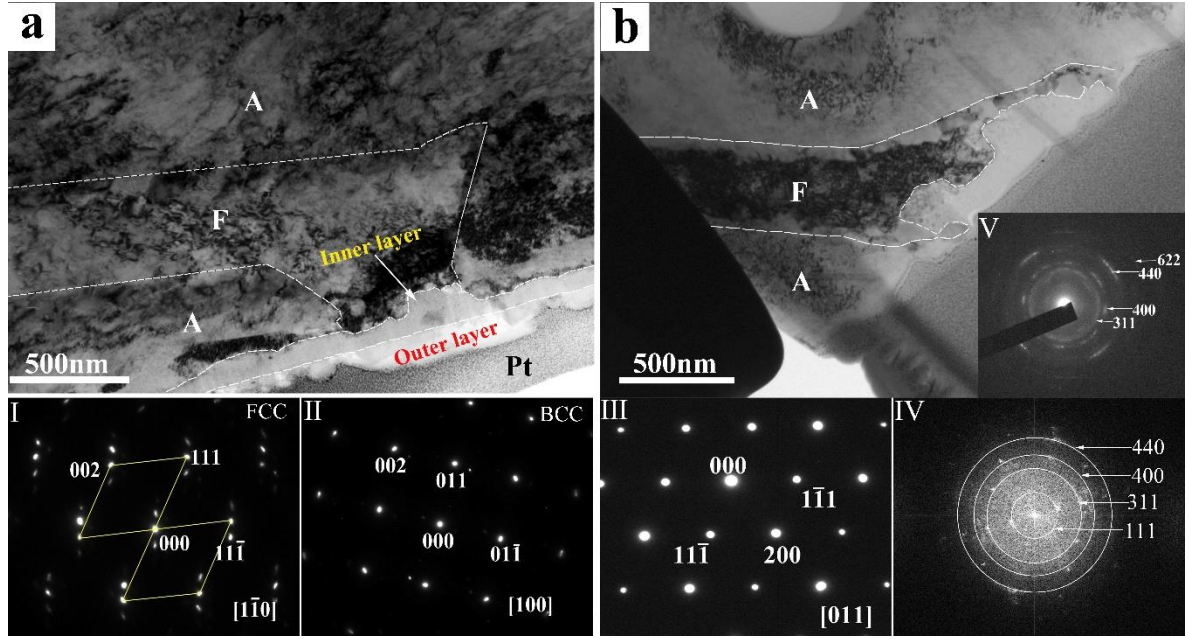
Fig. 14. TEM results of the sampling locations of the phase boundaries and oxide films formed on 308-600H after being exposed to deaerated high temperature water at 290 °C for 600 h: (a) TEM-BF image of the sampling location 1 of the phase boundary and oxide film, (b) TEM-BF image of the sampling location 2 of the phase boundary and oxide film. SAED image of the austenite is shown in (a) as pattern I, SAED image of the ferrite is shown in (a) as pattern II, SAED image of the outer oxide is shown in (a) as pattern III, the diffractions from FFT of the inner oxide is shown in (a) as pattern IV, the SAED image of the inner oxide is shown in (b) as pattern V. [36] □

Fig. 14. TEM results of the sampling locations of the phase boundaries and oxide films formed on 308-600H after being exposed to deaerated high temperature water at 290 °C for 600 h: (a) TEM-BF image of the sampling location 1 of the phase boundary and oxide film, (b) TEM-BF image of the sampling location 2 of the phase boundary and oxide film. SAED image of the austenite is shown in (a) as pattern I, SAED image of the ferrite is shown in (a) as pattern II, SAED image of the outer oxide is shown in (a) as pattern III, the diffractions from FFT of the inner oxide is shown in (a) as pattern IV, the SAED image of the inner oxide is shown in (b) as pattern V. [36]

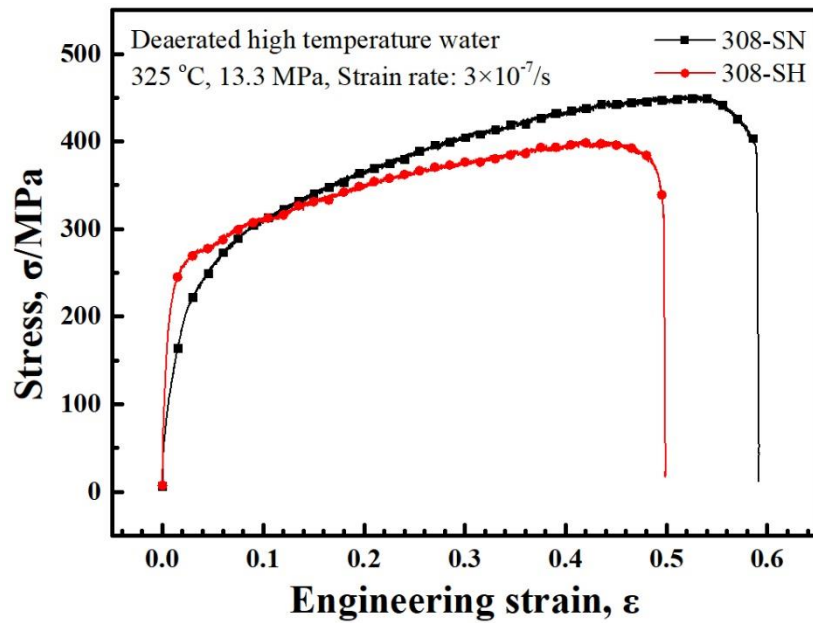
Fig. 15. Stress-strain curves after SSRT test at 3×10^{-7} /s for 308-SN and 308-SH specimens in deaerated high temperature water at 325 °C.

Fig. 15. Stress-strain curves after SSRT test at 3×10^{-7} /s for 308-SN and 308-SH specimens in deaerated high temperature water at 325 °C.

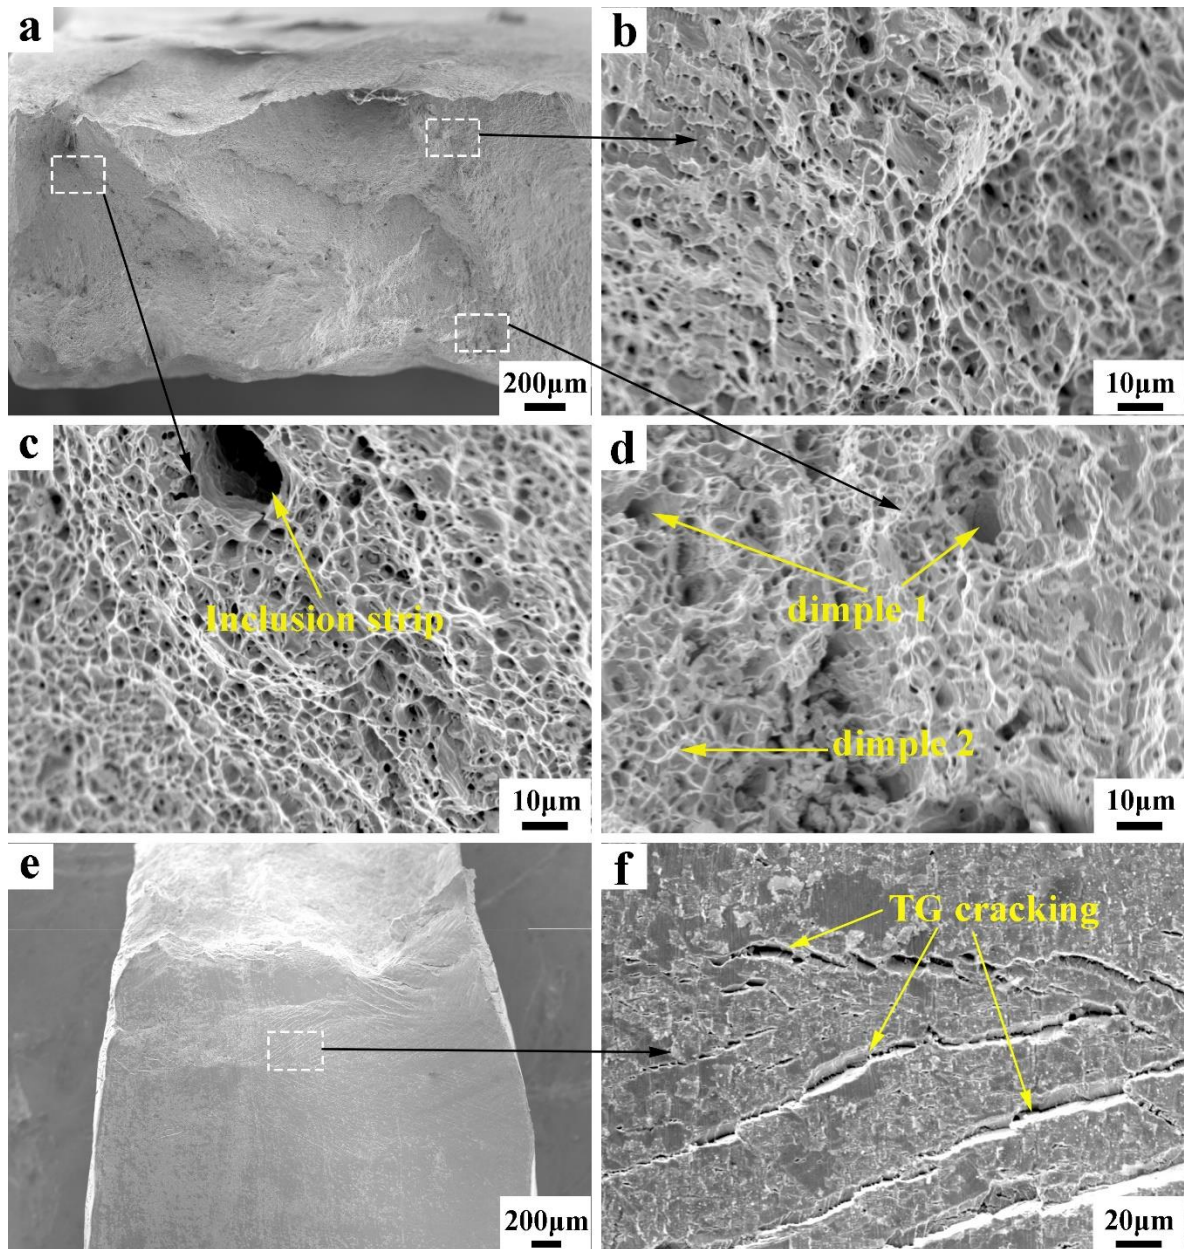
Fig. 16. SEM morphologies of the fracture surface after SSRT test at 3×10^{-7} /s for 308-SN specimen in deaerated high temperature water at 325 °C.

Fig. 16. SEM morphologies of the fracture surface and gauge side after SSRT test at 3×10^{-7} /s for 308-SN specimen in deaerated high temperature water at 325 °C.

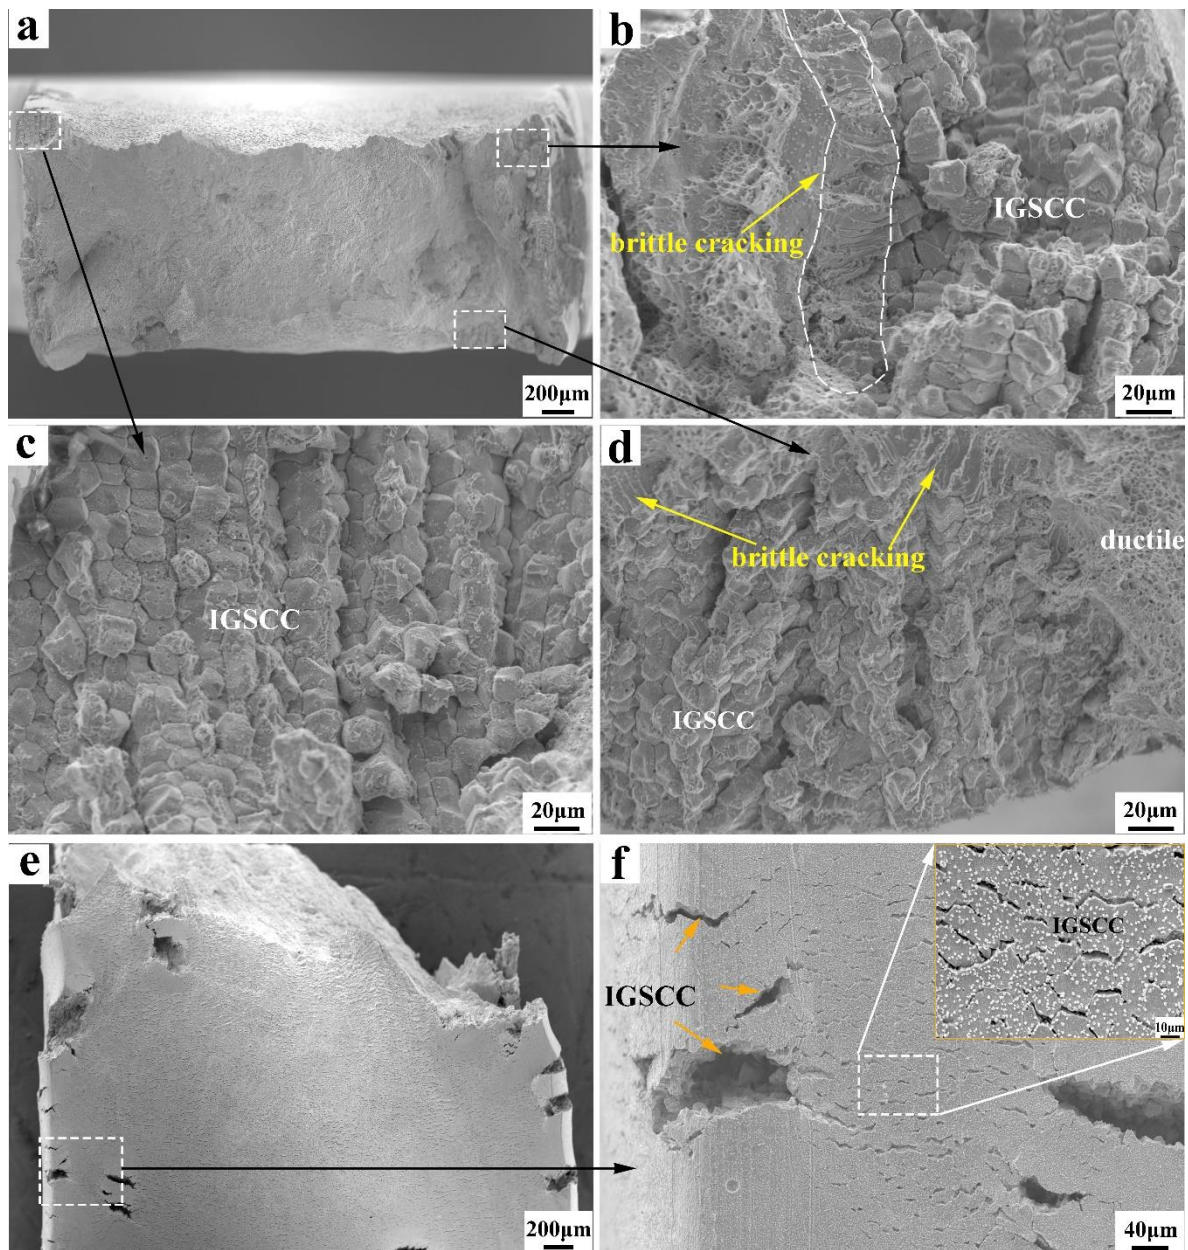
Fig. 17. SEM morphologies of the fracture surface after SSRT test at 3×10^{-7} /s for 308-SH specimen in deaerated high temperature water at 325 °C.

Fig. 17. SEM morphologies of the fracture surface and gauge side after SSRT test at 3×10^{-7} /s for 308-SH specimen in deaerated high temperature water at 325 °C.
